Appendix G: Camas Solar Project Site Reports and Permit Applications

CRITICAL AREAS WETLAND AND
WATERS DELINEATION REPORT FOR THE
CAMAS SOLAR PROJECT

CRITICAL AREAS WETLAND AND
WATERS DELINEATION REPORT FOR THE
CAMAS SOLAR PROJECT
KITITAS COUNTY, WASHINGTON

Report Prepared for
TUUSSO Energy, LLC

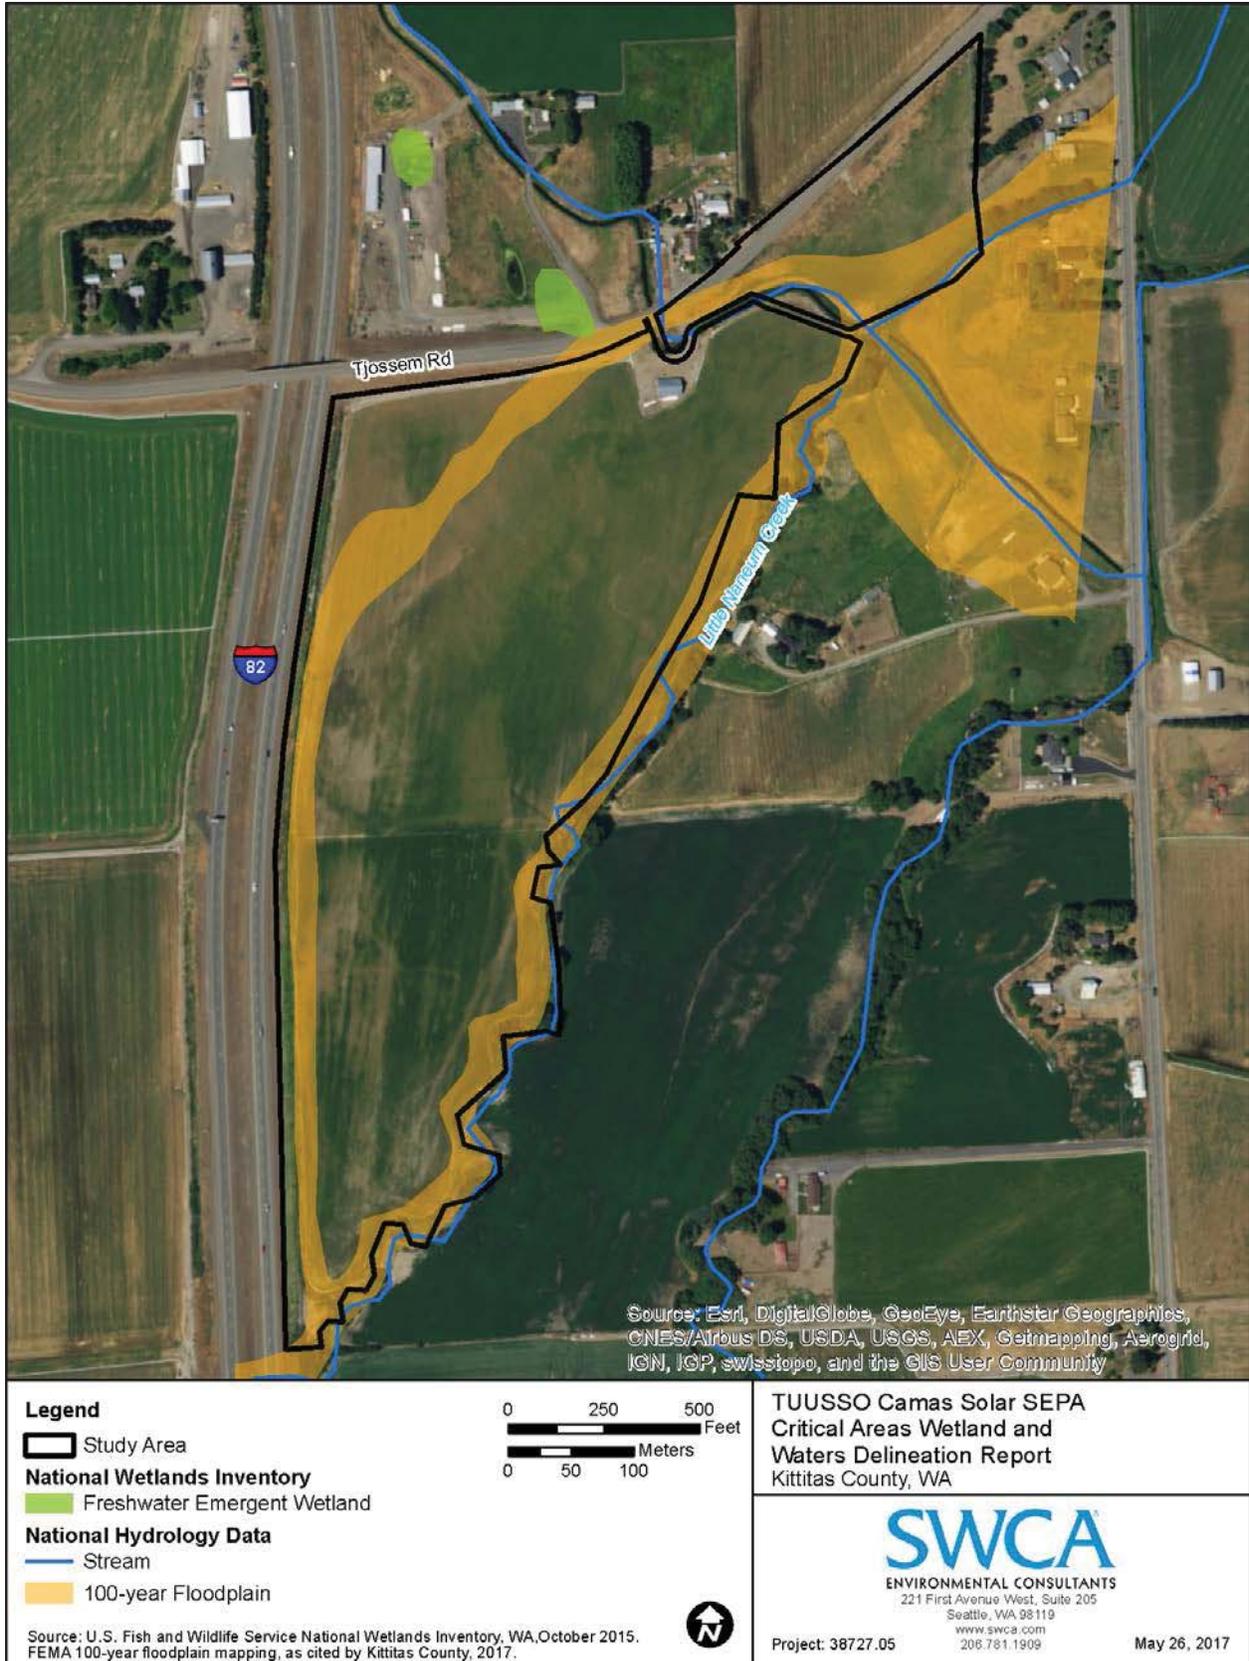
Figure 2. NWI, NHD, and floodplain mapping.

- Federal Emergency Management Agency (FEMA) Flood Insurance Rate Map (FIRM) Panel 5300950558B, included in Figure 2.

Spatial data obtained during the review of existing information were incorporated into the Camas Solar Project base maps (Figures 1 through 3).

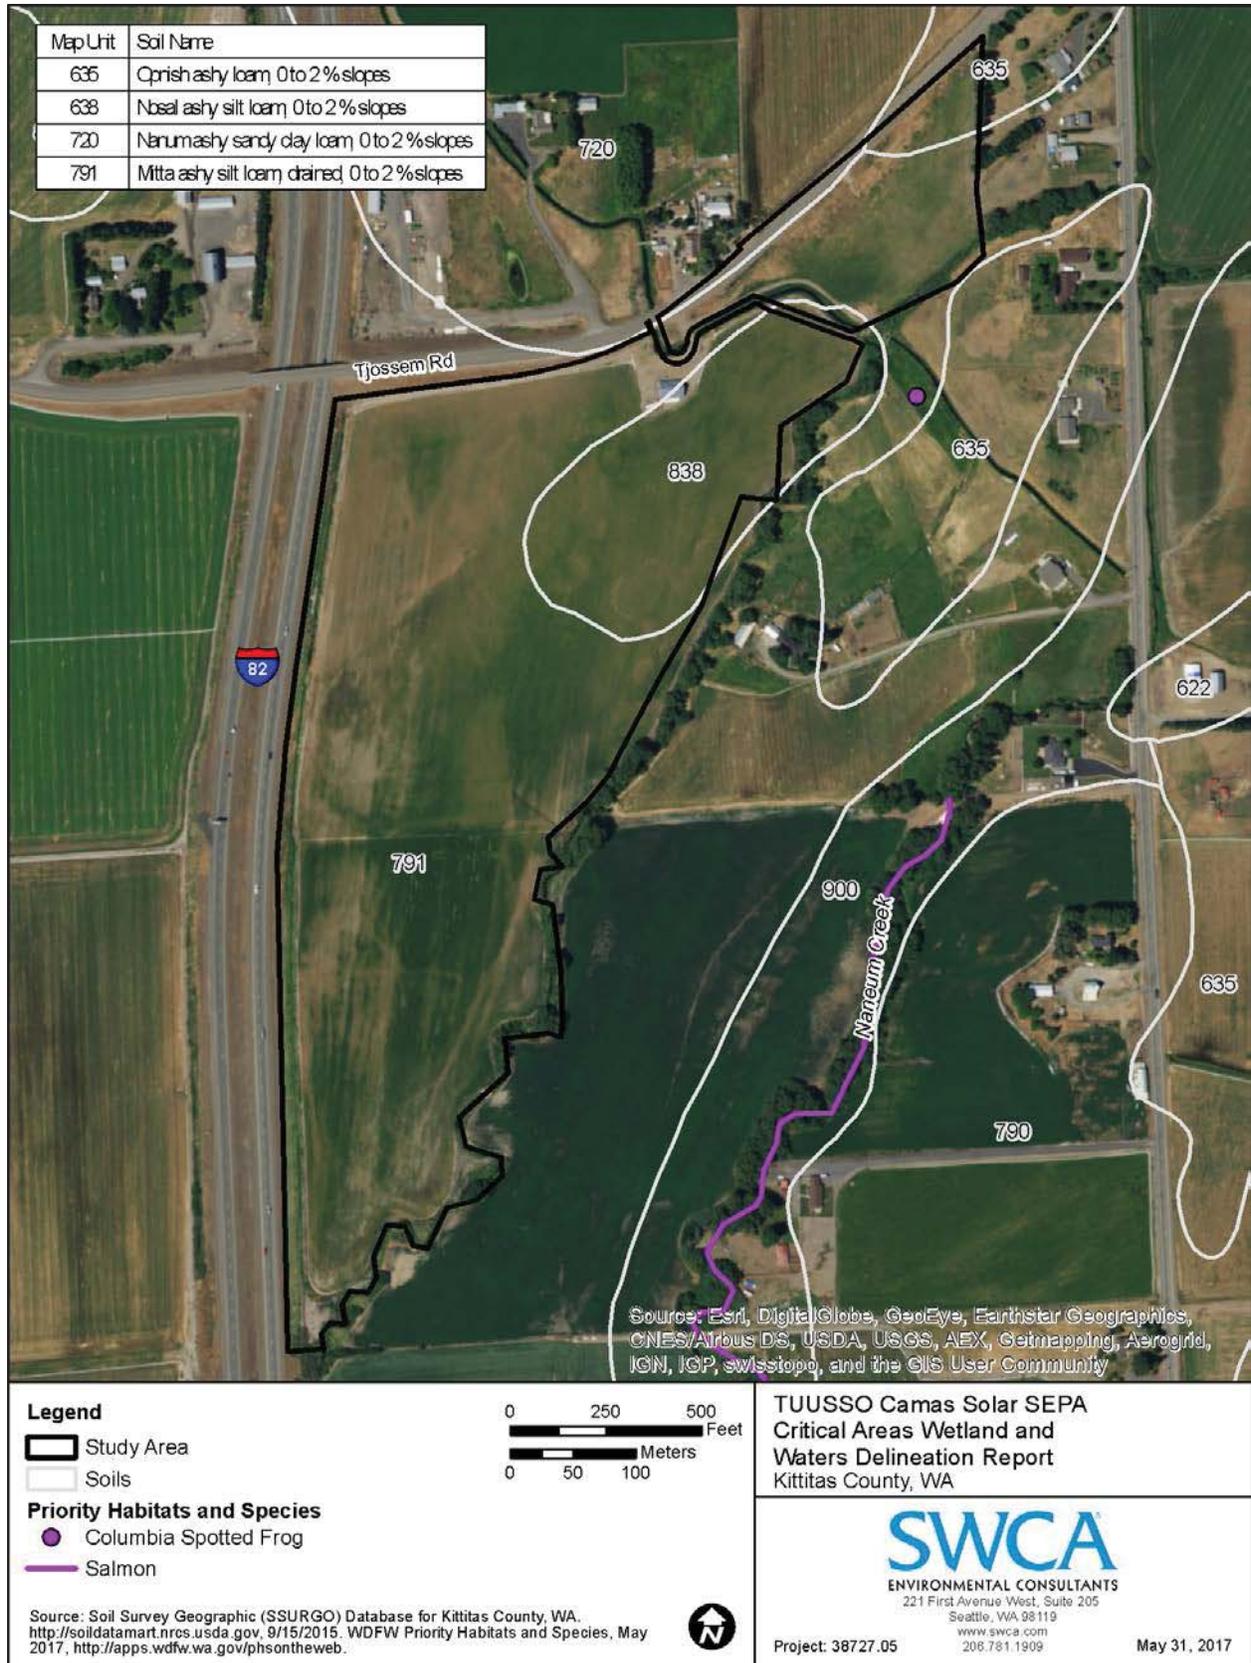
Figure 3. Soils and PHS mapping.

- Historical Google Earth aerial photography (2000–2016).
- U.S. Department of Agriculture (USDA) historical imagery (USDA 1954).
- U.S. Geological Survey (USGS) 7.5-minute topographic quadrangle map for Ellensburg South, Washington, included in Figure 1.
- USFWS National Wetlands Inventory (NWI) data and USGS National Hydrography Dataset (NHD), included in Figure 2.
- Natural Resources Conservation Service (NRCS) Soil Survey of Kittitas County Area, Washington and NRCS Web Soil Survey map of the study area, included in Figure 3.

- Includes riparian habitats and streams and rivers.
- Washington State Department of Fish and Wildlife (WDFW) SalmonScape online mapper.
- WDFW Priority Habitats and Species (PHS) online mapper, included in Figure 3.

Soils in Wetland CW01 are mapped as Mitta ashy silt loam, drained, with 0% to 2% slopes (NRCS 2017a) (see Figure 3). The soil profile observed within 16 inches of the soil surface consisted of very dark grayish brown (2.5Y 3/2) silt loam over a black (2.5Y 2.5/1) silt loam with redoximorphic features starting at 8 inches (Munsell Color 2009). The soils in Wetland CW01 meet the hydric soil indicator for Redox Dark Surface (F6).

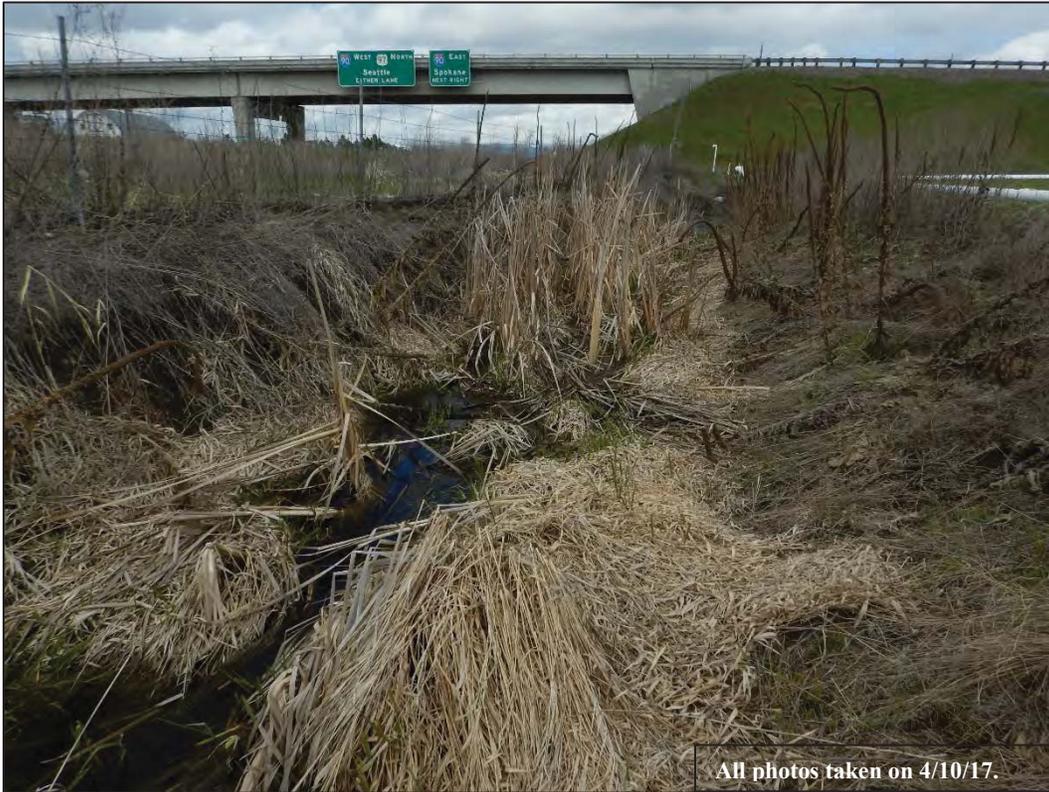
Photo A. View north of northern portion of Wetland CW01.

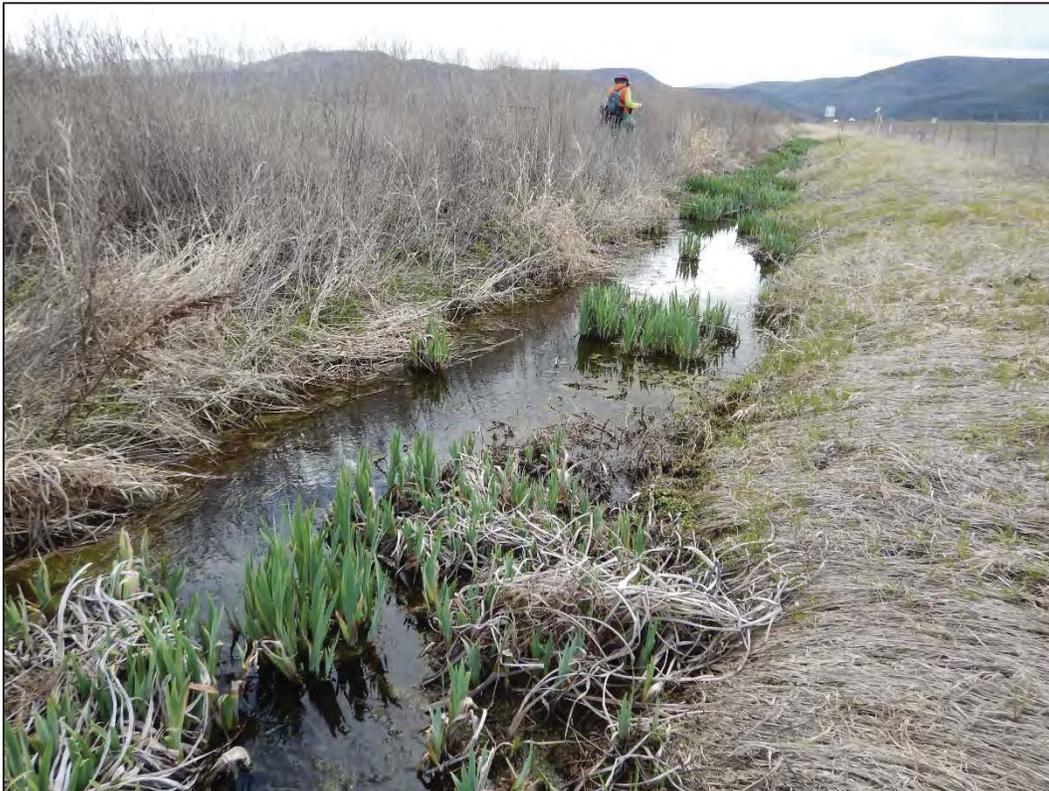
Photo B. View south of the middle portion of Wetland CW01, with fellow flag iris.

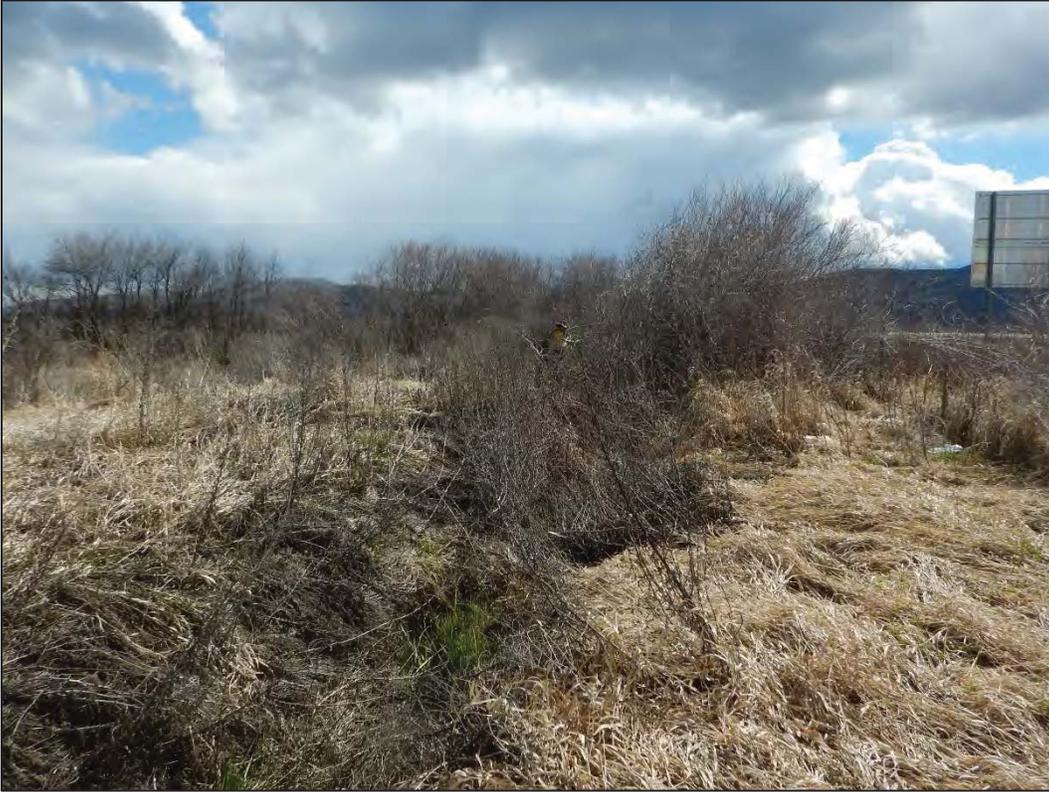
Photo C. View south of southern portion of Wetland CW01.

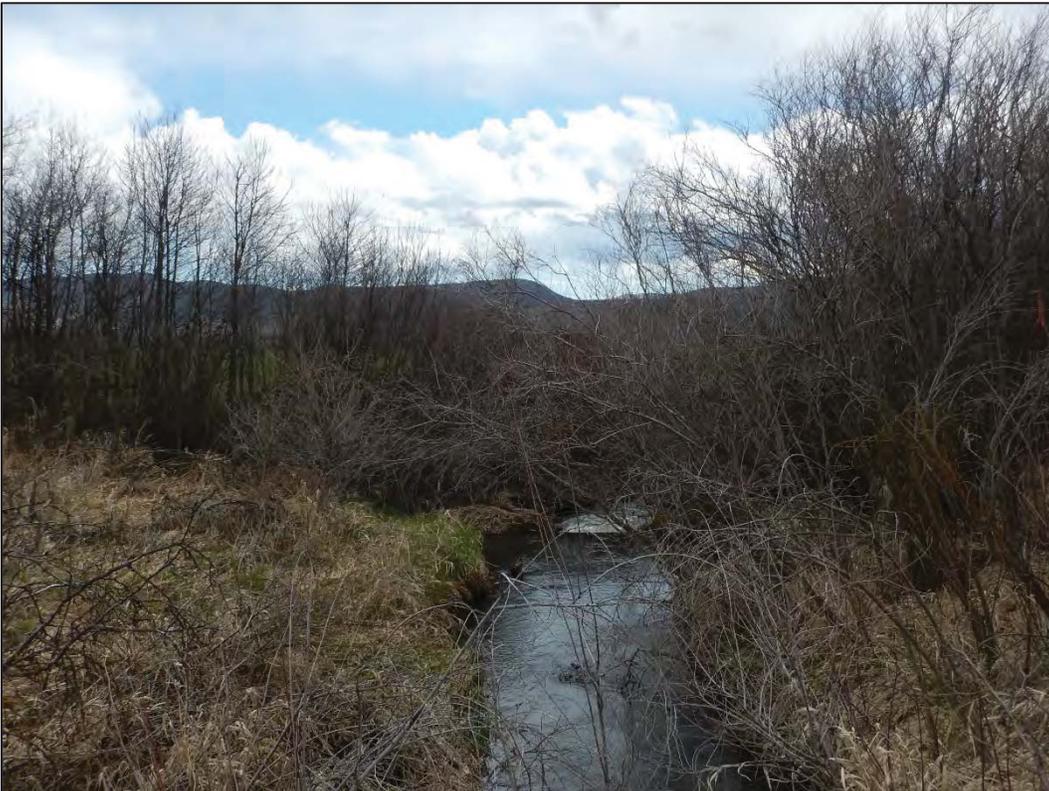
Photo D. View south of the southern study area extent of Little Naneum Creek.

Little Naneum Creek continues to travel a tightly meandering sinuous path southeast along the remainder of the eastern project site boundary, and then passes through a box culvert beneath I-82. The reach of the creek southwest of the Bull Ditch has moderate shrub cover for about 2,000 feet that gradually diminishes as the creek flows southwest. A small bridge crosses the creek. The southern 1,000 feet of the creek has little tree or shrub cover. Riparian vegetation along Little Naneum Creek consists mainly of crack willow (*Salix X fragilis*), Nootka rose (*Rosa nutkana*), black hawthorn (*Crataegus douglasii*), reed canary grass, Canadian thistle (*Cirsium arvense*), Fuller's teasel (*Dipsacus fullonum*), and singing nettle (*Urtica dioica*). The banks of the creek are relatively stable where adequate larger vegetation has stabilized the silt loam soils. The substrate of the creek consists of cobble, gravel, and sediment. There are many areas where large woody debris has fallen into the creek, which has caused moderate channel complexity. The creek is not constrained within the channel and floodplain roughness is relatively high, with abundant large woody debris, shrubs, and trees present along most of the reach.

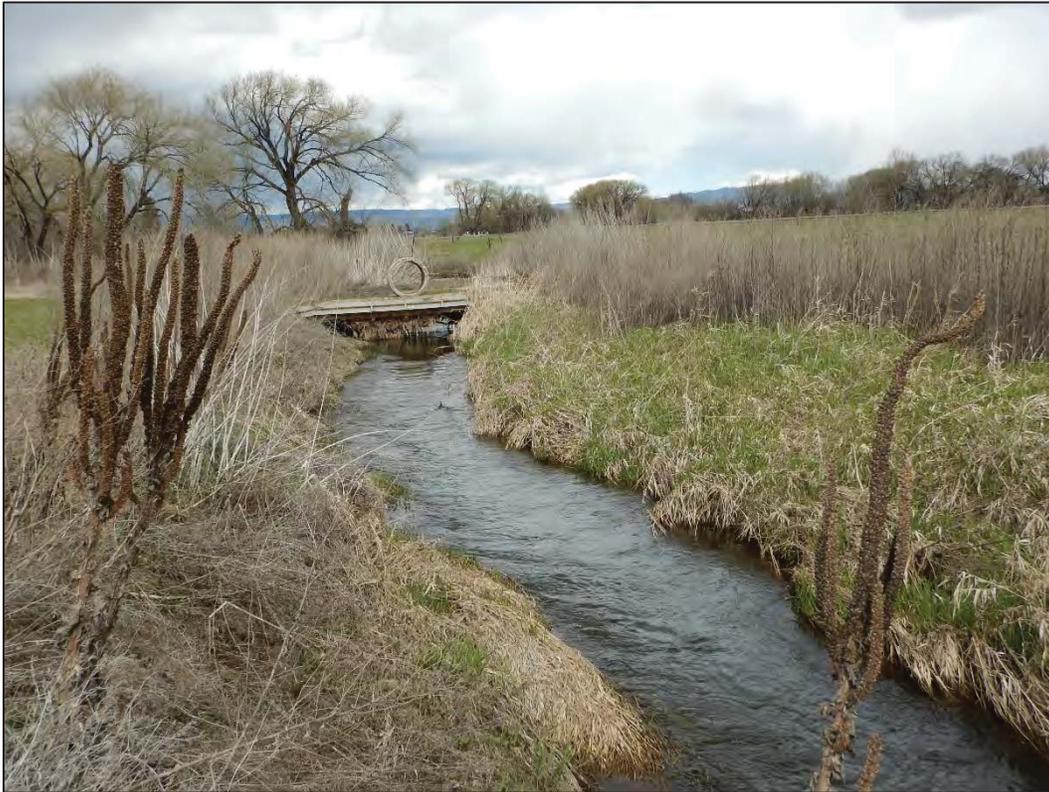
Photo E. View northeast of old bridge crossing of Little Naneum Creek.

The reach of Little Naneum Creek, within the Camas Solar Project study area, is somewhat altered from its natural condition. The creek flows unimpeded into the study area from the property to the northeast, where the creek flows southwest along the eastern project site boundary for about 150 feet, where a diversion channel captures and conveys some water parallel to the creek for about 200 feet, to Bull Ditch. Little Naneum Creek crosses over the top of Bull Ditch, which has been routed beneath the creek through a culvert.

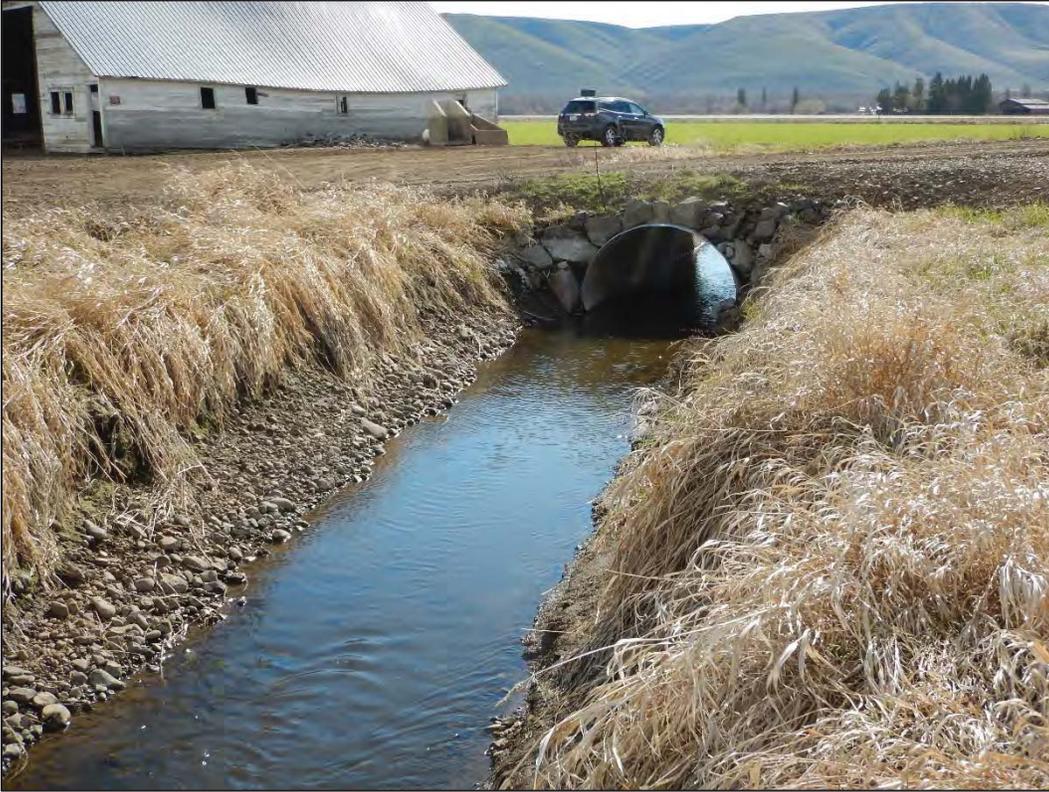
Photo G. View northwest of Bull Ditch at road crossing.
