# **DESERT CLAIM WIND POWER LLC.**

## **DESERT CLAIM WIND POWER PROJECT WETLAND DELINEATION AND ANALYSIS REPORT**

### **APPENDIX E: CROSSING PHOTO EXHIBIT**

## Part 7 and 8 Exhibit: Impact Details Per Crossing

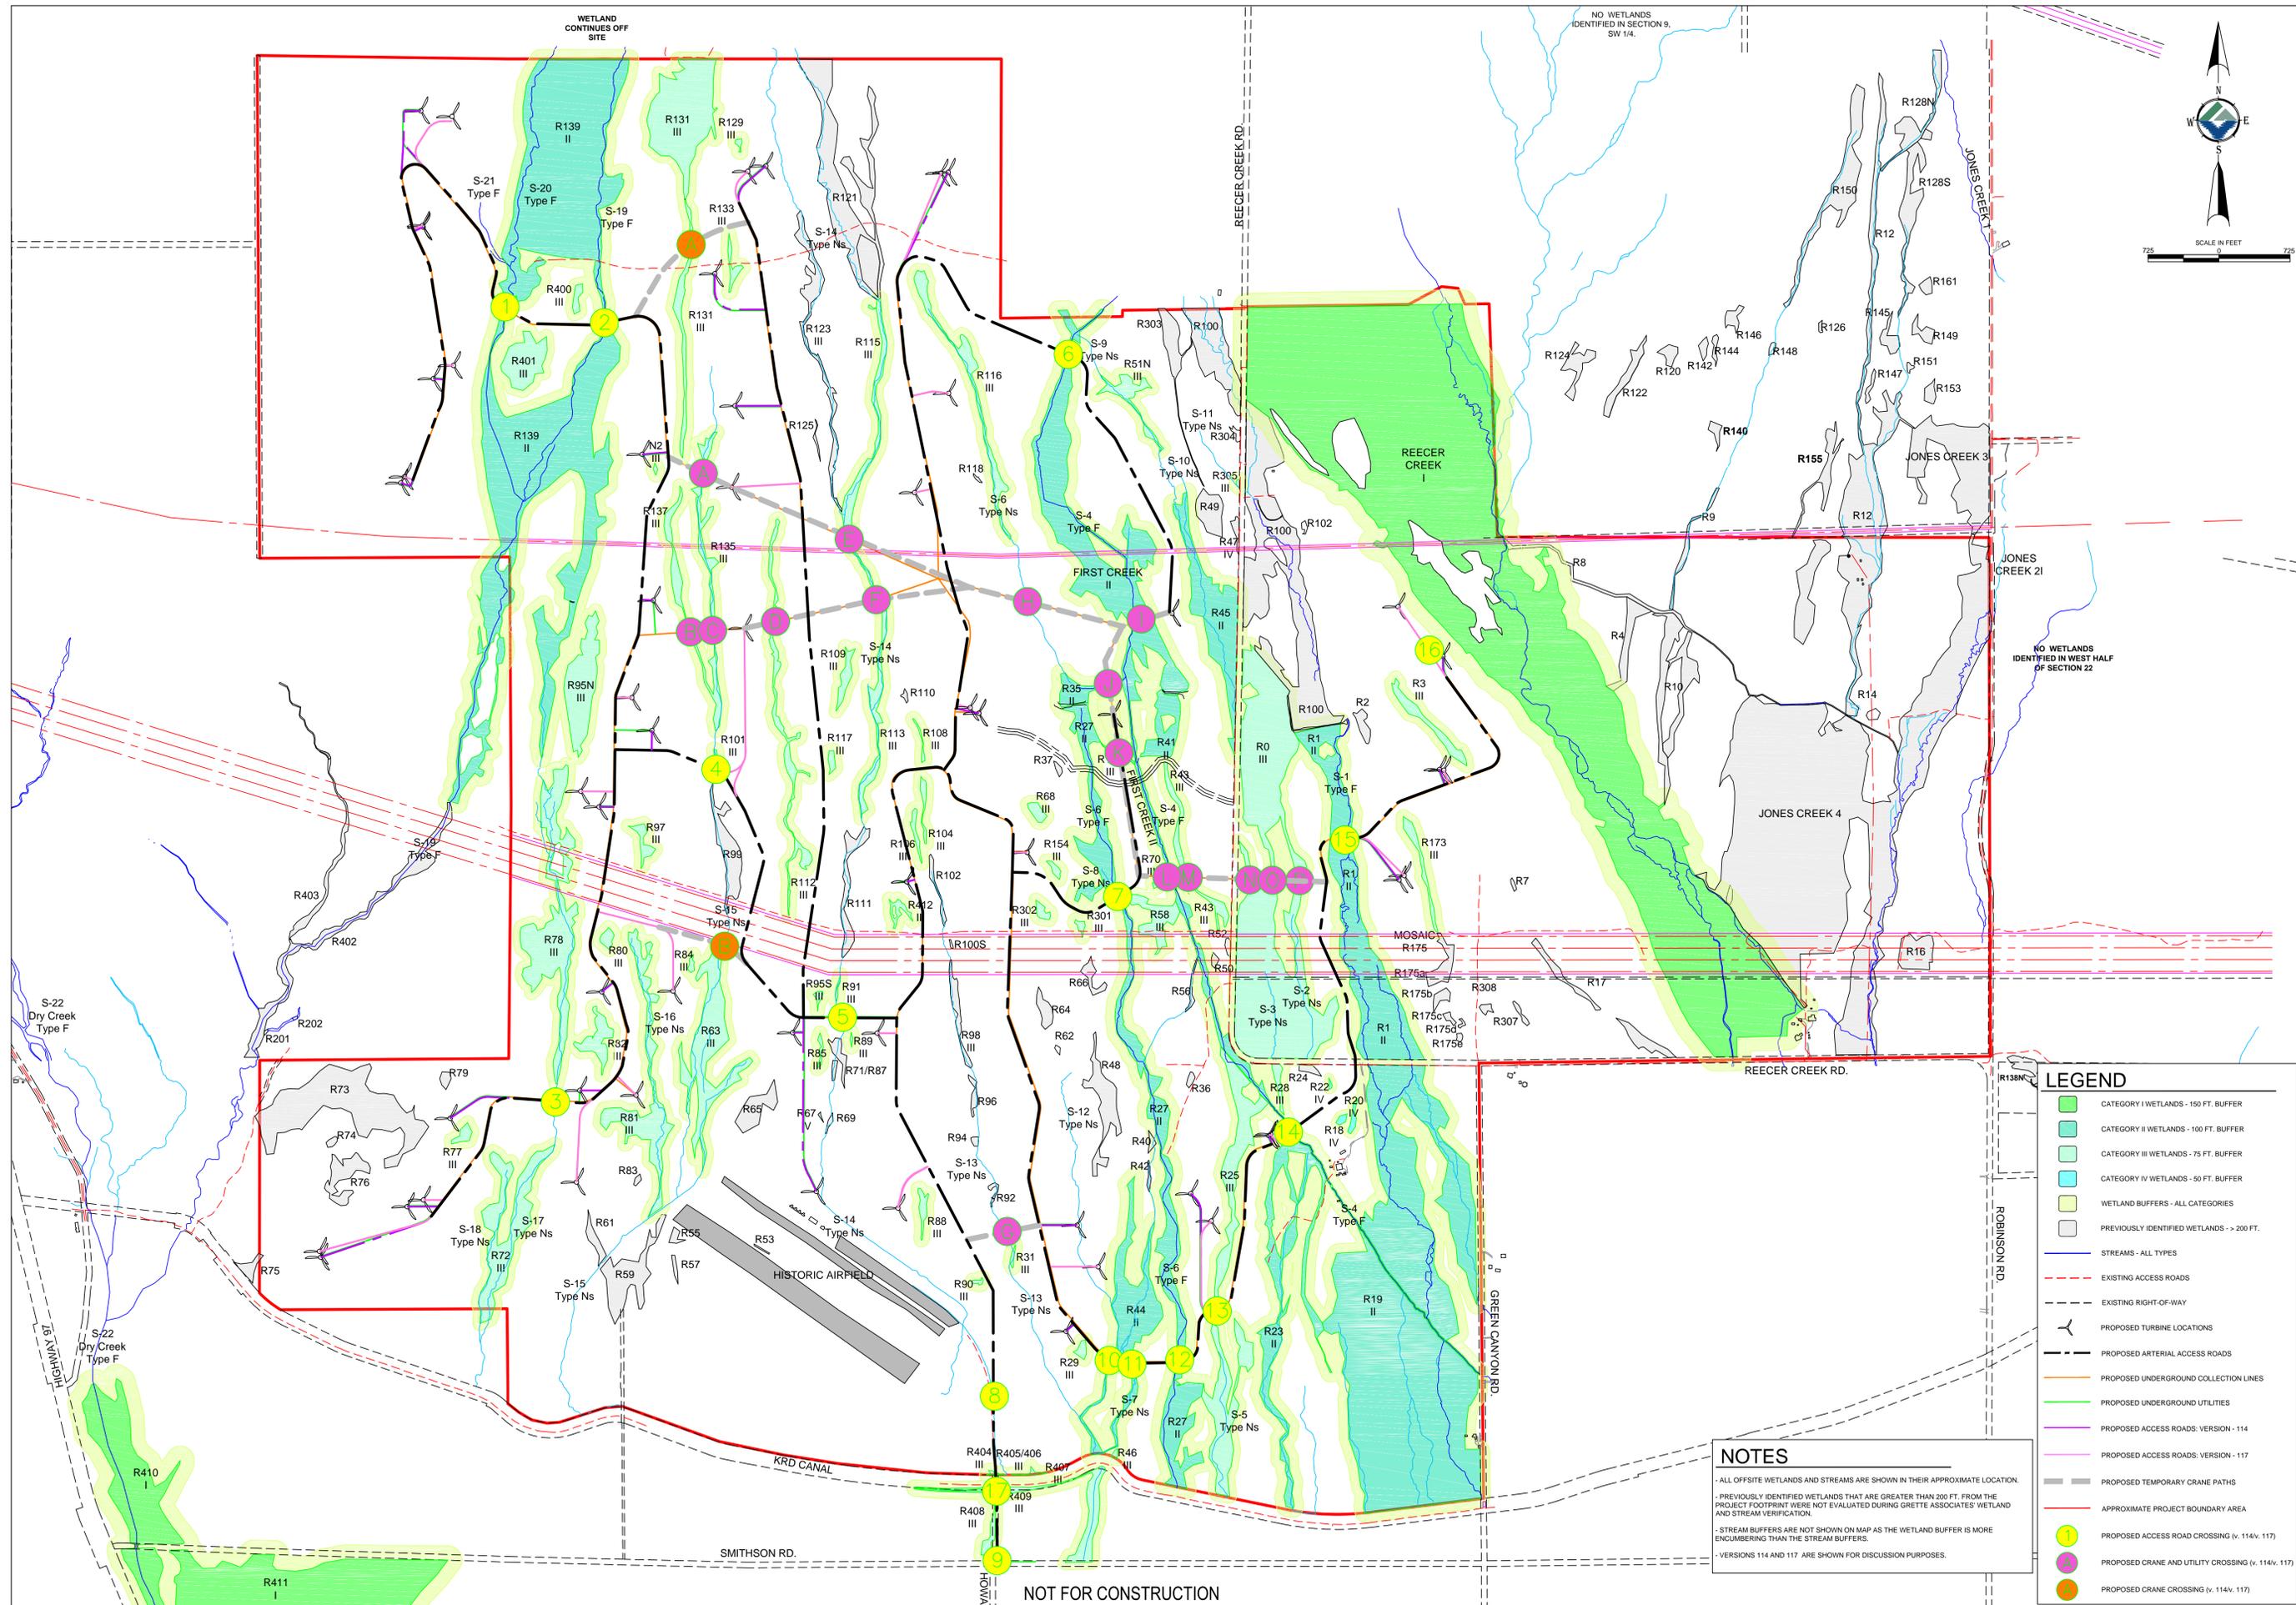
**DELINEATION MAP**  
**DESERT CLAIM WIND**  
**POWER PROJECT**

- ALL OFFSITE WETLANDS AND STREAMS ARE SHOWN IN THEIR APPROXIMATE LOCATION.
- PREVIOUSLY IDENTIFIED WETLANDS THAT ARE GREATER THAN 200 FT. FROM THE PROJECT FOOTPRINT WERE NOT EVALUATED DURING GRETTE ASSOCIATES' WETLAND AND STREAM VERIFICATION.
- STREAM BUFFERS ARE NOT SHOWN ON MAP AS THE WETLAND BUFFER IS MORE ENCOMPASSING THAN THE STREAM BUFFERS.
- VERSIONS 114 AND 117 ARE SHOWN FOR DISCUSSION PURPOSES.

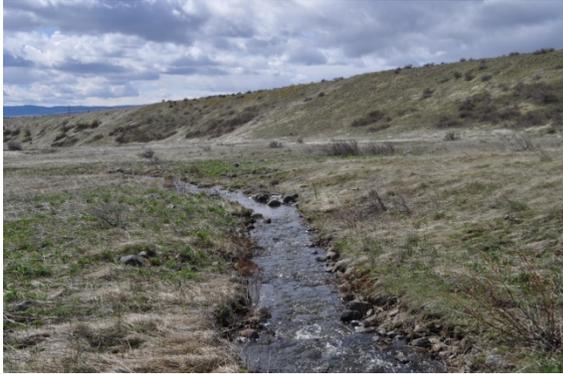
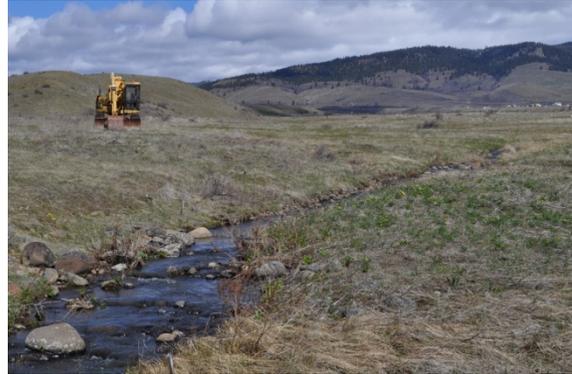
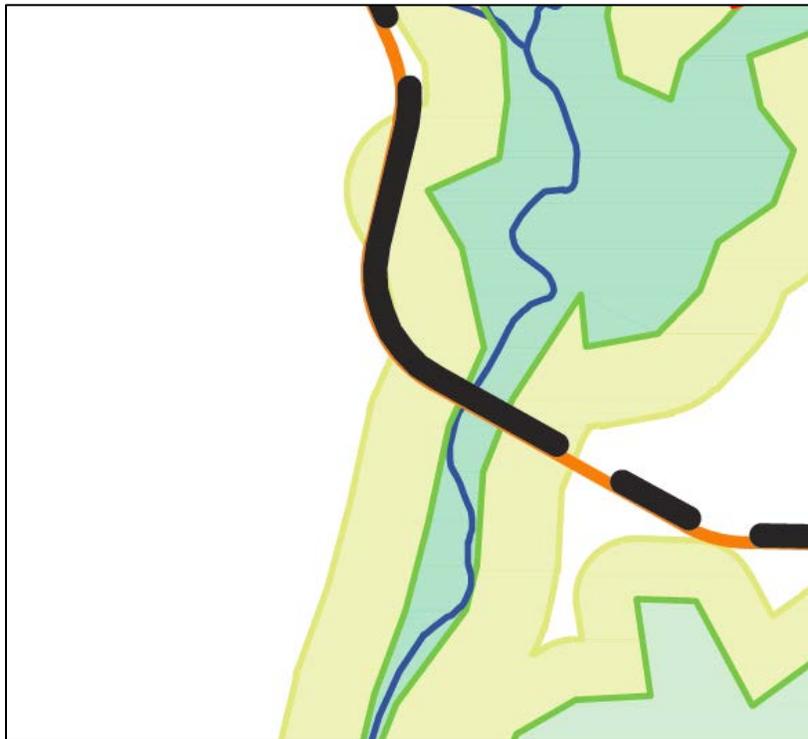
Wetland R139, Stream S-20

**Crossing RX-1:** Seasonal stream within the western portion of R139. Stream was observed dry in summer of 2017. Standard Duty Crossing.

Activity	Wetland/Type	Impact /volume (ft <sup>2</sup> /yds <sup>3</sup> )	Stream/Type	Impact /volume (ft <sup>2</sup> /yds <sup>3</sup> )
Permanent Fill	R139 Riverine Cat II	1002/76	S20 Type F	174/13
Disturbance (<90 days)	Same	2222	Same	349

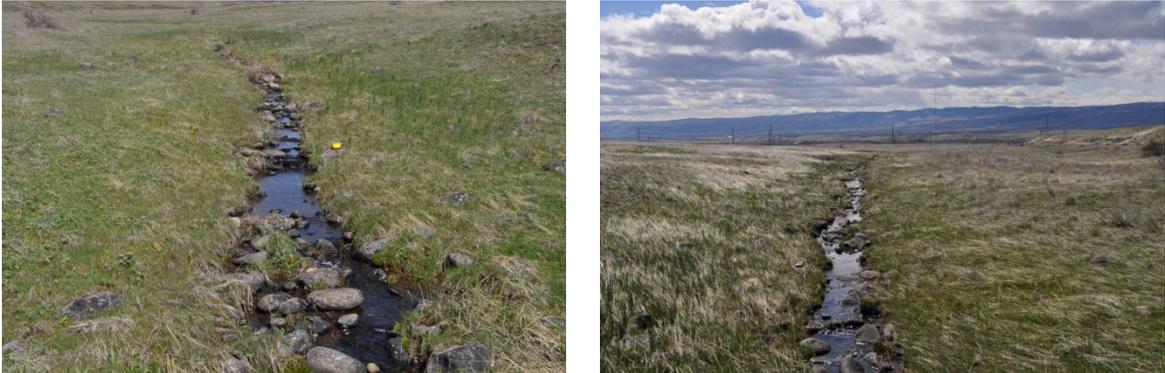
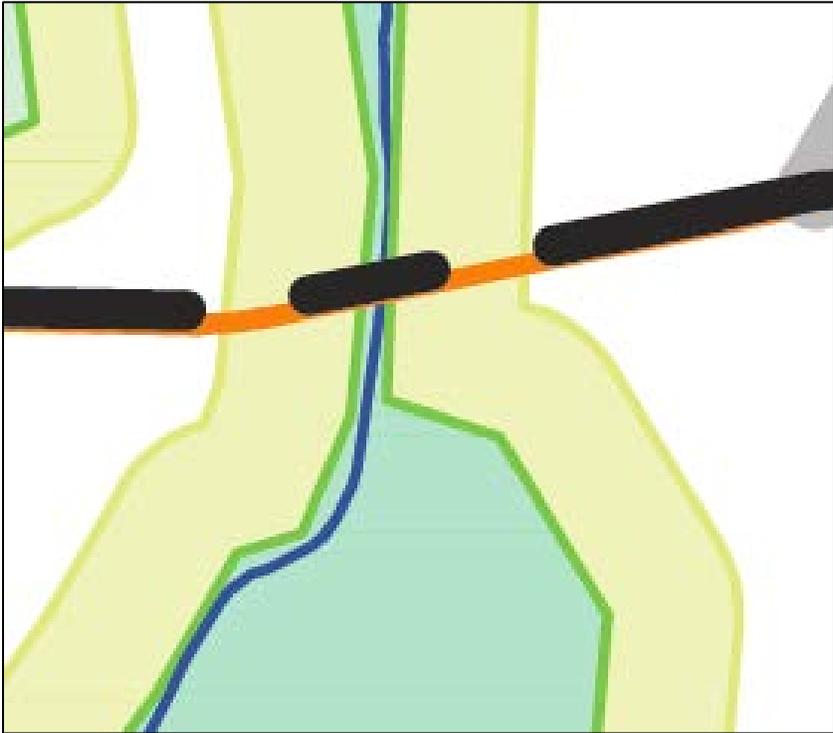
Wetland R-139, Stream S-19

RX-2: Seasonal stream within the eastern portion of R139. Stream was observed dry in summer of 2017. Standard duty crossing.

Activity	Wetland/Type	Impact /volume (ft <sup>2</sup> /yds <sup>3</sup> )	Stream/Type	Impact /volume (ft <sup>2</sup> /yds <sup>3</sup> )
Permanent Fill	R-139 Riverine Cat II	392/28	S19 Type F	44/4
Disturbance (<90 days)	Same	828ft <sup>2</sup>	Same	131ft <sup>2</sup>

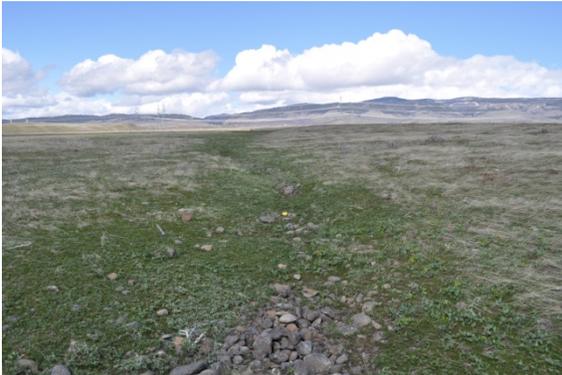
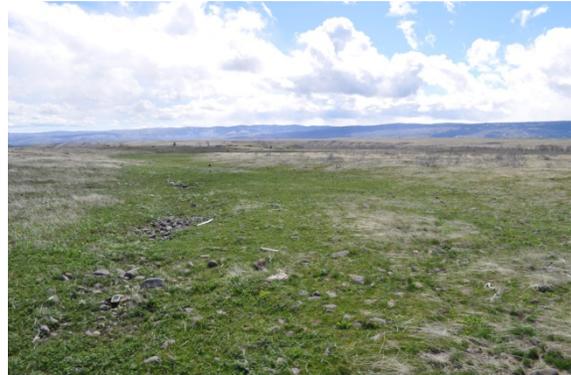
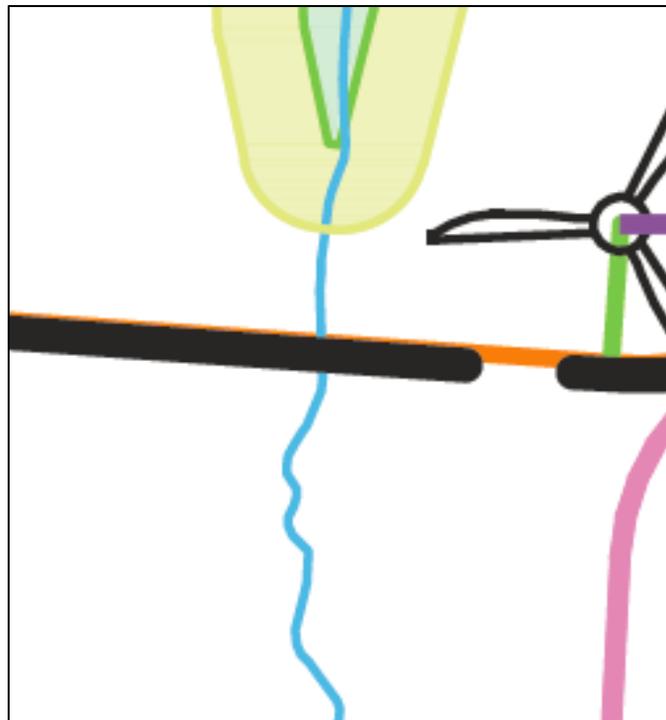
Stream S-17

RX-3: Observed stream characteristics (bed and channel) are fragmented within a vegetated topographic swale. Channeled area was observed with no hydrology (S-17). The origin of any continuous feature would be situated south within R72. Standard duty crossing.

Activity	Wetland/Type	Impact /volume (ft <sup>2</sup> /yds <sup>3</sup> )	Stream/Type	Impact /volume (ft <sup>2</sup> /yds <sup>3</sup> )
Permanent Fill	N/A	N/A	S-17 Type Ns	44/4
Disturbance (<90 days)	N/A	N/A	Same	131ft <sup>2</sup>

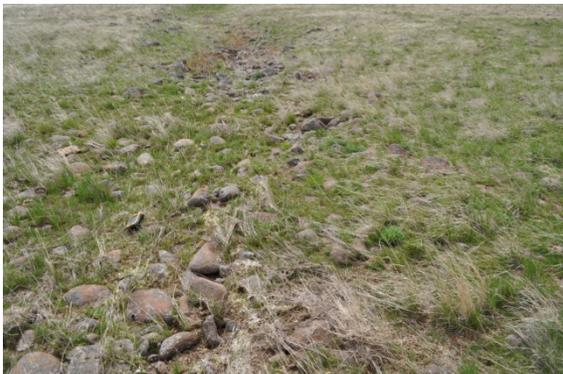
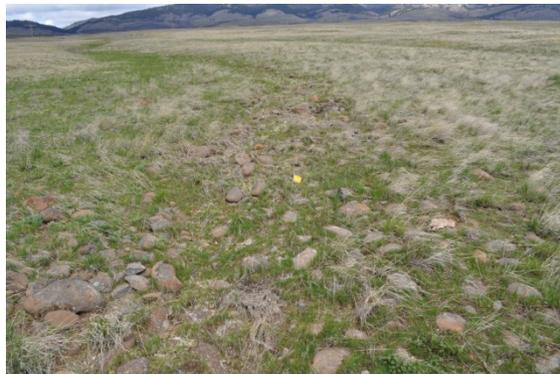
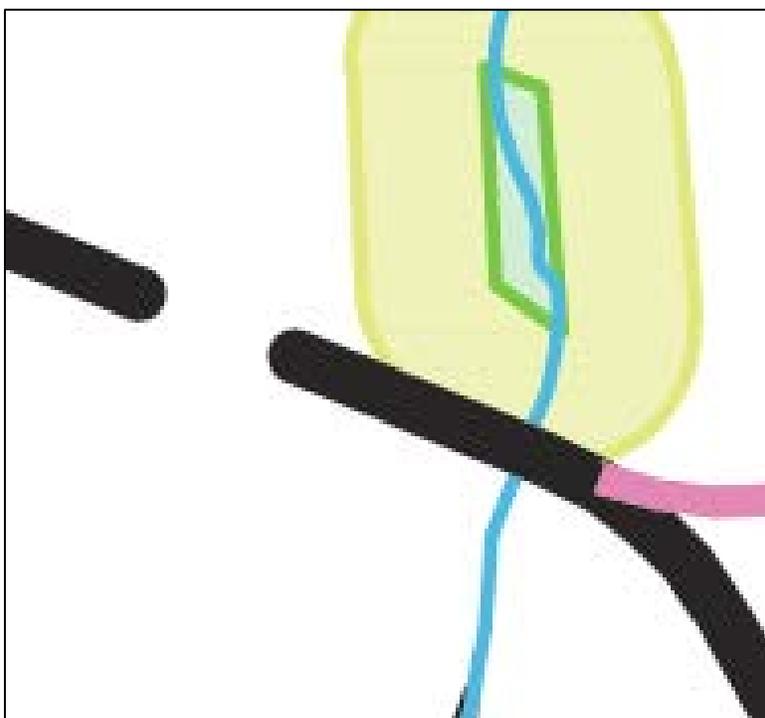
Stream S-15

RX-4: Indication of periodic flow or ponding (non-flow) was observed. Area was dry. Based on observation, the more appropriate characterization of this feature (S-15) is an ephemeral swale. In addition, upslope observations at CCX-A, B, and C did not observe any channelized flow. Observed surface hydrology (sheet flow) was associated with wetland R1. Standard duty crossing.

Activity	Wetland/Type	Impact /volume (ft <sup>2</sup> /yds <sup>3</sup> )	Stream/Type	Impact /volume (ft <sup>2</sup> /yds <sup>3</sup> )
Permanent Fill	N/A	N/A	S-15 Type Ns	131/9
Disturbance (<90 days)	N/A	N/A	Same	262ft <sup>2</sup>

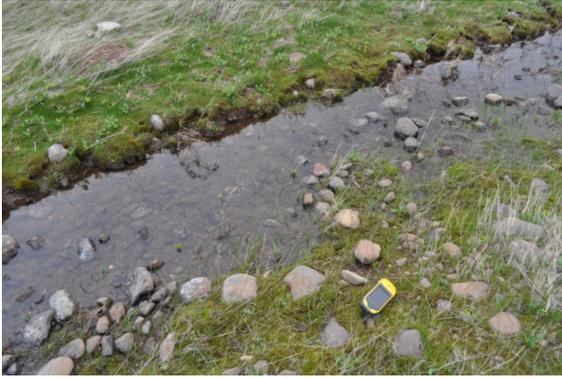
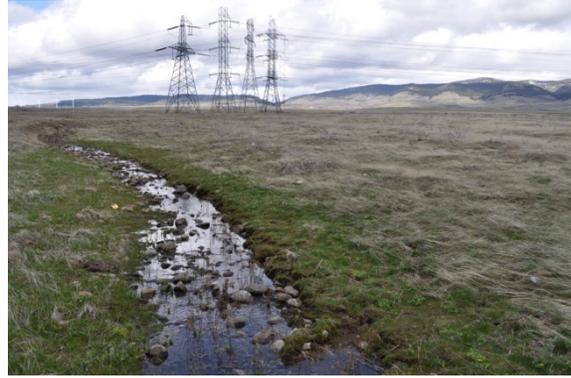
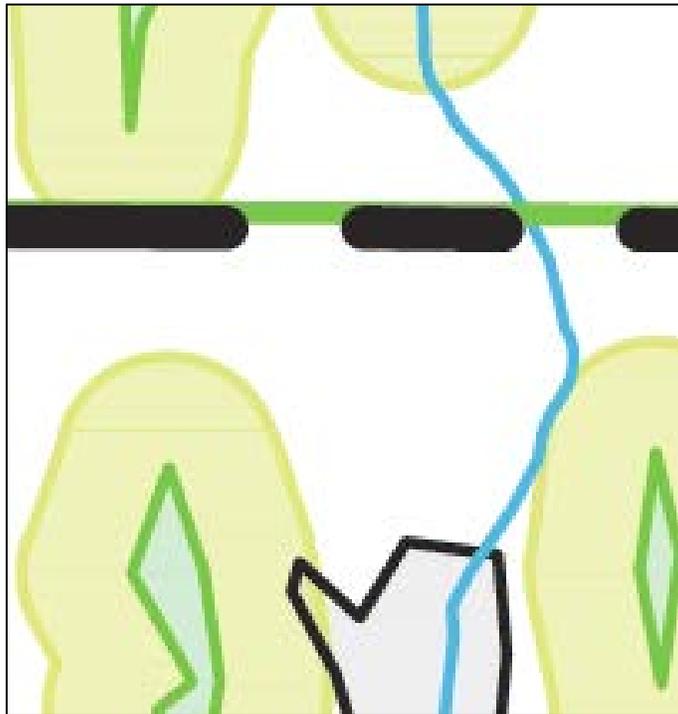
Stream S-14

RX-5: Seasonal stream (S-14), no fringe wetland. Standard duty crossing.

Activity	Wetland /Type	Impact /volume (ft <sup>2</sup> /yds <sup>3</sup> )	Stream/Type	Impact /volume (ft <sup>2</sup> /yds <sup>3</sup> )
Permanent Fill	N/A	N/A	S-14, Type Ns	131/10
Disturbance (<90 days)	N/A	N/A	Same	262ft <sup>2</sup>

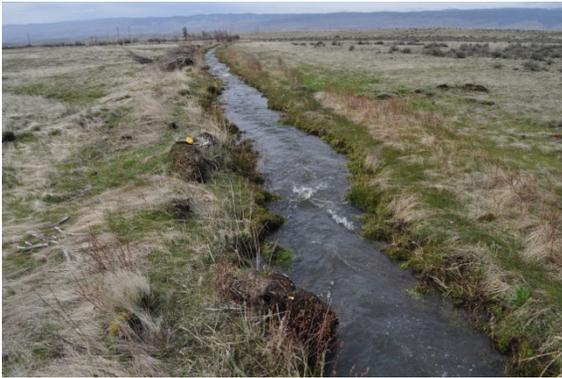
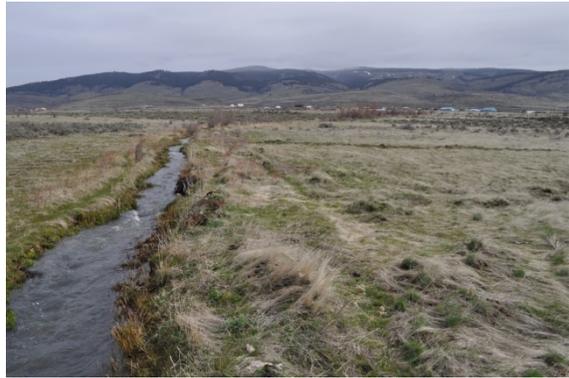
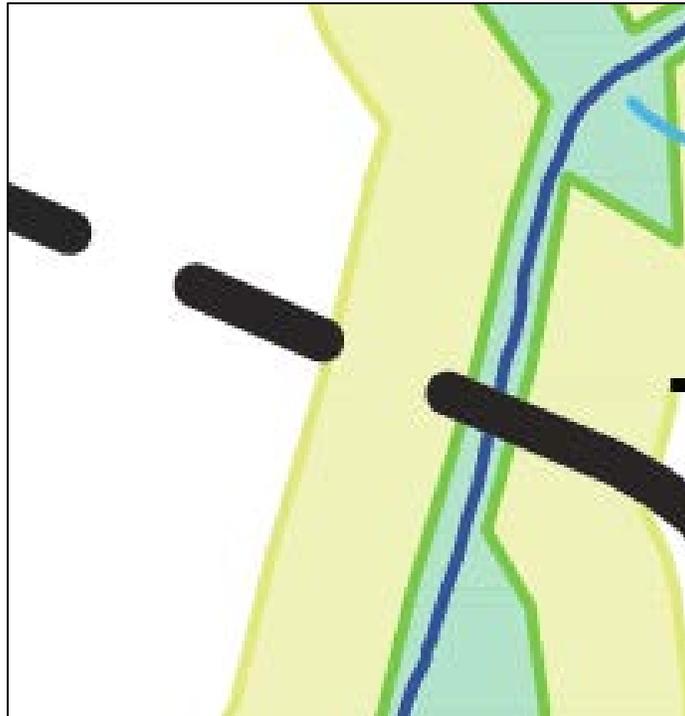
RX-6: First Creek (S-4) crossing. Standard duty crossing with culvert.

Activity	Wetland/Type	Impact /volume (ft <sup>2</sup> /yds <sup>3</sup> )	Stream/Type	Impact /volume (ft <sup>2</sup> /yds <sup>3</sup> )
Permanent Fill	First Creek Riverine Cat II	653/47	S-4, Type F	87/7
Disturbance (<90 days)	Same	1394ft <sup>2</sup>	Same	218ft <sup>2</sup>

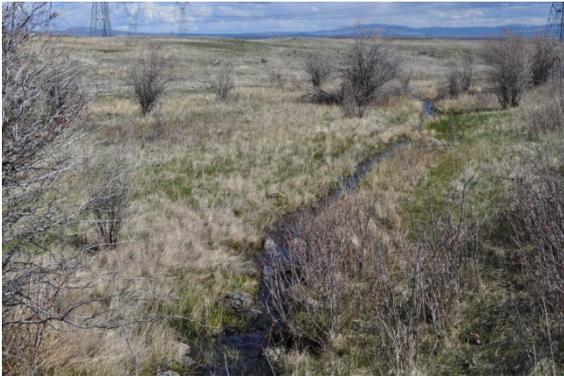
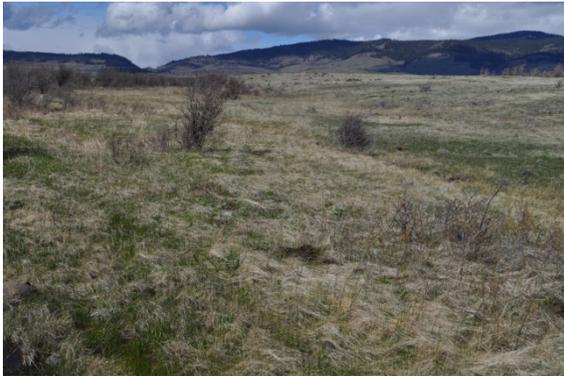
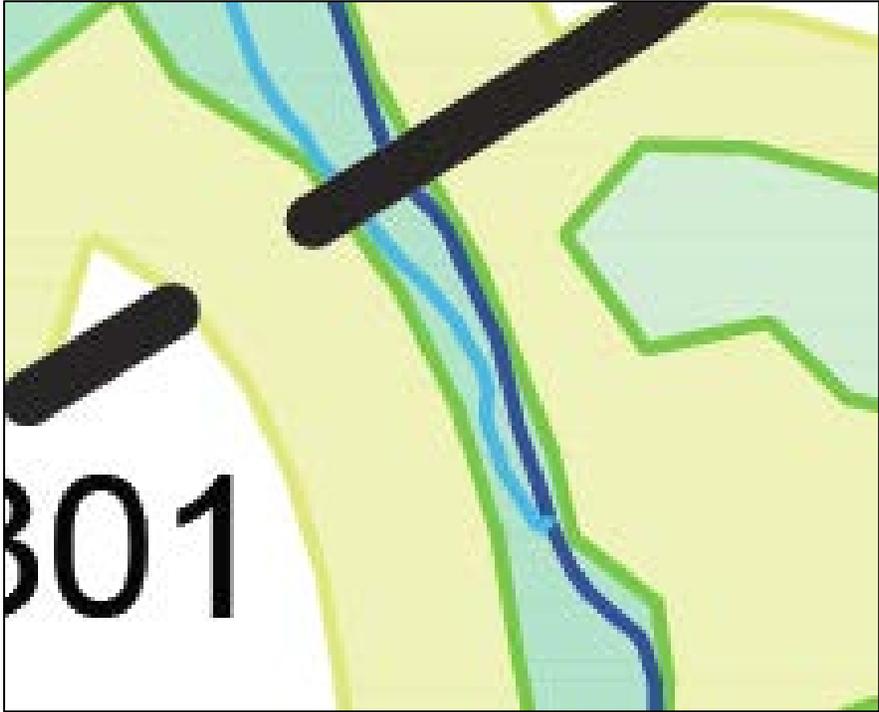
Wetland R2, Stream S-6

RX-7: Perennial stream with fringe wetland. Standard duty crossing.

Activity	Wetland/Type	Impact /volume (ft <sup>2</sup> /yds <sup>3</sup> )	Stream/Type	Impact /volume (ft <sup>2</sup> /yds <sup>3</sup> )
Permanent Fill	R27 Riverine Cat II	1020/76	S-6, Type F	44/4
Disturbance (<90 days)	Same	2090ft <sup>2</sup>	Same	131ft <sup>2</sup>

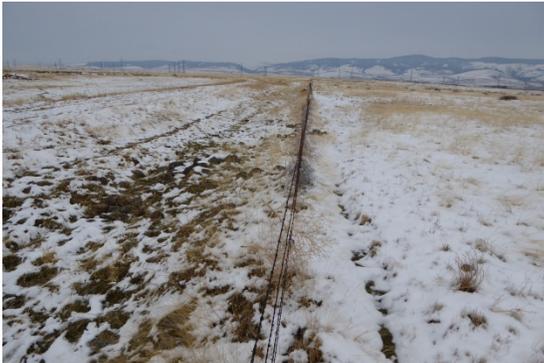
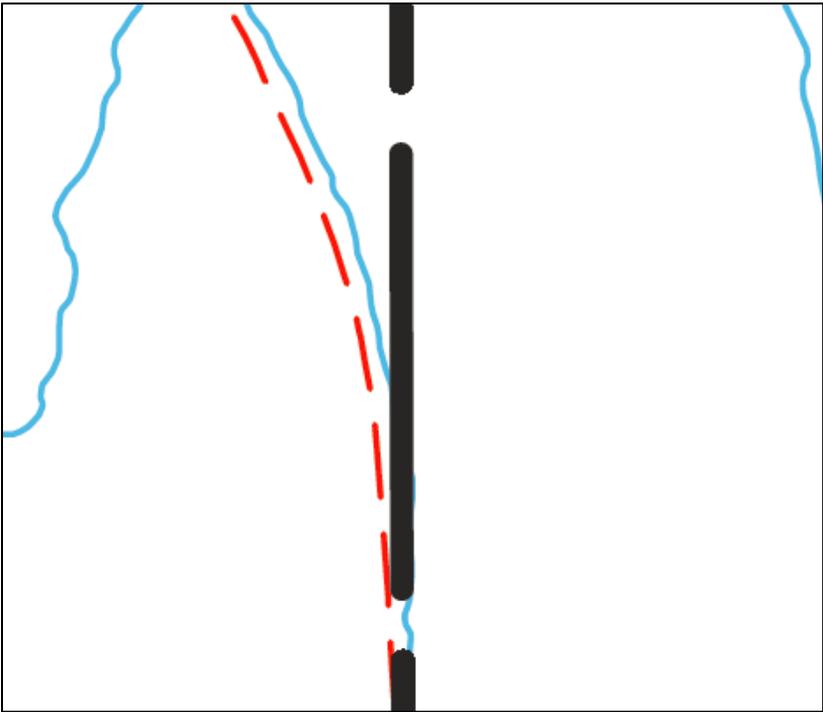
Stream S-14

RX-8: Ditched ephemeral stream (S-14). Standard duty crossing.

Activity	Wetland/Type	Impact /volume (ft <sup>2</sup> /yds <sup>3</sup> )	Stream/Type	Impact /volume (ft <sup>2</sup> /yds <sup>3</sup> )
Permanent Fill	N/A	N/A	S-14, Type Ns	44/4
Disturbance (<90 days)	N/A	N/A	Same	131ft <sup>2</sup>

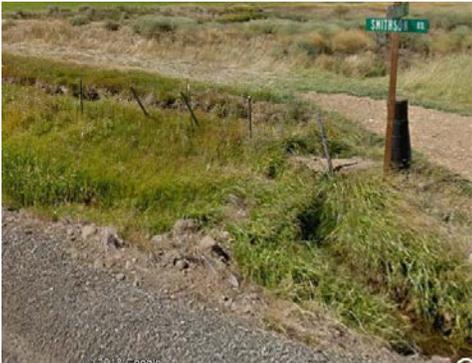
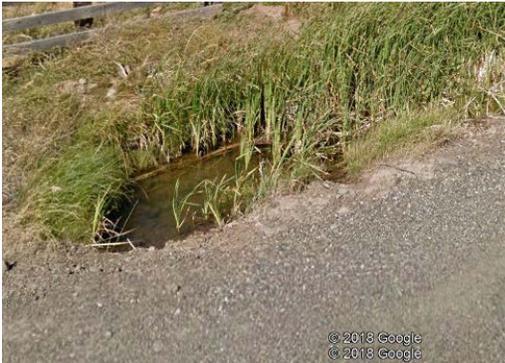
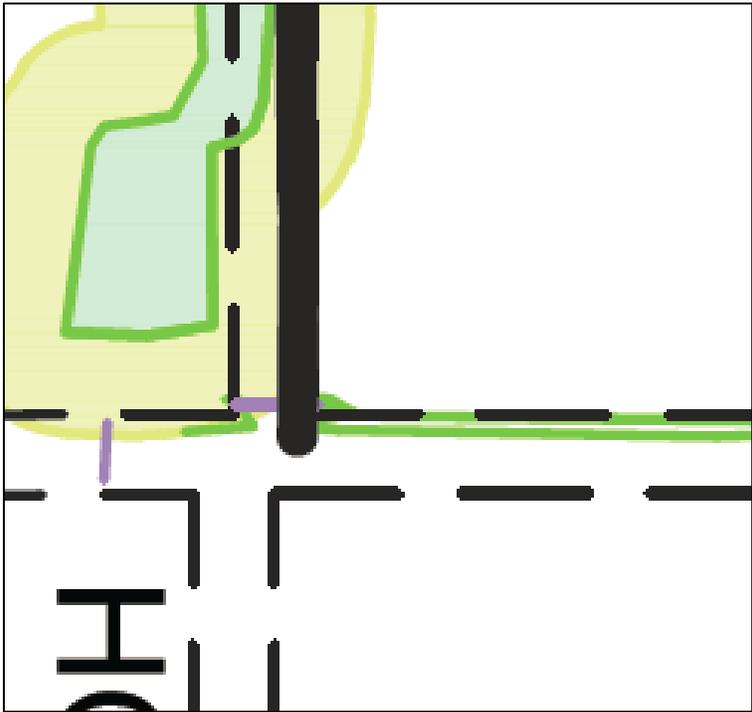
Smithson Rd ditch

RX-9: Ditch along Smithson Rd.

Activity	Wetland/Type	Impact /volume (ft <sup>2</sup> /yds <sup>3</sup> )	Stream/Type	Impact /volume (ft <sup>2</sup> /yds <sup>3</sup> )
Permanent Fill	N/A	N/A	Ditch	N/A
Disturbance (<90 days)	N/A	N/A	Same	828ft <sup>2</sup>

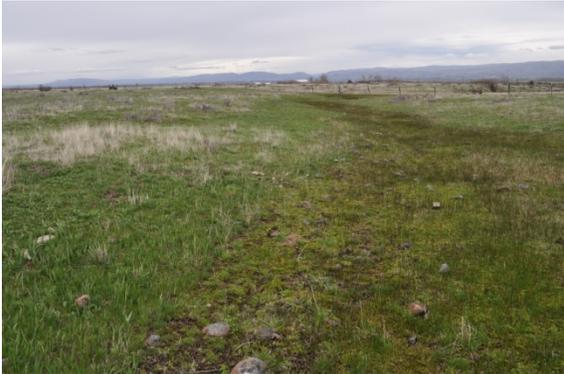
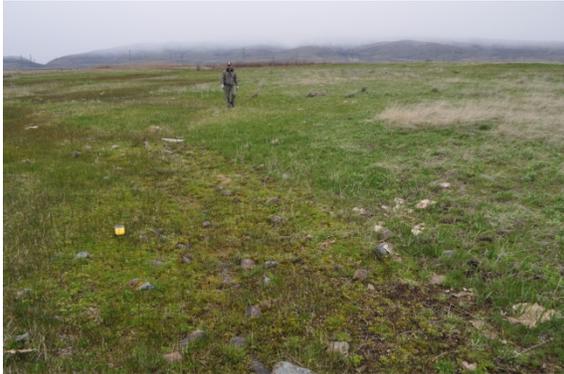
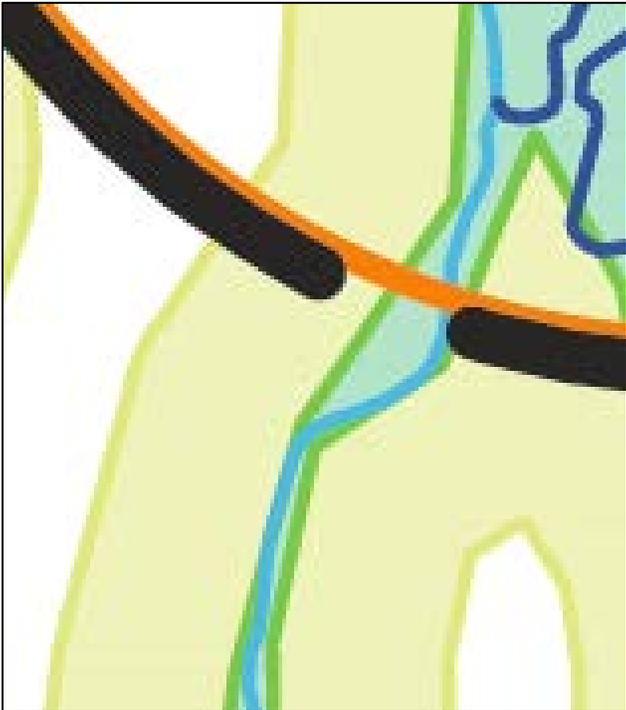
Wetland R44, Stream S-12

RX-10: Very little surface water observed. No stream indicators observed at crossing location. Standard duty crossing.

Activity	Wetland/Type	Impact /volume (ft <sup>2</sup> /yds <sup>3</sup> )	Stream/Type	Impact /volume (ft <sup>2</sup> /yds <sup>3</sup> )
Permanent Fill	R44 Riverine Cat II	871/64	S-12 Type Ns	44/3
Disturbance (<90 days)	Same	1742ft <sup>2</sup>	Same	88ft <sup>2</sup>

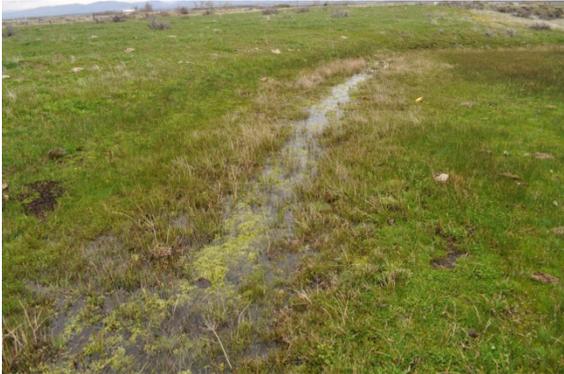
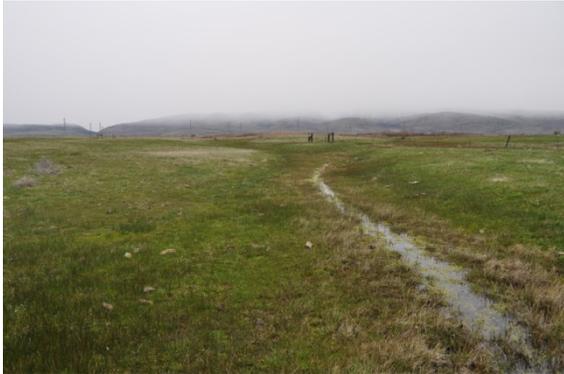
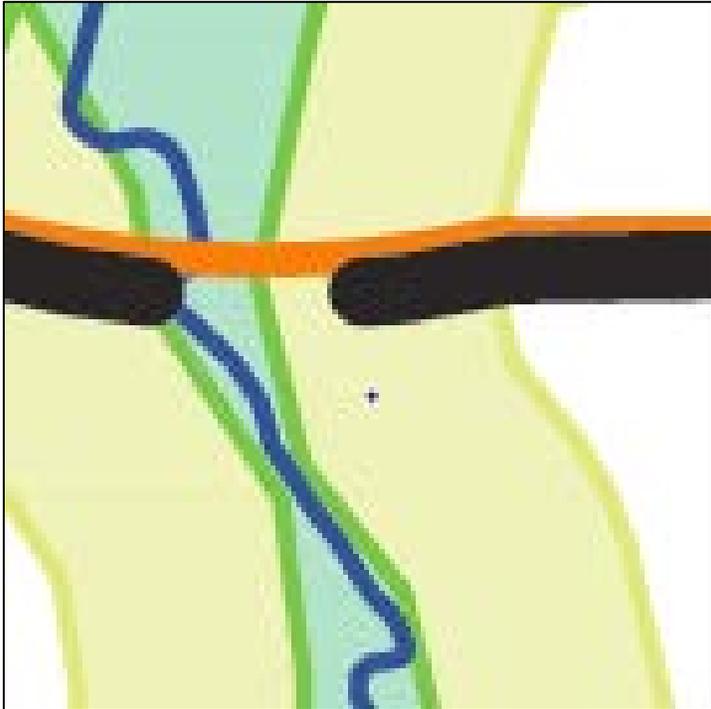
Wetland R44, Stream S-6

RX-11: Surface water and flow was observed. Flow was confined in a vegetated area within the wetland. Standard duty crossing.

Activity	Wetland/Type	Impact /volume (ft <sup>2</sup> /yds <sup>3</sup> )	Stream/Type	Impact /volume (ft <sup>2</sup> /yds <sup>3</sup> )
Permanent Fill	R44 Riverine Cat II	915/68	S-6 Type F	44/3
Disturbance (<90 days)	Same	1873ft <sup>2</sup>	Same	88ft <sup>2</sup>

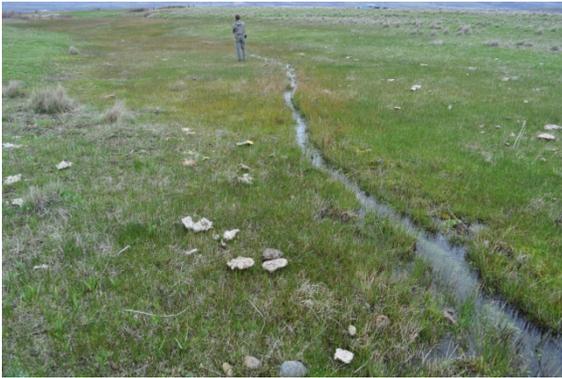
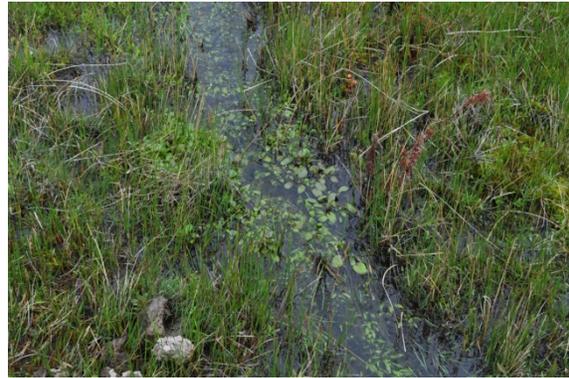
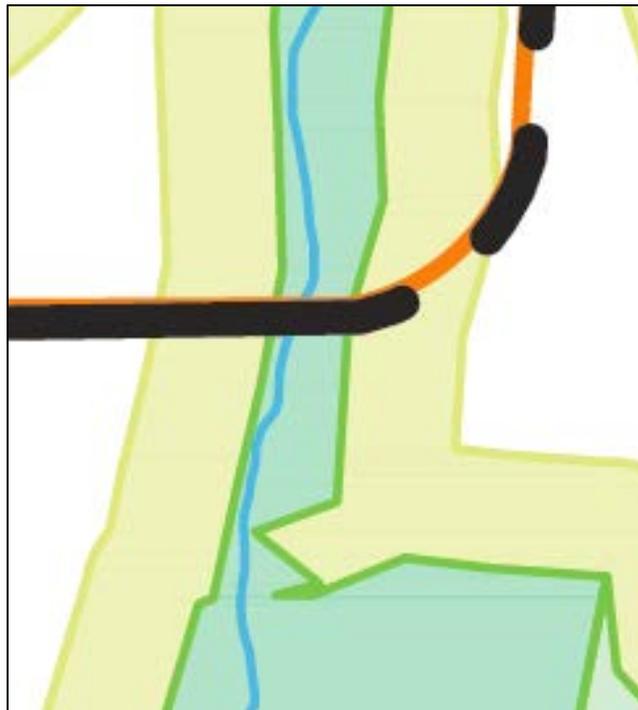
Wetland R27, Stream S-7

RX-12: This portion of stream was dry in summer of 2017. Standard duty crossing.

Activity	Wetland/Type	Impact /volume (ft <sup>2</sup> /yds <sup>3</sup> )	Stream/Type	Impact /volume (ft <sup>2</sup> /yds <sup>3</sup> )
Permanent Fill	R27 Riverine Cat II	1263/93	S-7 Type Ns	44/3
Disturbance (<90 days)	Same	2570ft <sup>2</sup>	Same	88ft <sup>2</sup>

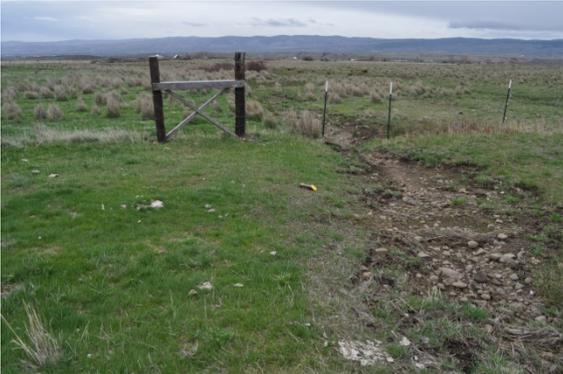
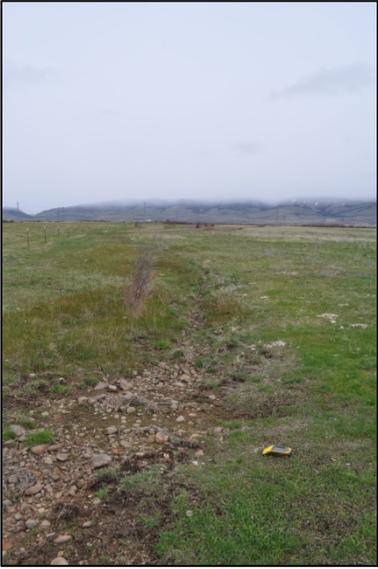
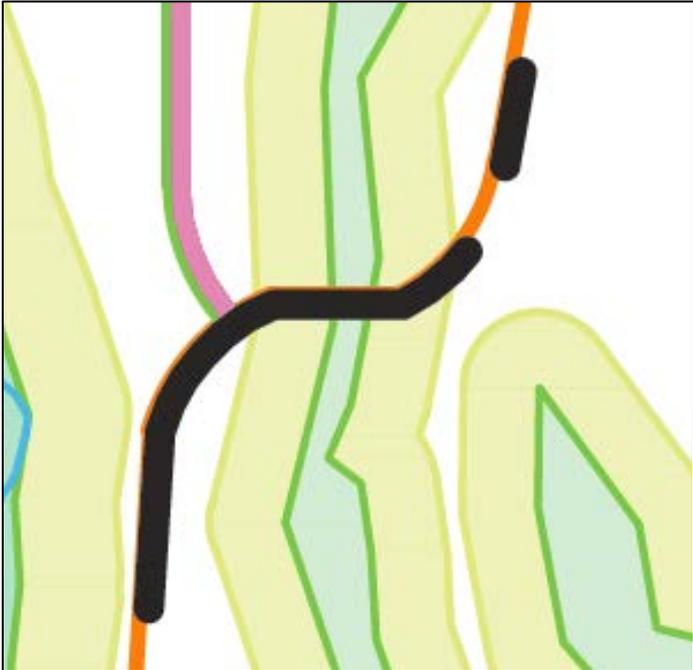
Wetland R25

RX-13: Ephemeral channel associated with the irrigation system up slope. Standard duty crossing.

Activity	Wetland/Type	Impact /volume (ft <sup>2</sup> /yds <sup>3</sup> )	Stream/Type	Impact /volume (ft <sup>2</sup> /yds <sup>3</sup> )
Permanent Fill	R25 Slope Cat III	741/56	N/A	N/A
Disturbance (<90 days)	Same	1481ft <sup>2</sup>	N/A	N/A

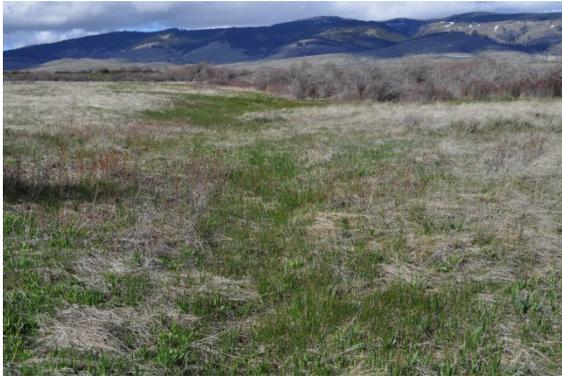
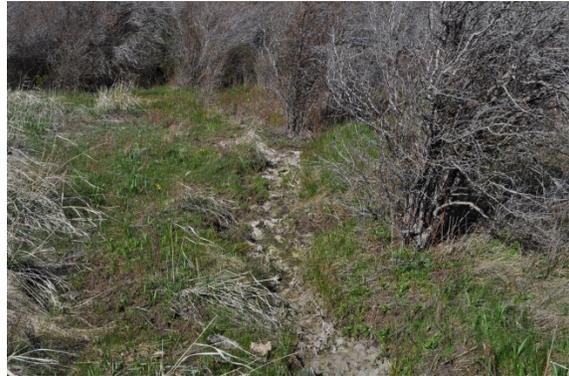
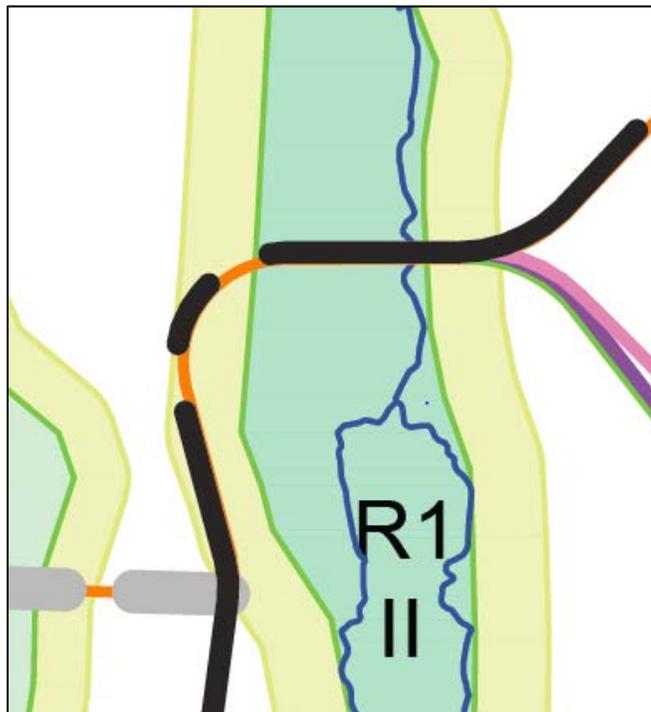
Wetland R1, Stream S-1

RX-15: Ephemeral Stream in Wetland R1. Standard duty crossing with culvert.

Activity	Wetland/Type	Impact /volume (ft <sup>2</sup> /yds <sup>3</sup> )	Stream/Type	Impact /volume (ft <sup>2</sup> /yds <sup>3</sup> )
Permanent Fill	R1 Riverine Cat II	4443/330	S-1 Type F	218/15
Disturbance (<90 days)	Same	740ft <sup>2</sup>	Same	305ft <sup>2</sup>

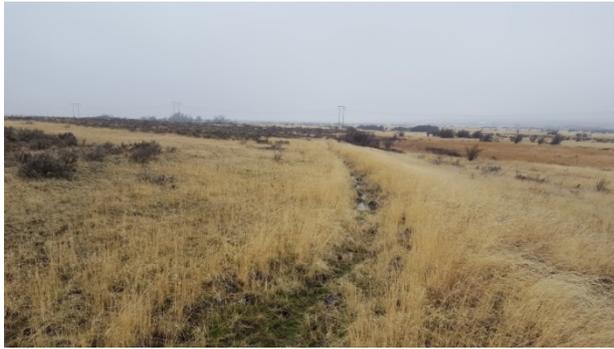
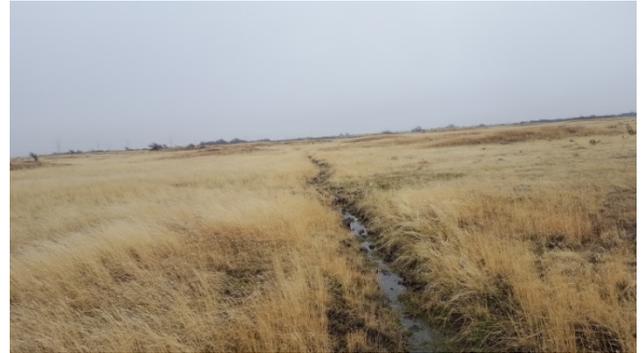
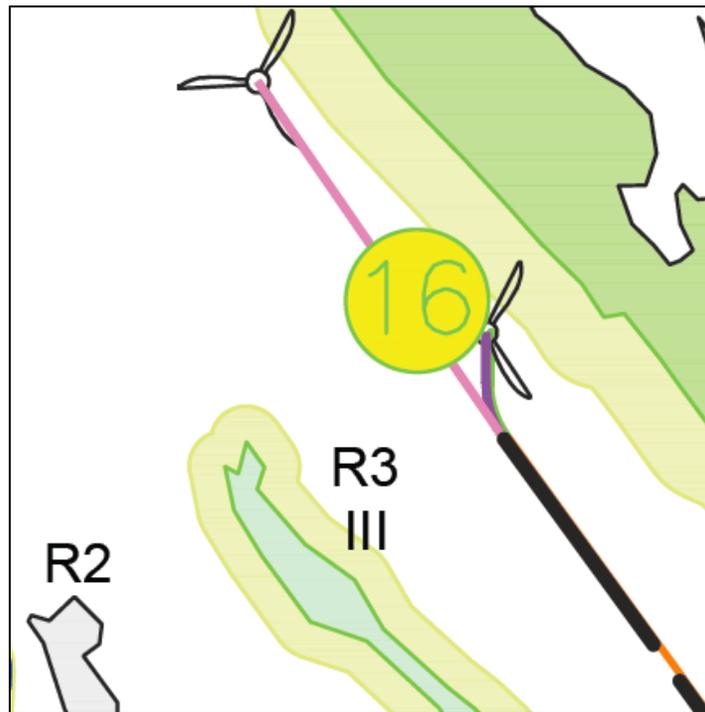
Lateral ditch in NE portion of Project Area

RX-16: Lateral ditch through uplands. Standard duty crossing with culvert.

Activity	Wetland/Type	Impact /volume (ft <sup>2</sup> /yds <sup>3</sup> )	Stream/Type	Impact /volume (ft <sup>2</sup> /yds <sup>3</sup> )
Permanent Fill	N/A	N/A	Ditch	44/4
Disturbance (<90 days)	N/A	N/A	Same	88ft <sup>2</sup>

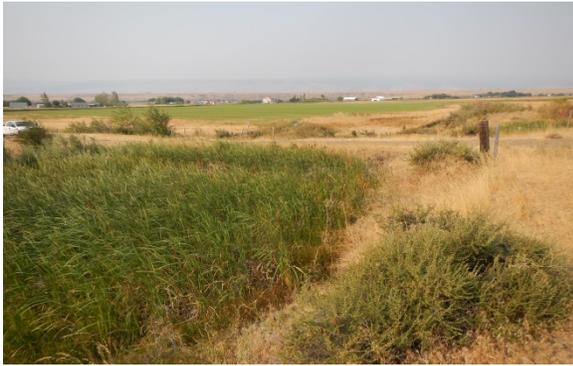
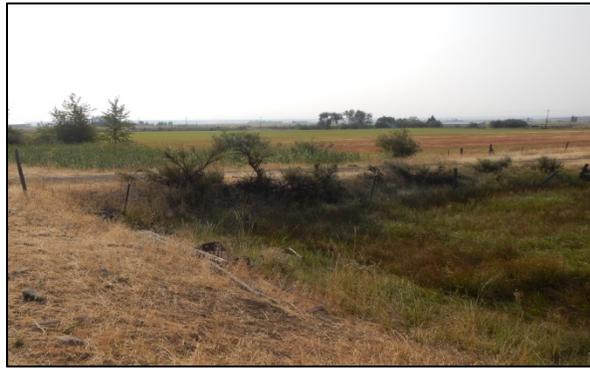
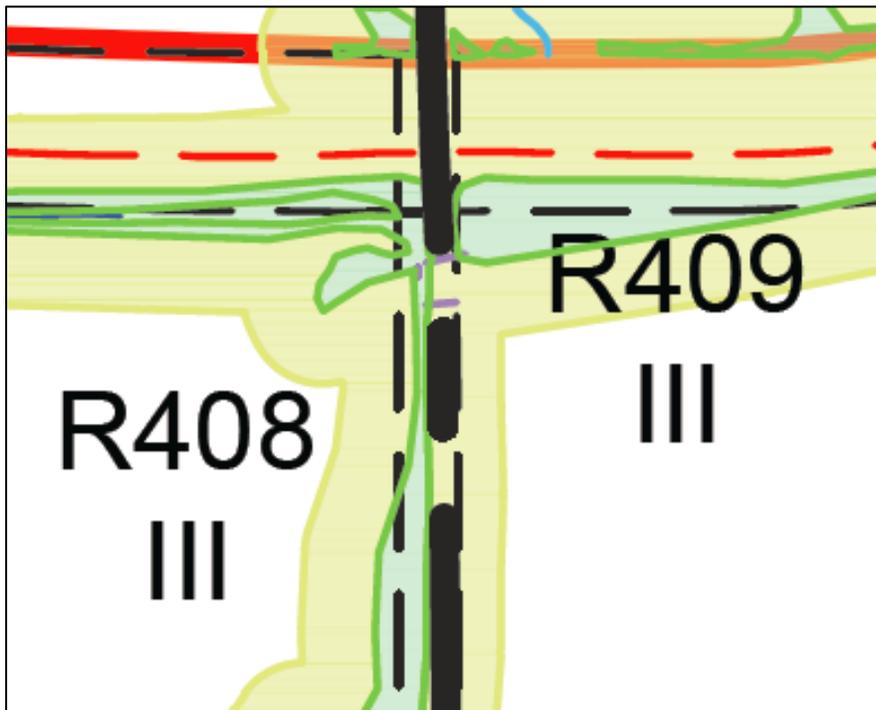
Approach to bridge over KRD canal

RX-17: Bridge approach/bridge replacement.

Activity	Wetland/Type	Impact /volume (ft <sup>2</sup> /yds <sup>3</sup> )	Stream/Type	Impact /volume (ft <sup>2</sup> /yds <sup>3</sup> )
Permanent Fill	R408 Depression Cat III	3485/381	N/A	N/A
Disturbance (<90 days)	N/A	N/A	N/A	N/A

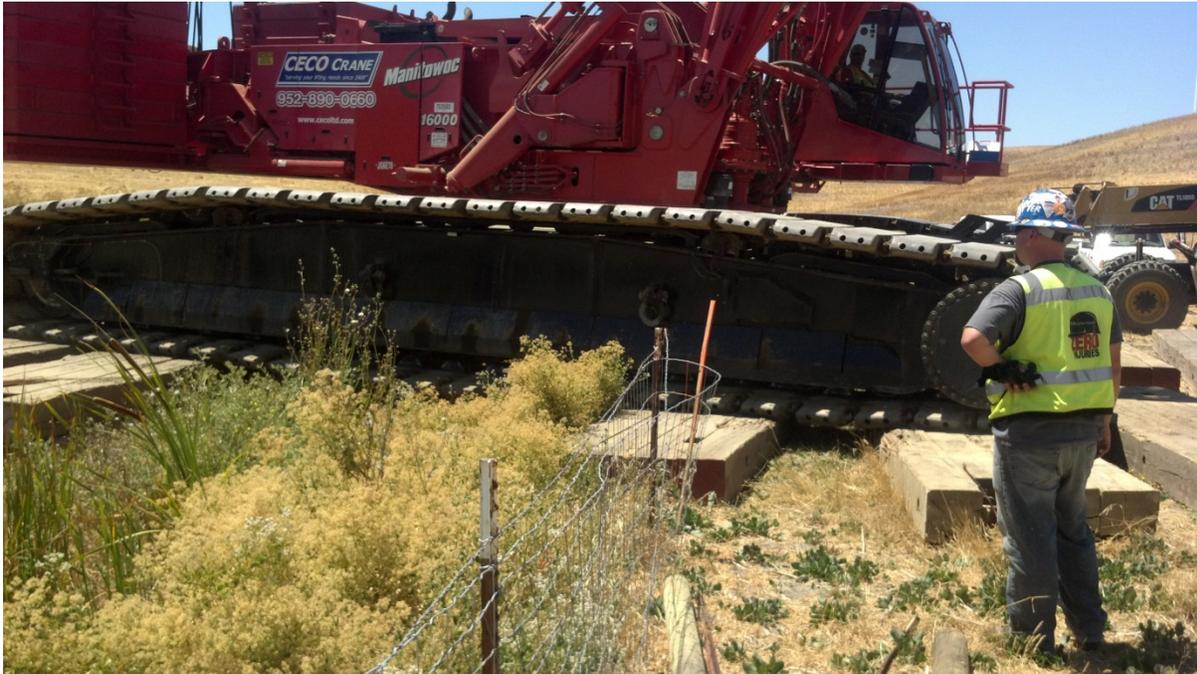
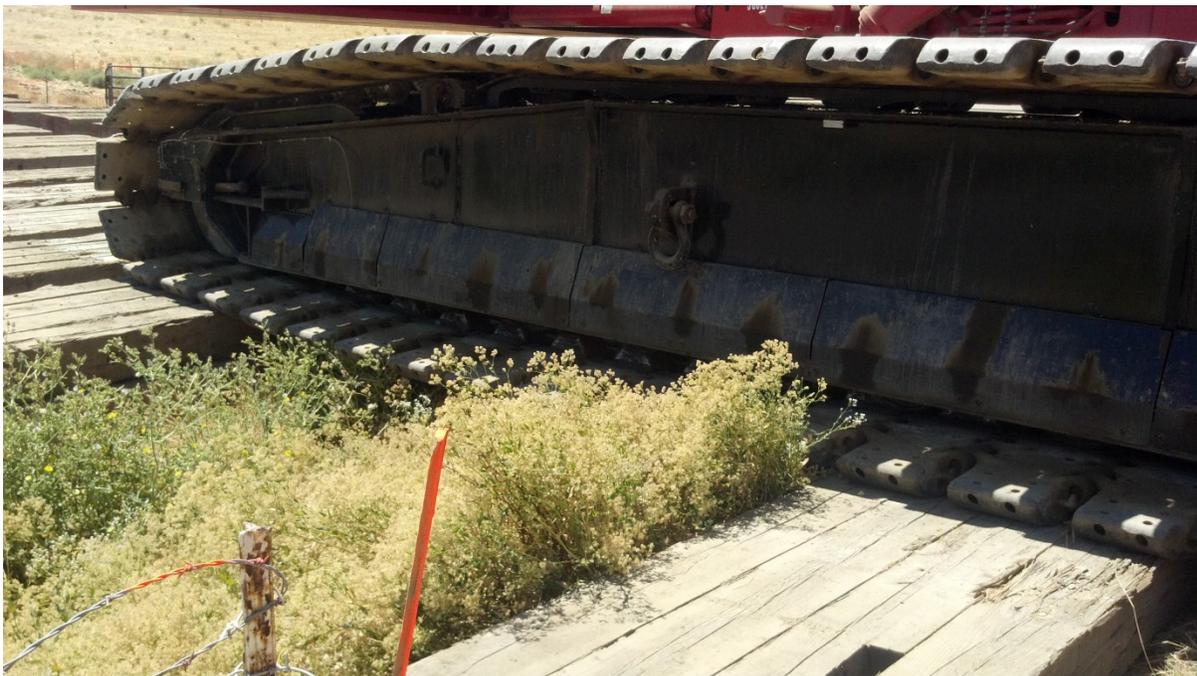
## Example photos of crane crossing

The air bridge can be used for narrow and shallow wetland or stream crossings with a low grade. Timber pads are placed on the ground for the crane to traverse. Due to the size of the crane treads and the timber pads, weight is distributed over a large surface reducing compaction and impact. The timber pads are left in place only long enough for the crane to pass over them (then they are re-deployed at another crossing).
