# Wetland and Waterbody Delineation Report

September 28, 2020  
Revised June 25, 2021  
Revised October 11, 2021

**High Top Solar, LLC (NWS-2021-741)**

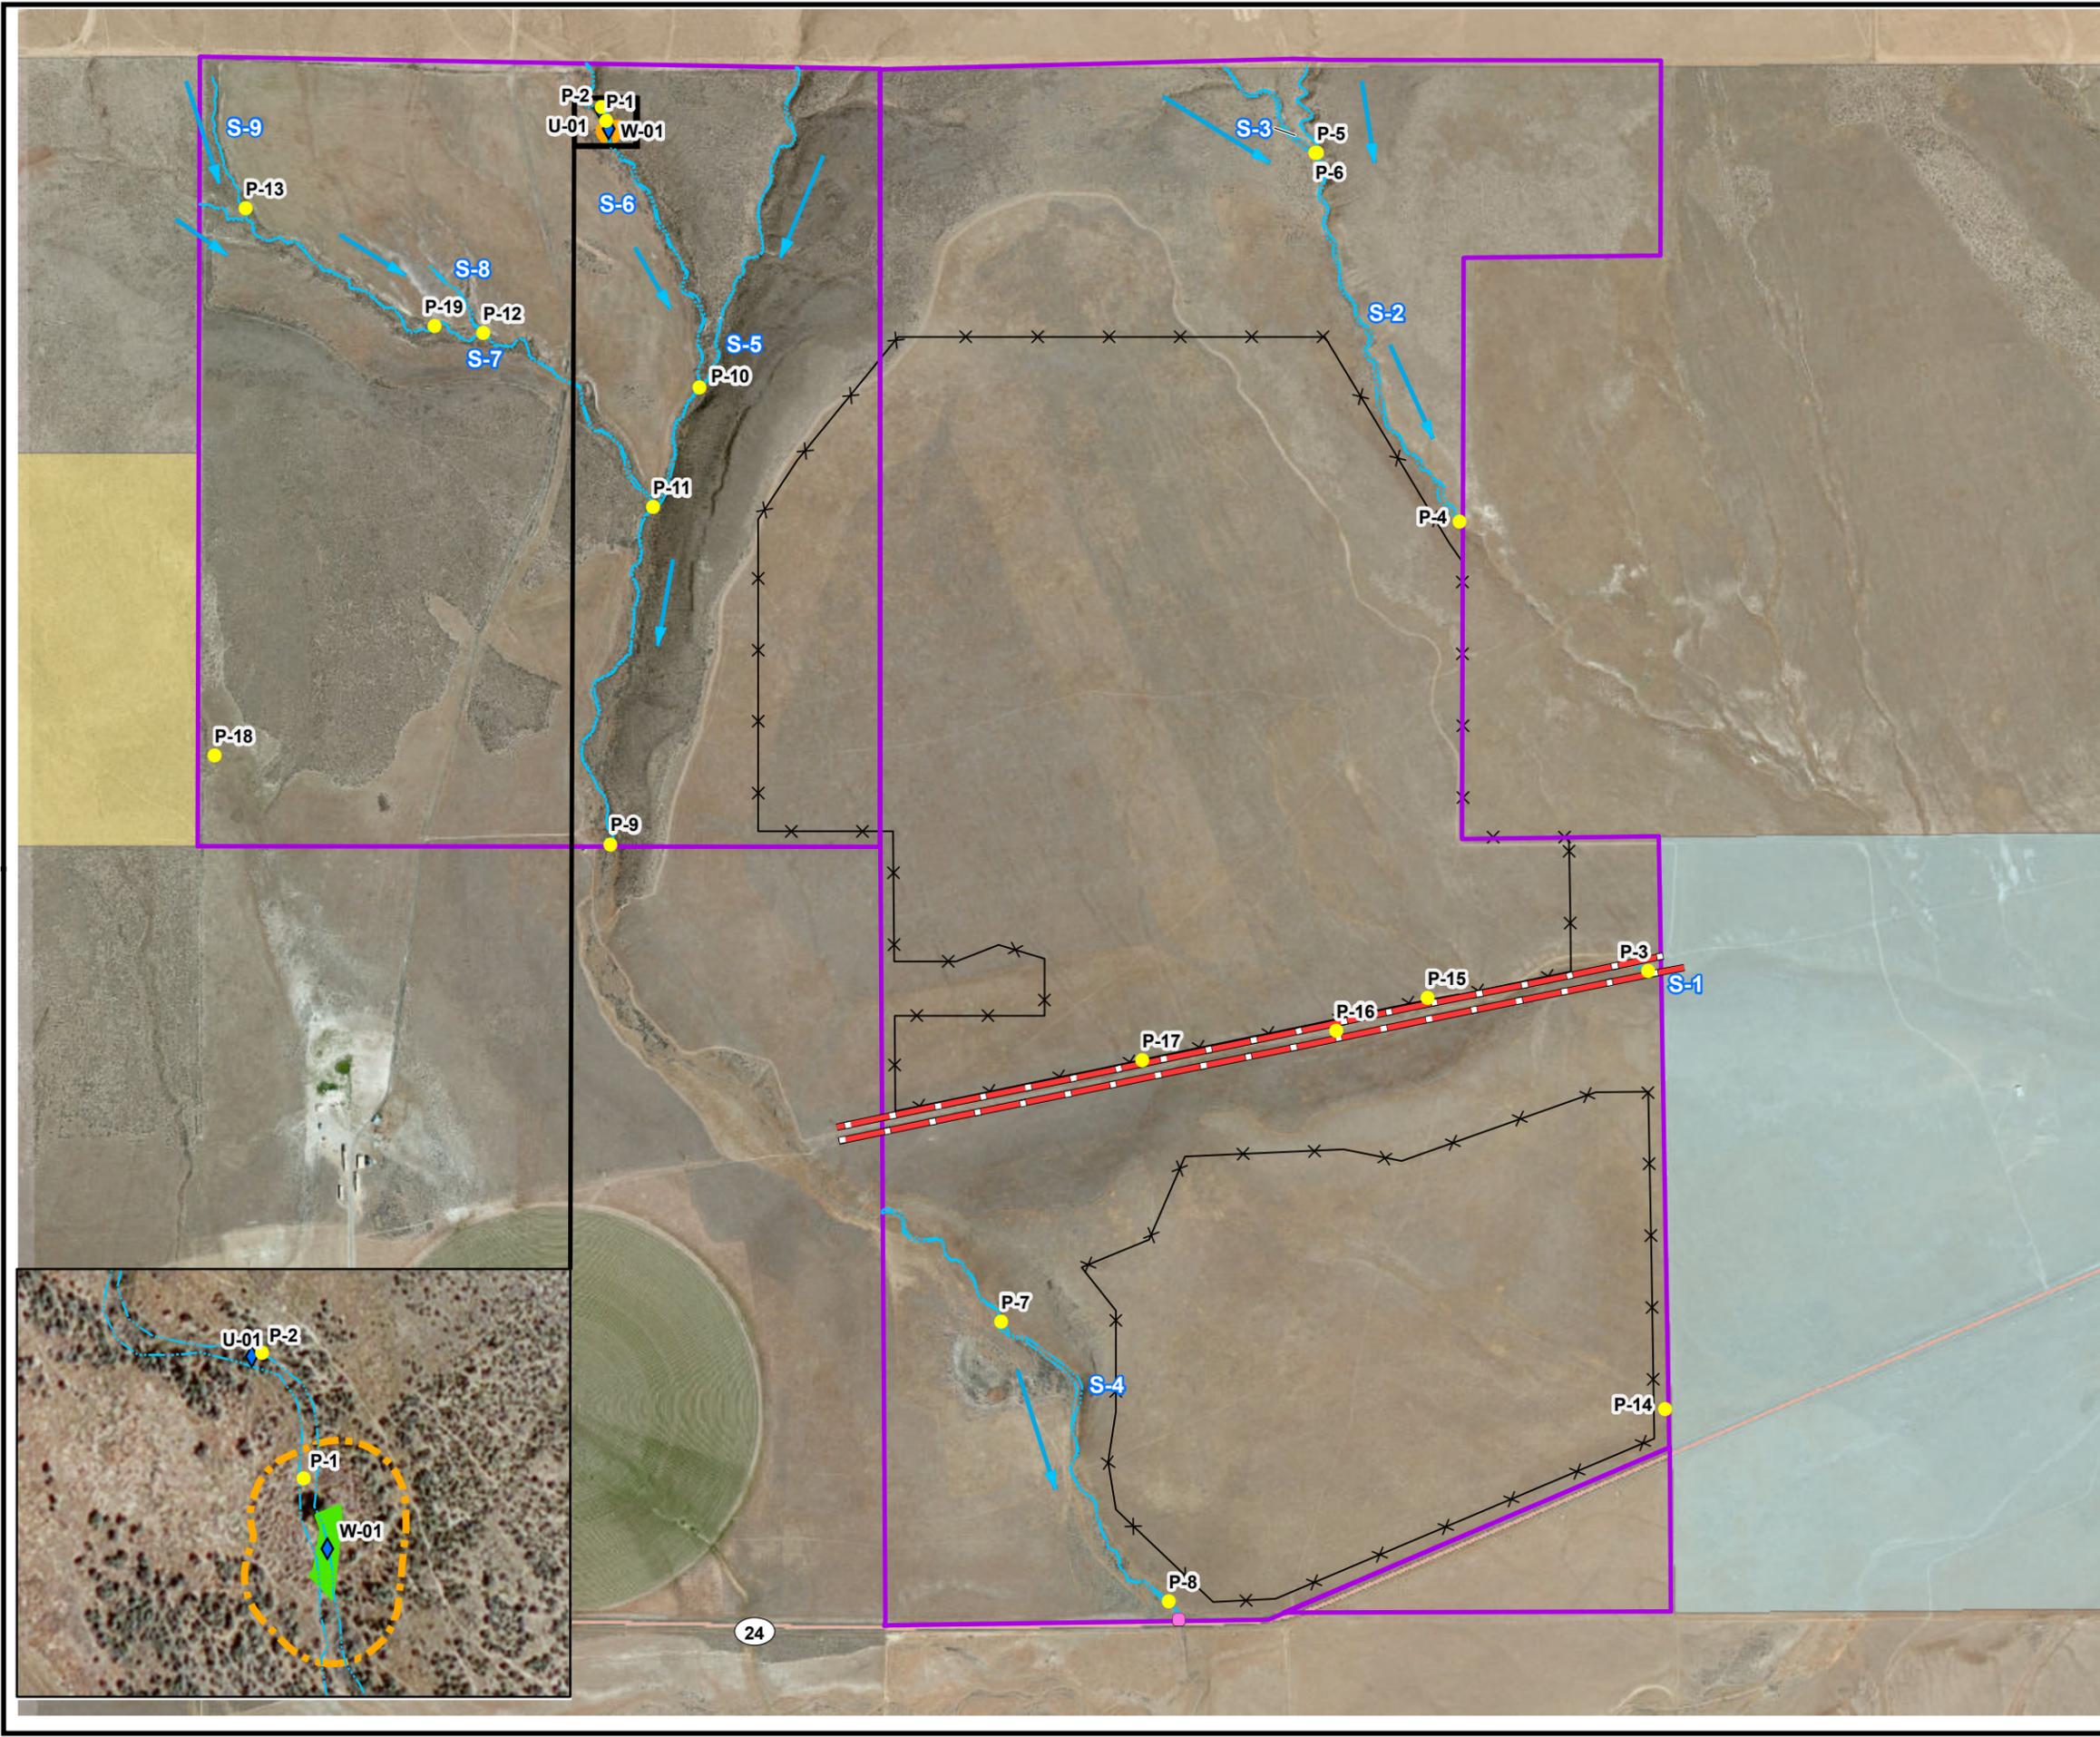
- Survey Area
- Proposed Project Fence Line
- CCR-DXC-Electrical Overhead
- Surveyed Stream
- Delineated Wetland
- Wetland 50ft Buffer
- ◆ Soil Pit
- Photo Point
- Culvert
- Bureau of Land Management
- U.S. Dept. of Defense-Yakima Training Center
- State Lands
- Flow Direction

No NWI-identified wetlands were identified in the Survey Area (Figure 3). Field surveys identified one seep wetland (W-01) in the northwest portion of the Survey Area (Figure 4). W-01 is characterized as a freshwater palustrine emergent wetland (PEM) dominated by reed canary

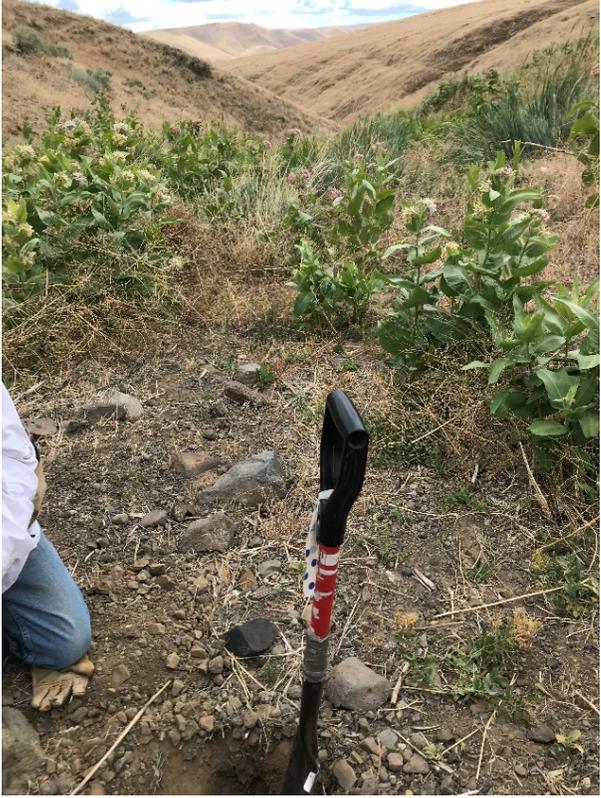
Photo ID: P-1

Date Taken: 7/1/20	
Photo Direction: Southeast	
Description: Wetland W-01 wetland soil pit

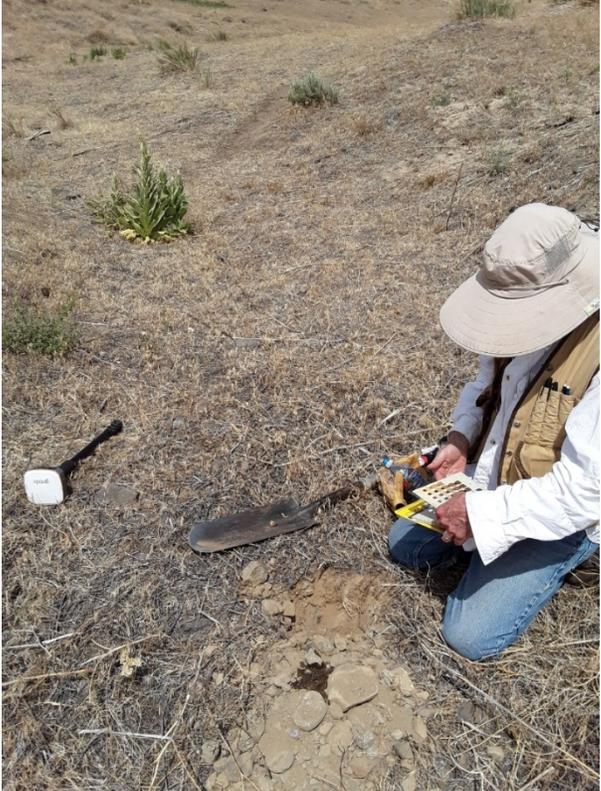
Photo ID: P-2

Date Taken: 7/1/20	
Photo Direction: North	
Description: Wetland W-01 upland soil pit (U-01).

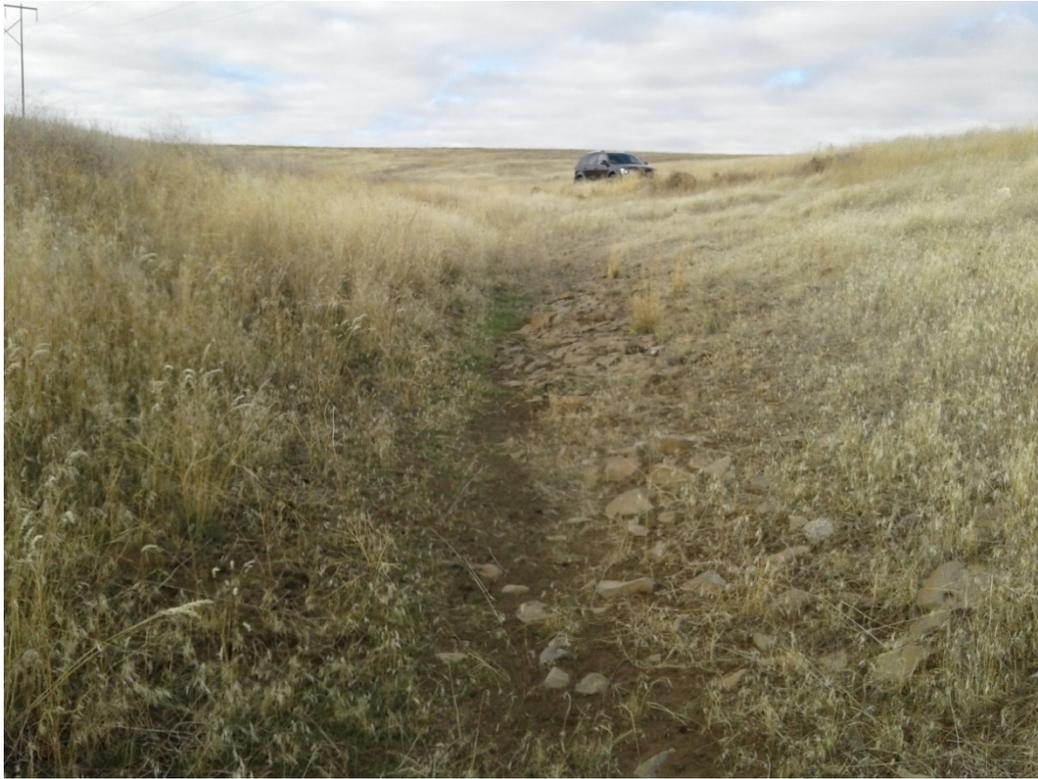
Description:  
Channel S-1, looking upstream

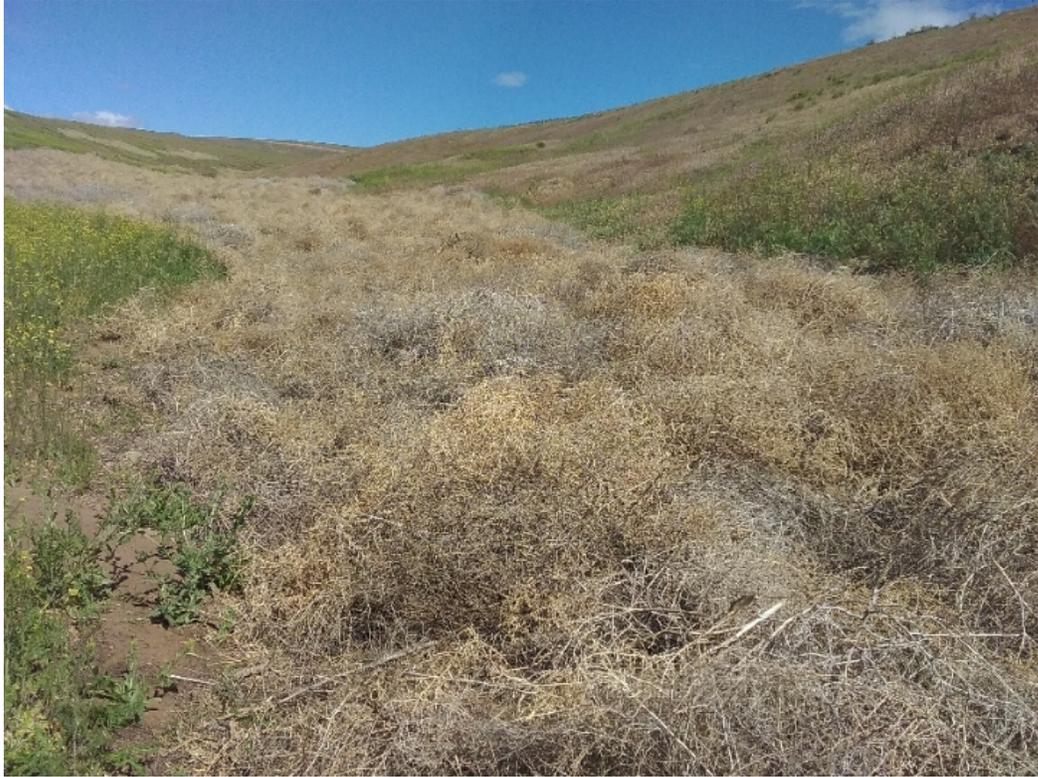
Photo ID: P-4

Description:  
Channel S-2, looking upstream. Dried tumbleweeds are found along portions of the channel.

Large patches of dried “tumbleweed” species (include tumble mustard, kochia, knapweed, and Russian thistle) were found along and in deep piles in many of the channels limiting flow in those areas. The piles of tumbleweed varied in thickness from 0.5 foot to several feet deep in places and in width from 1 foot to over 10 feet wide. The tumbleweed was matted, and vegetation was not observed growing underneath. Where channels crossed barbed wire fences the tumbleweed was stacked up along the fence. The culverts were also filled with tumbleweed.

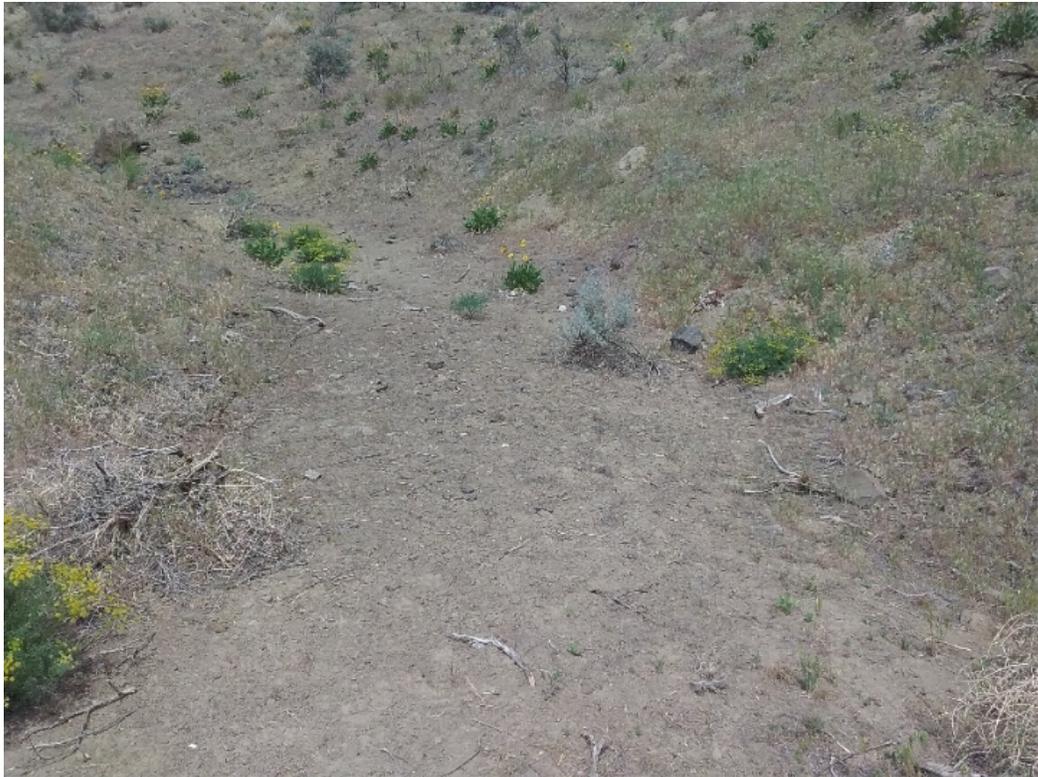
Photo ID: P-5

Date Taken: 5/7/2021	
Photo Direction: North	
<b>Description:</b> Channel S-2, looking upstream	
Photo ID: P-6

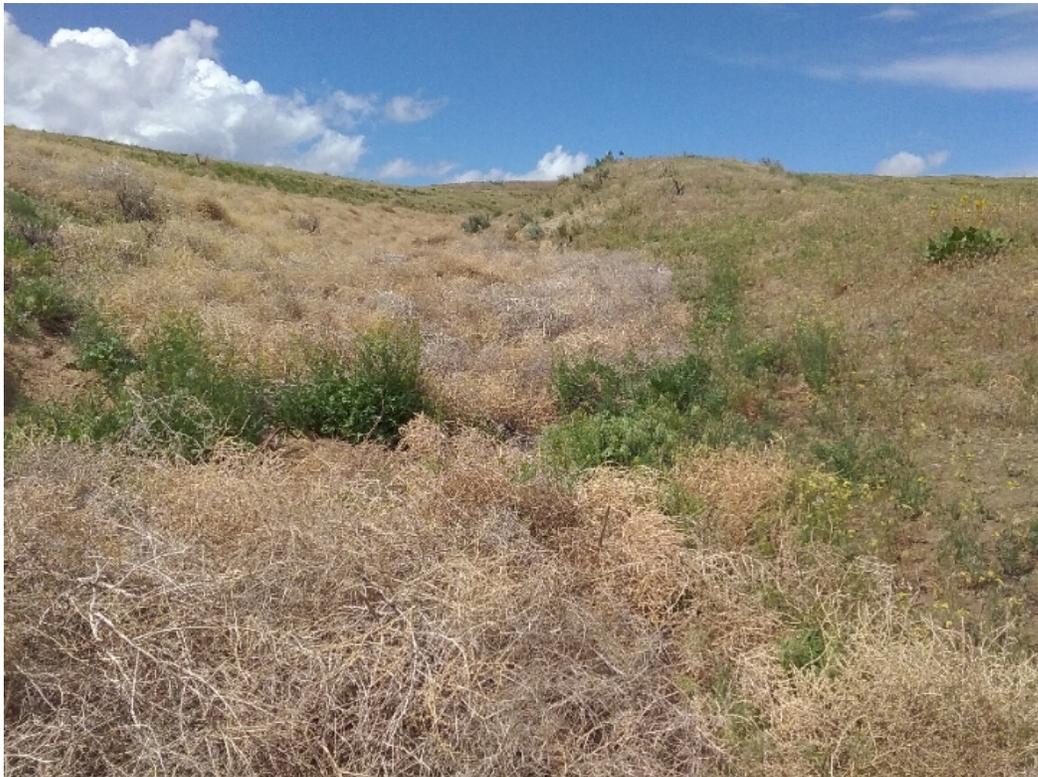
Date Taken: 5/7/2021	
Photo Direction: Northwest	
<b>Description:</b> Channel S-3, looking upstream. Dried tumbleweeds are found along portions of the channel.

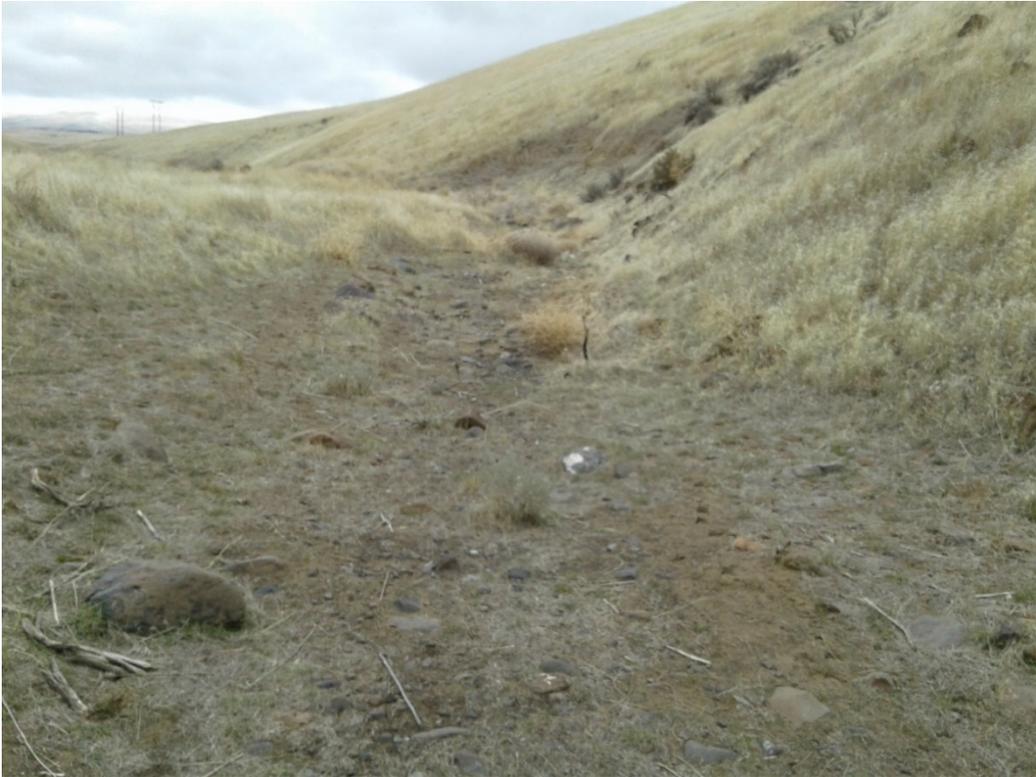
Photo ID: P-7

Date Taken: 7/2/2021	
Photo Direction: Northwest	
<p>Description:</p> <p>Channel S-4, looking upstream.</p>	
Photo ID: P-8

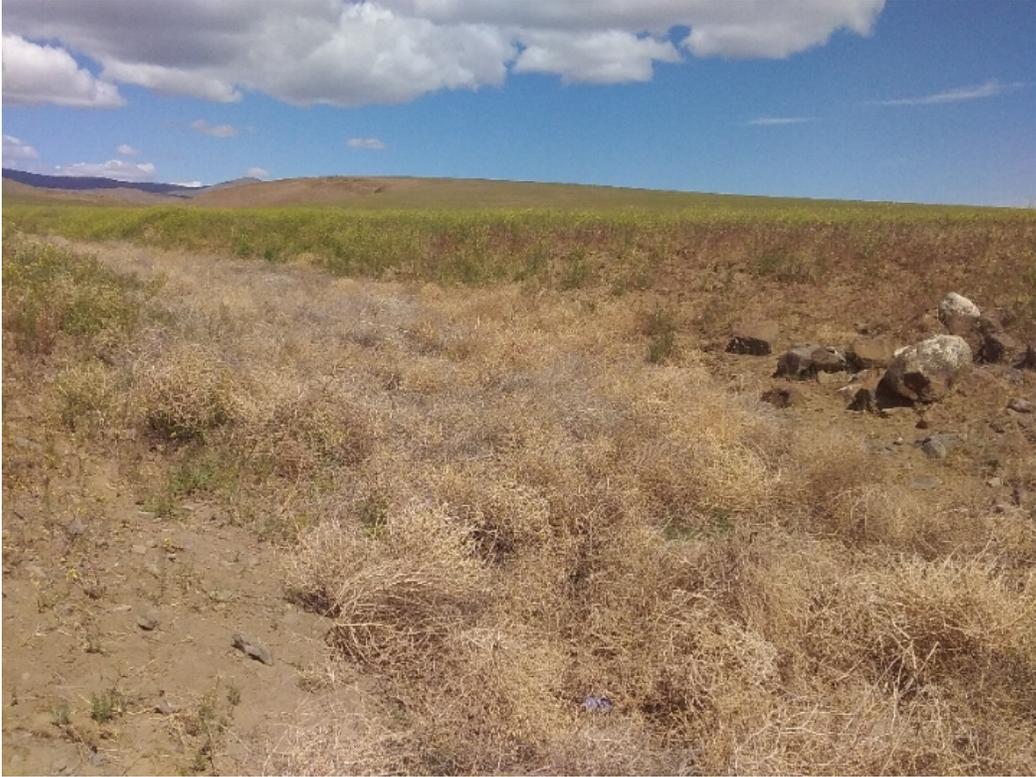
Date Taken: 5/9/2021	
Photo Direction: Northwest	
<p>Description:</p> <p>Channel S-4, looking upstream. Dried tumbleweeds are found along portions of the channel.</p>

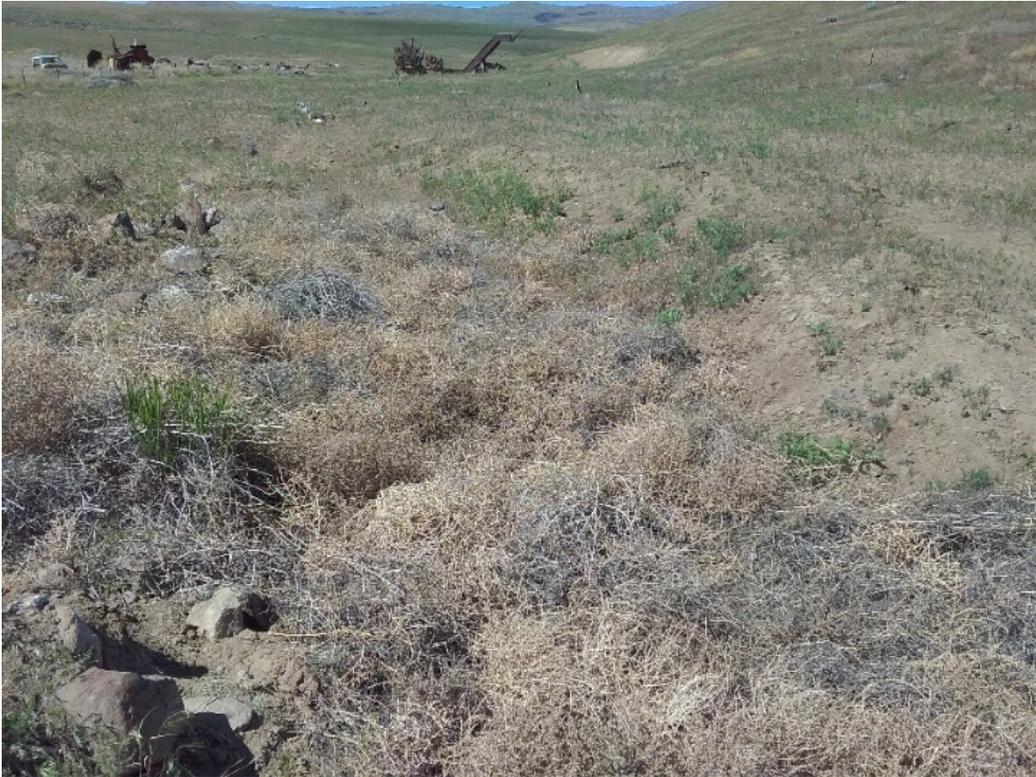
Photo ID: P-9

Date Taken: 5/8/2021	
Photo Direction: North	
<b>Description:</b> Channel S-5, looking upstream. Dried tumbleweeds are found along portions of the channel.	
Photo ID: P-10

Natural or Anthropogenic Disturbance Russian thistle and other under dried vegetation is found in the bulk of the channel. The channel path has been altered, has multiple discontinuous channels, and several broken cement barriers

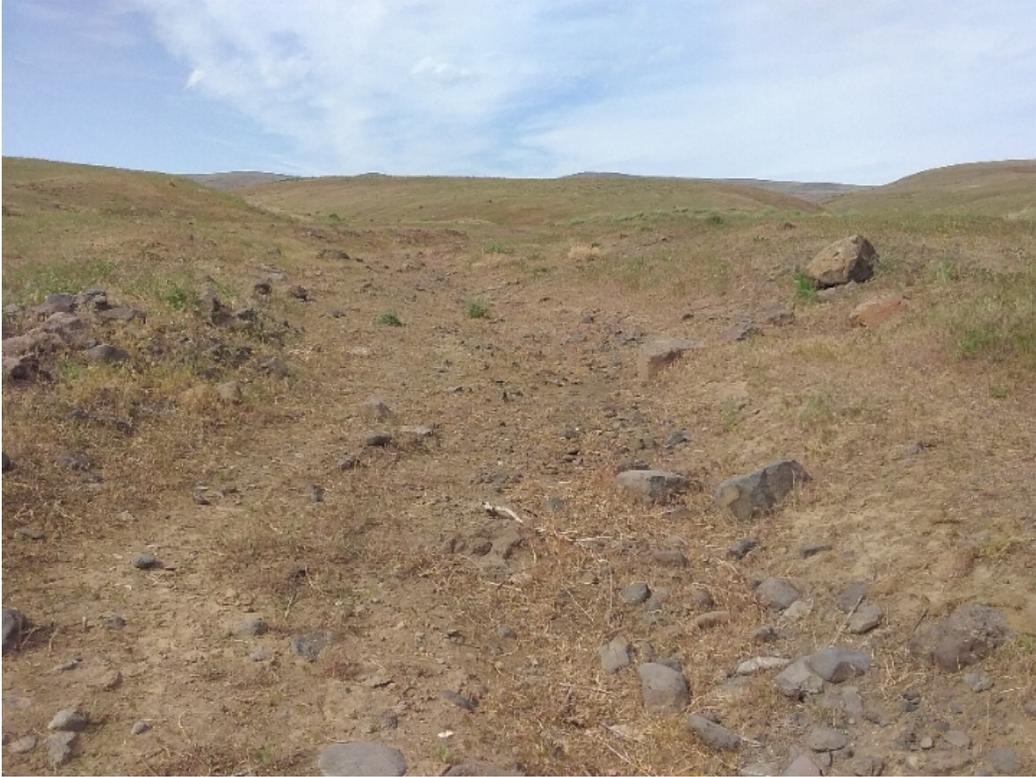
Date Taken: 5/6/2021	
Photo Direction: North	
<b>Description:</b> Channel S-6, looking upstream

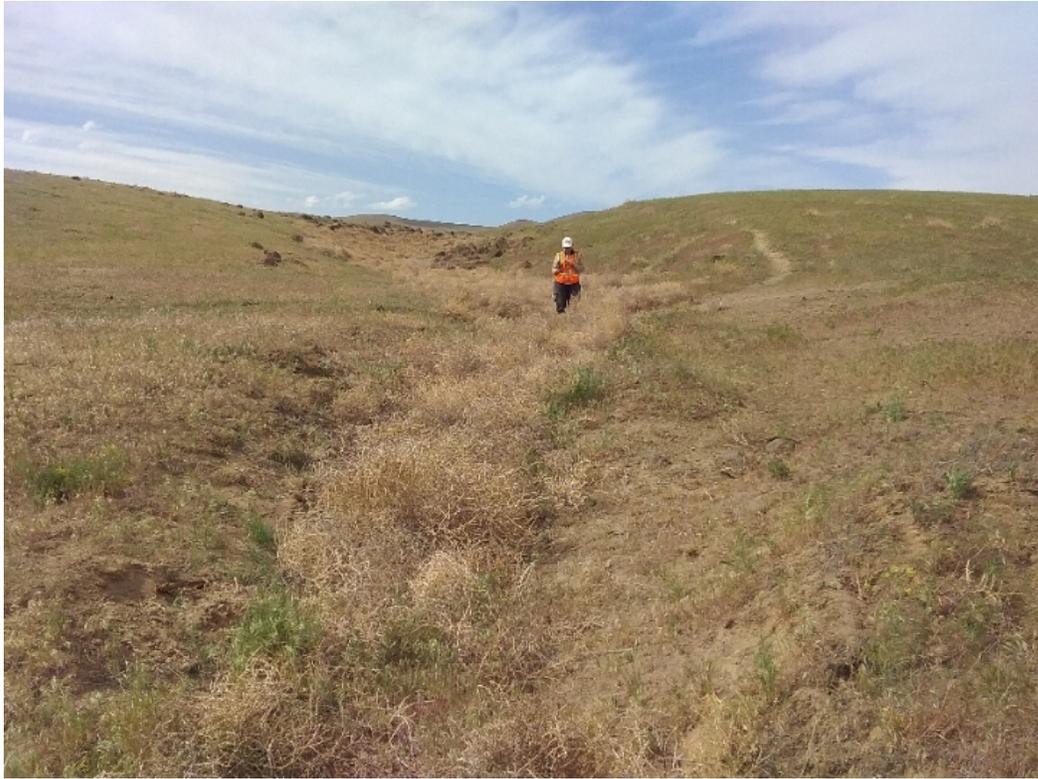
Description:  
Channel S-7, looking upstream. Dried tumbleweeds are found along portions of the channel.

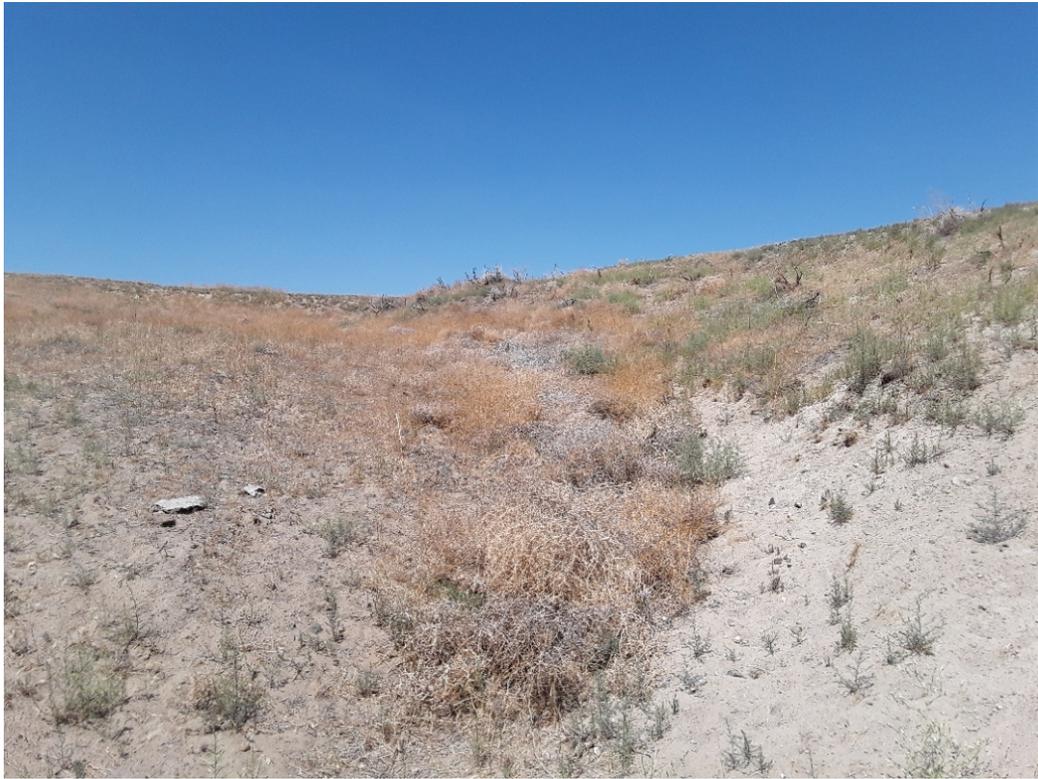
Photo ID: P-12

Description:  
Channel S-8, looking upstream. Dried tumbleweeds are found along portions of the channel.

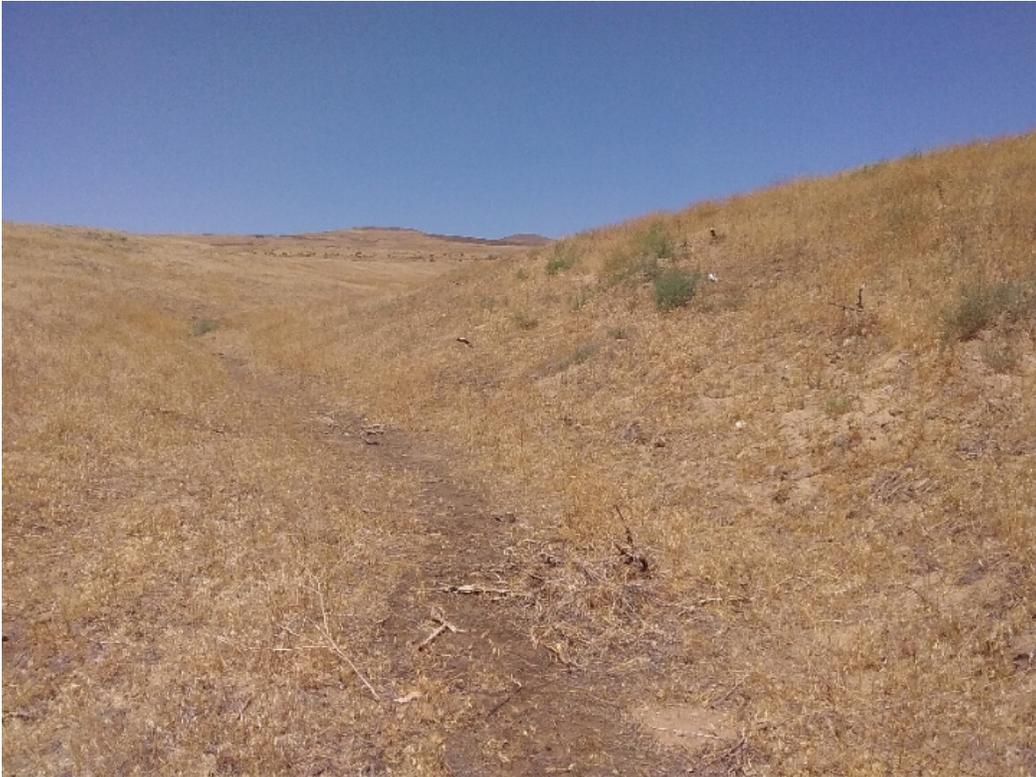
Photo ID: P-13

Date Taken: 7/11/2021	
Photo Direction: North	
<b>Description:</b> Channel S-9, looking upstream	
Photo ID: P-14

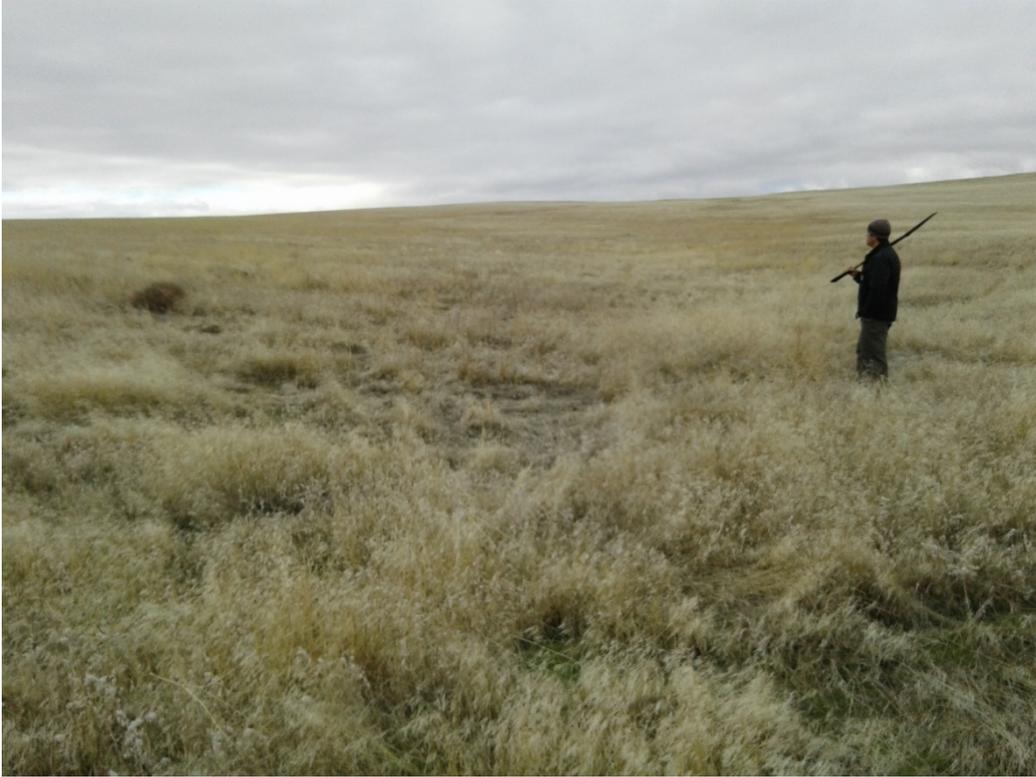
Date Taken: 7/11/2021	
Photo Direction: North	
<b>Description:</b> NWI/NHD feature. No OHWM indicators observed in the field.

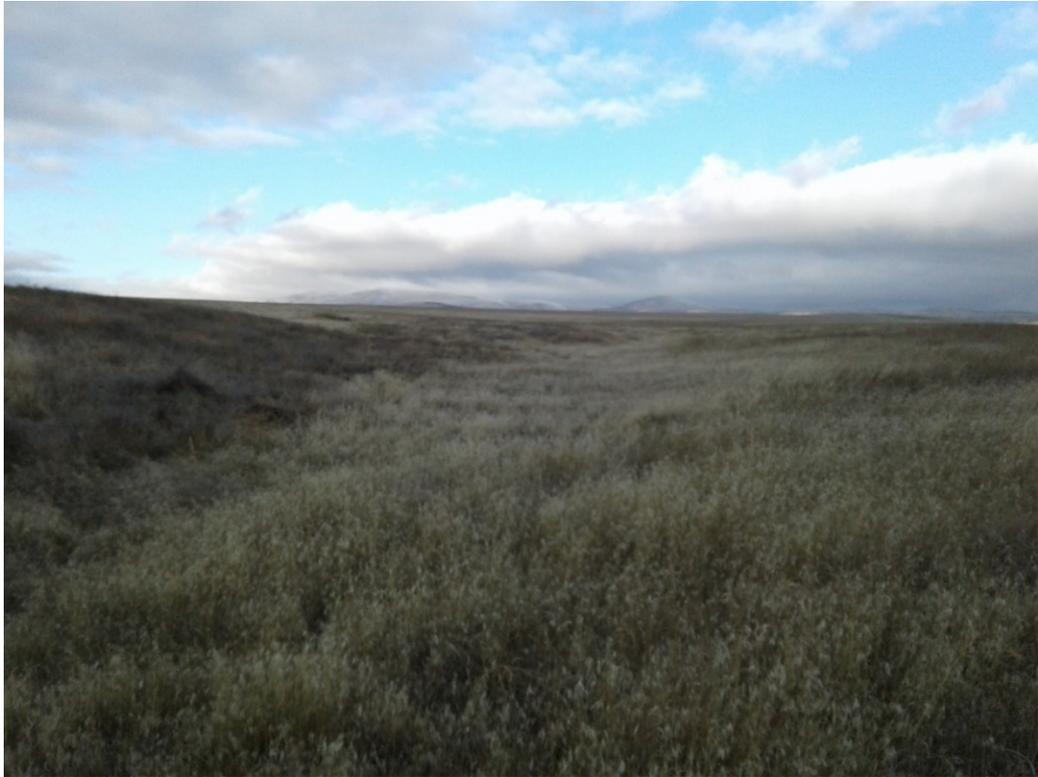
Photo ID: P-15

Date Taken: 7/1/2021	
Photo Direction: North	
<p><b>Description:</b></p> <p>NWI/NHD feature. No OHWM indicators observed in the field.</p>	
Photo ID: P-16

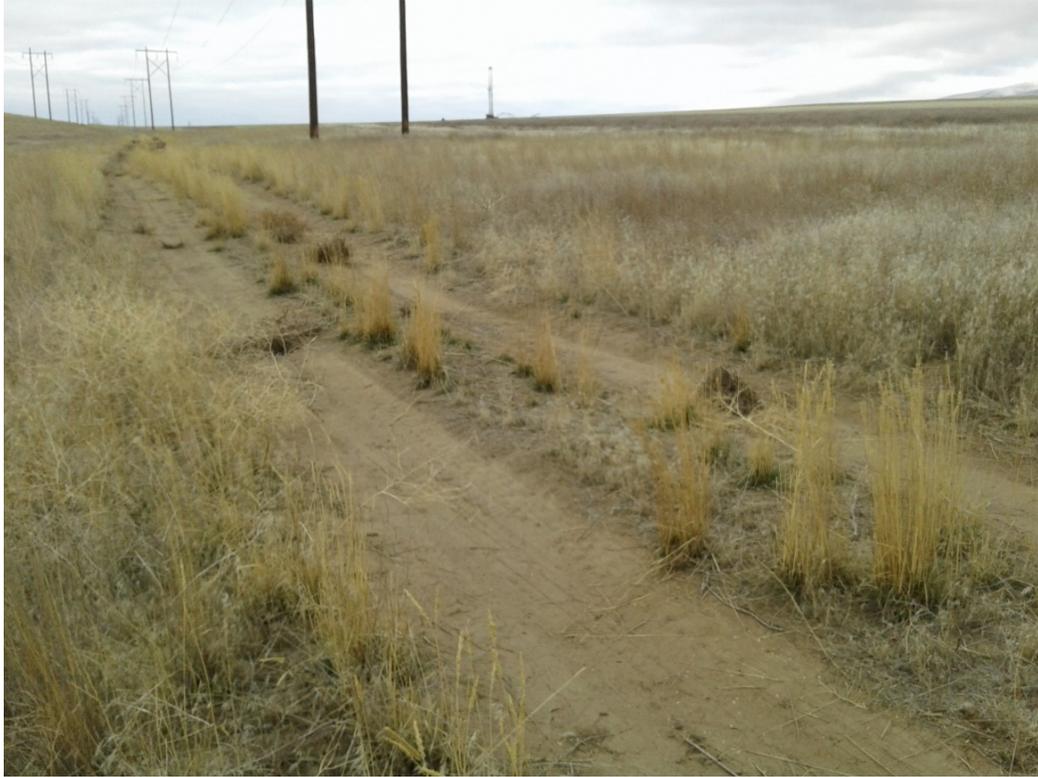
Date Taken: 7/1/20	
Photo Direction: Northwest	
<p><b>Description:</b></p> <p>NWI/NHD feature. No OHWM indicators observed in the field.</p>

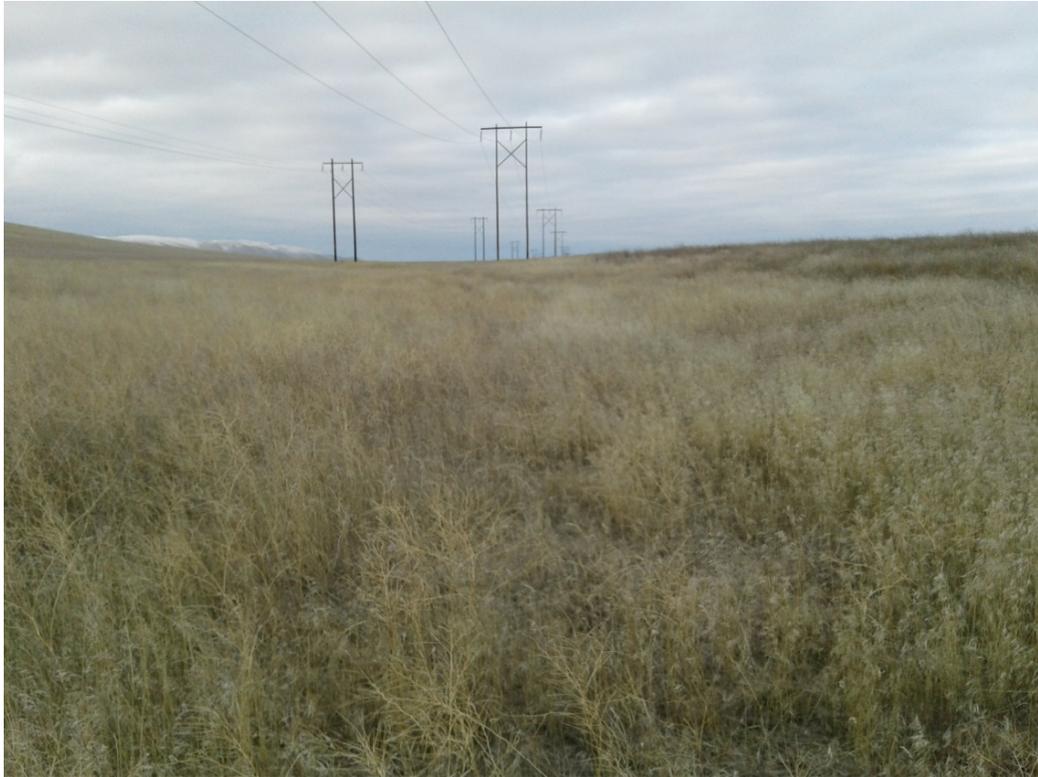
Photo ID: P-17

Date Taken: 7/1/20	
Photo Direction: West	
<b>Description:</b> NWI/NHD feature. No OHWM indicators observed in the field.	
Photo ID: P-18

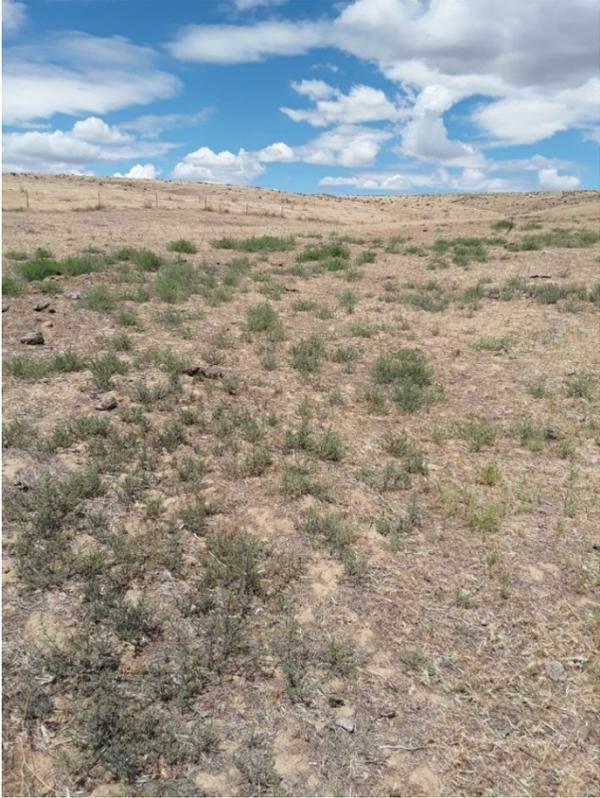
Date Taken: 7/1/20	
Photo Direction: North	
<b>Description:</b> NWI/NHD feature. No OHWM indicators observed in the field.

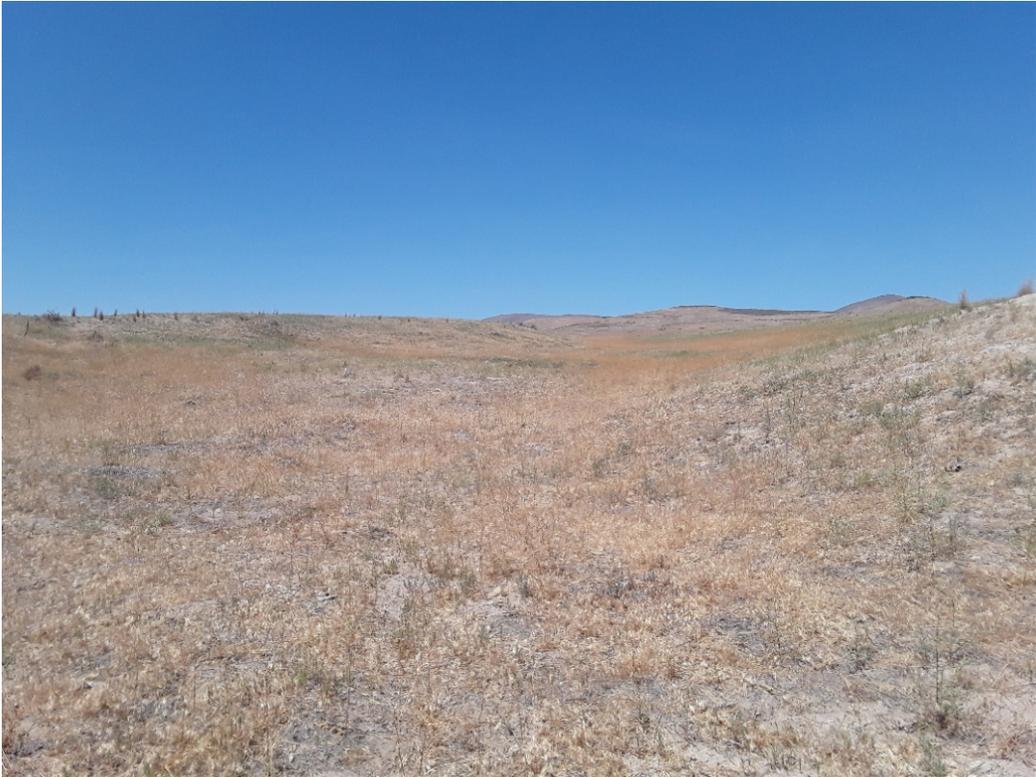
Photo ID: P-19

Date Taken: 7/11/2021	
Photo Direction: Northwest	
<p>Description:</p> <p>NWI/NHD feature. No OHWM indicators observed in the field.</p>
