**Appendix B**  
**Geotechnical Report**  
**November 2007**

Preliminary Geotechnical Report  
Saddleback Wind Energy Project  
White Salmon, Washington

*Prepared by*  
**URS Corporation**  
URS Job #33758687

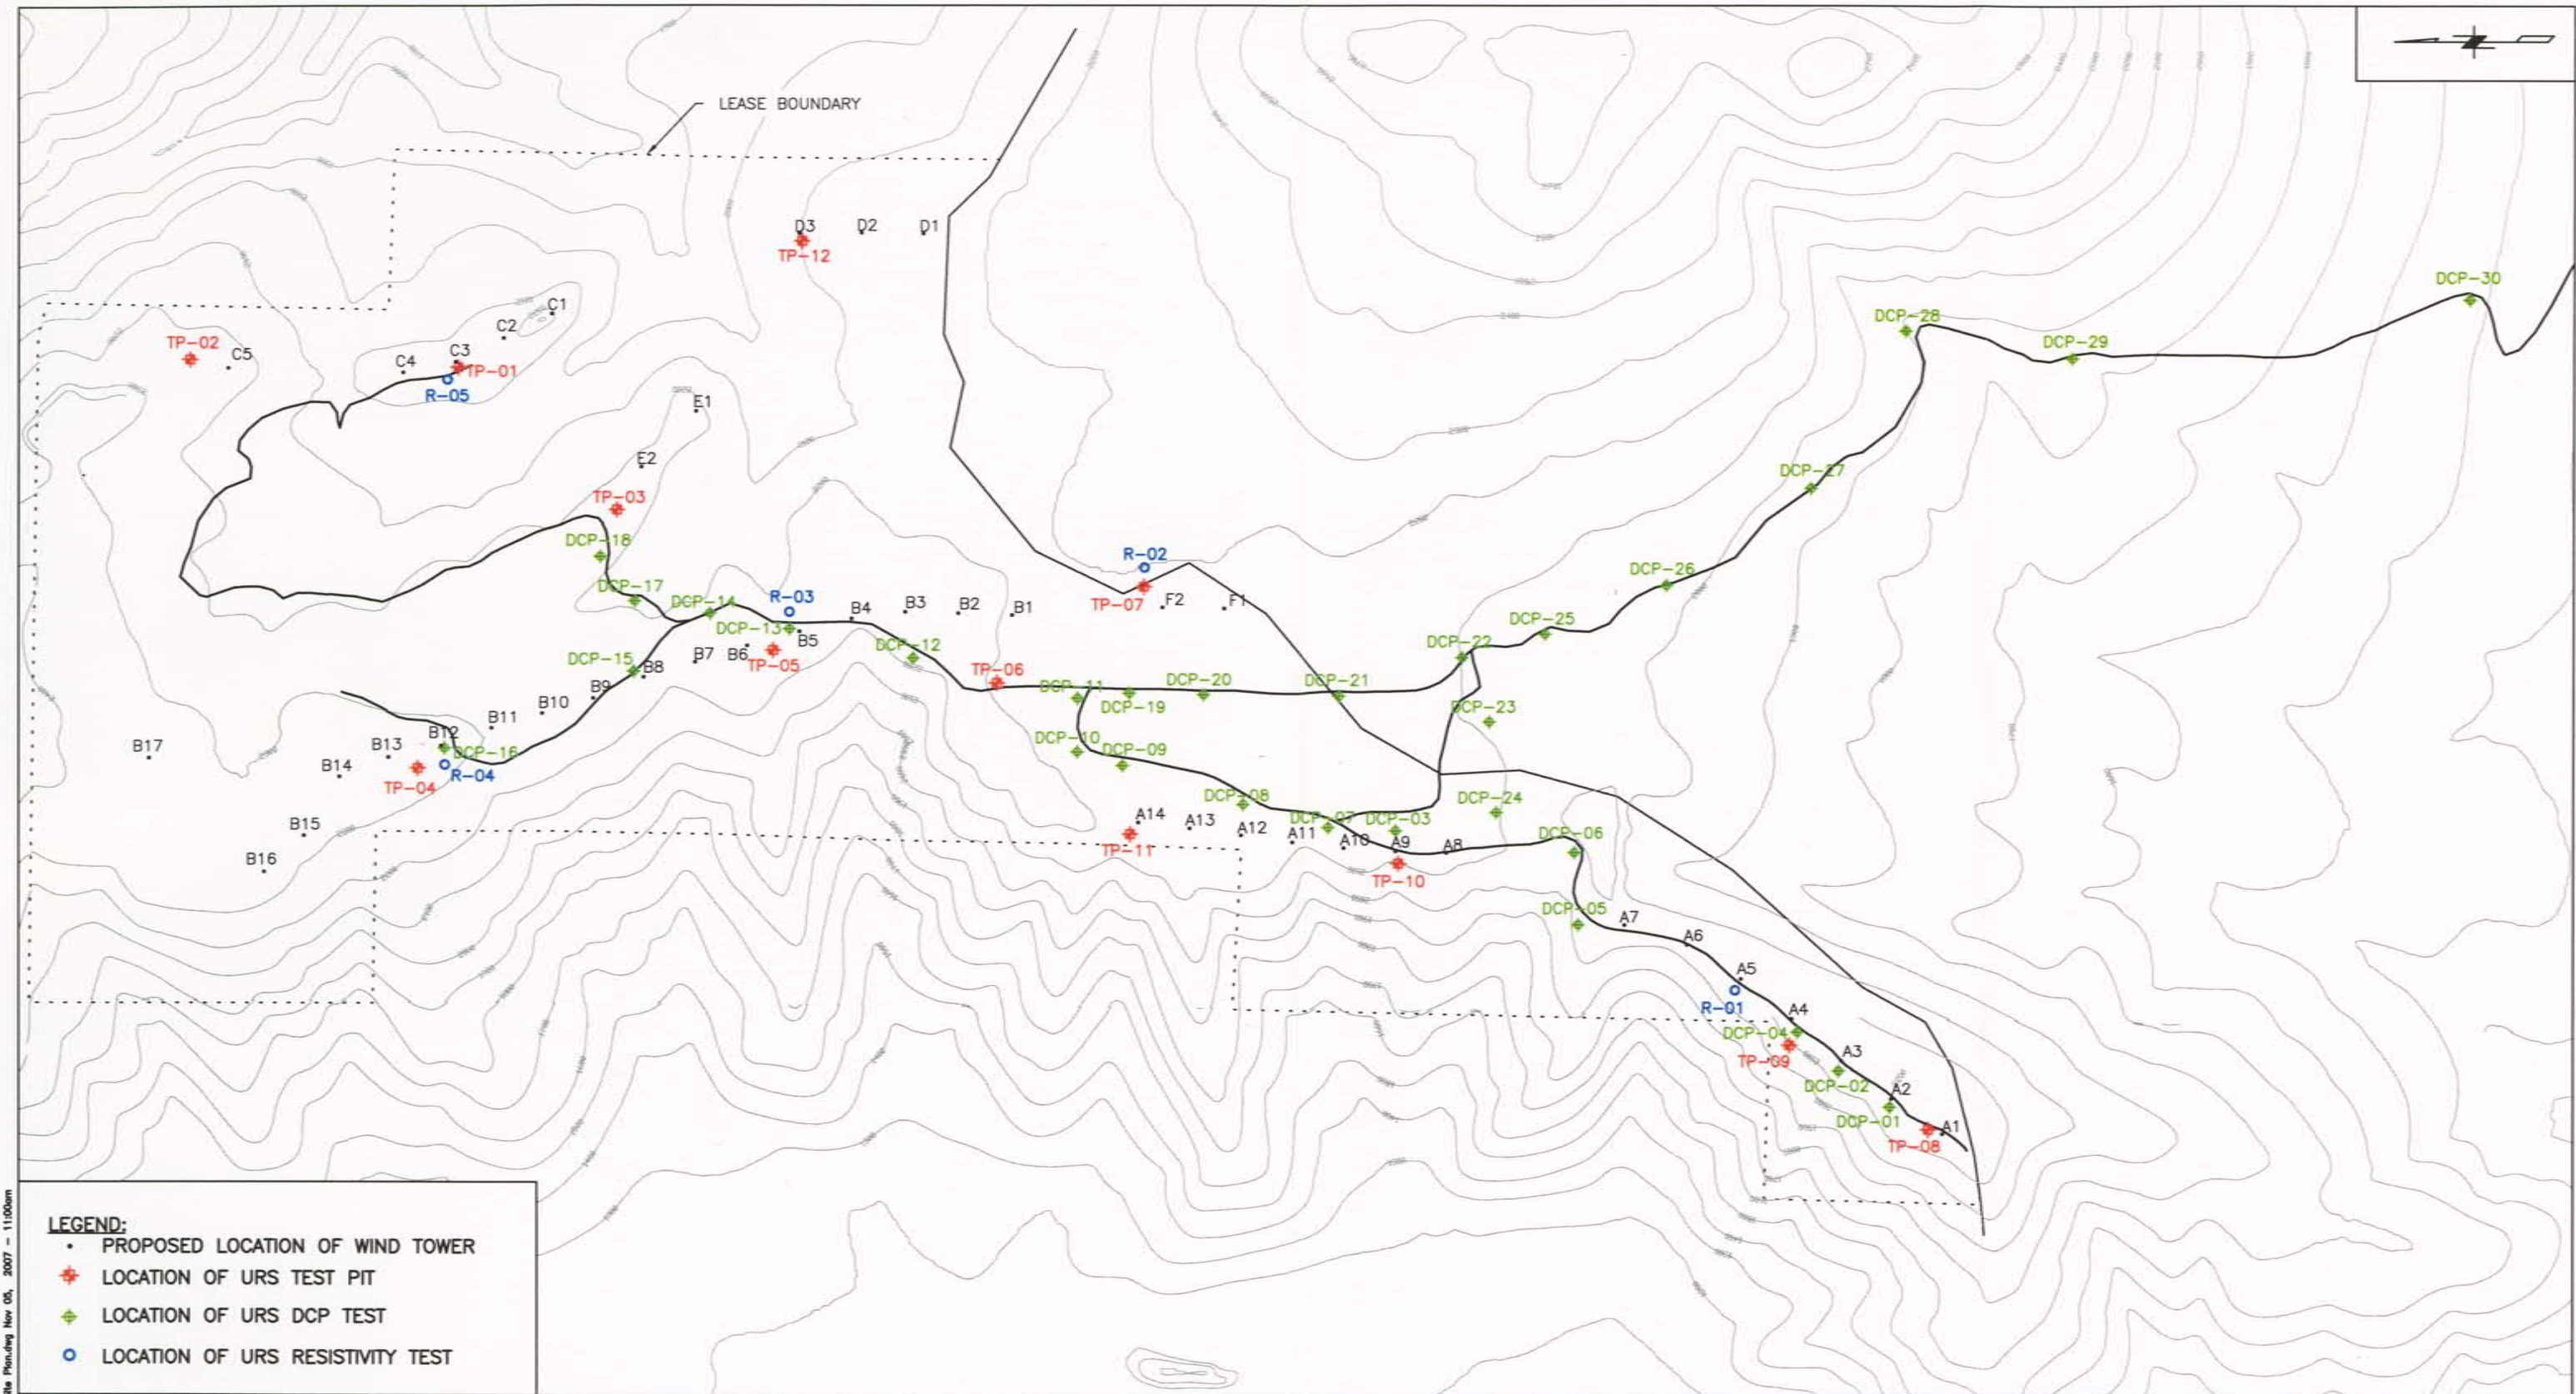
**Figure 2**

- LEGEND:**
- PROPOSED LOCATION OF WIND TOWER
  - ★ LOCATION OF URS TEST PIT
  - ✚ LOCATION OF URS DCP TEST
  - LOCATION OF URS RESISTIVITY TEST

Resistivity tests for the proposed Wind Energy Project site were performed on September 24, 2007 to assess the electrical resistivity of the near surface soil. The locations of the tests are noted on Figure 2, Site Plan. Test locations were selected to correspond with the sites of the proposed Wind Turbine Generators. A Strata-Scout Model R-40CY resistivity meter was used to measure the resistance by the 4-point (Wenner) configuration at equal spacing of 5, 10, and 20 feet for tests R-1 through R-5. A Nilsson Model 400 meter was used in the same configuration at equal spacing of 5, 15, and 20 feet for tests R-1 through R-5. The resistance and spacing were used to calculate the resistivity at each location. Results of the resistivity tests are presented in Appendix B. These indicators can be used for determinations regarding corrosion potential and grounding grid design.

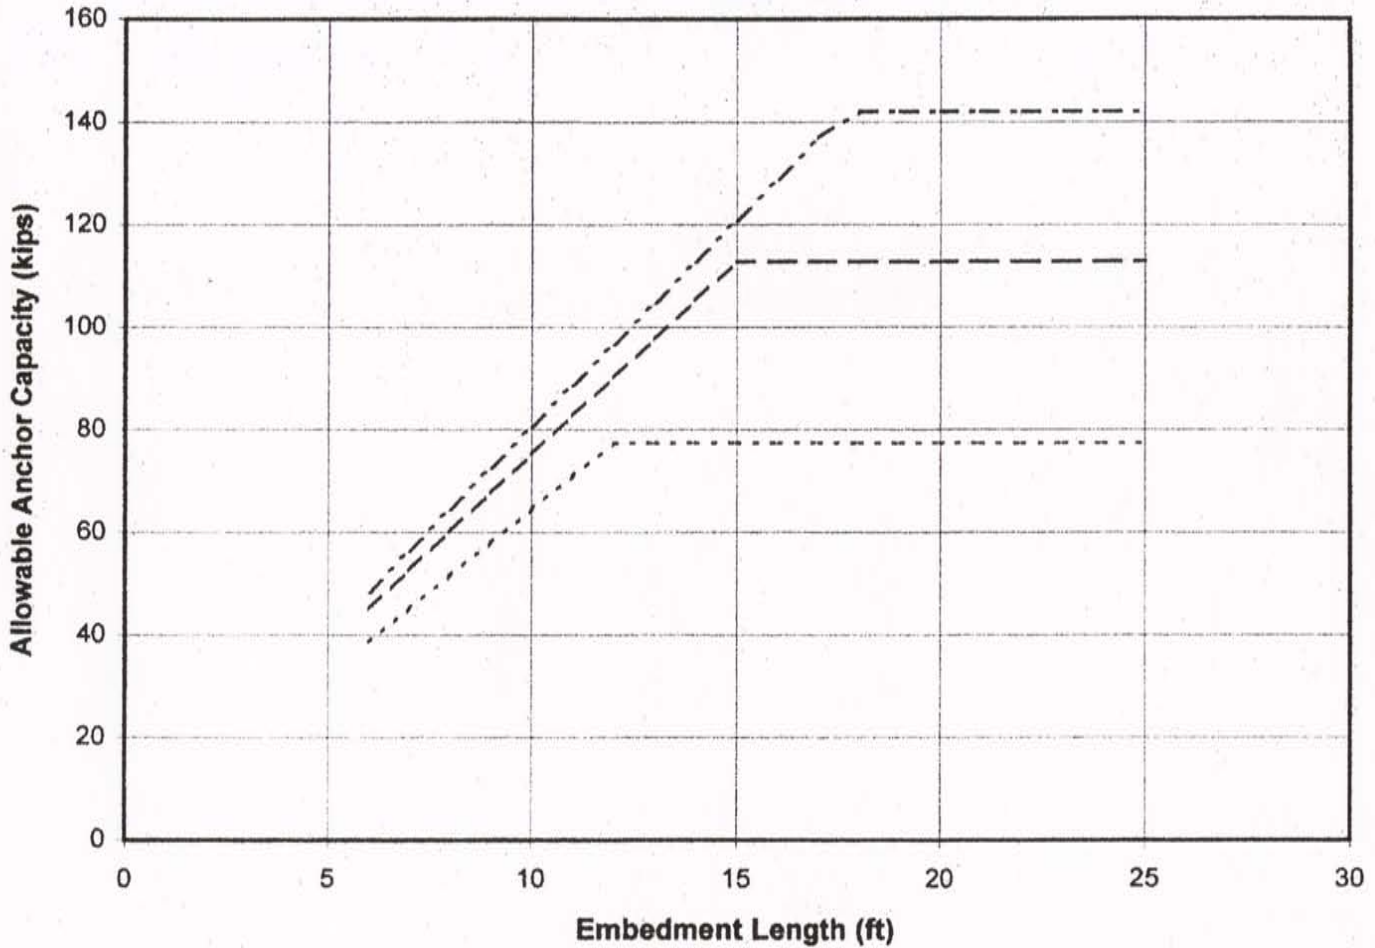
PRELIMINARY ROCK ANCHOR CAPACITY - RESIN

150ksi Steel, 13ksi Resin

.....#8 Bar --- #9 Bar - - - #10 Bar

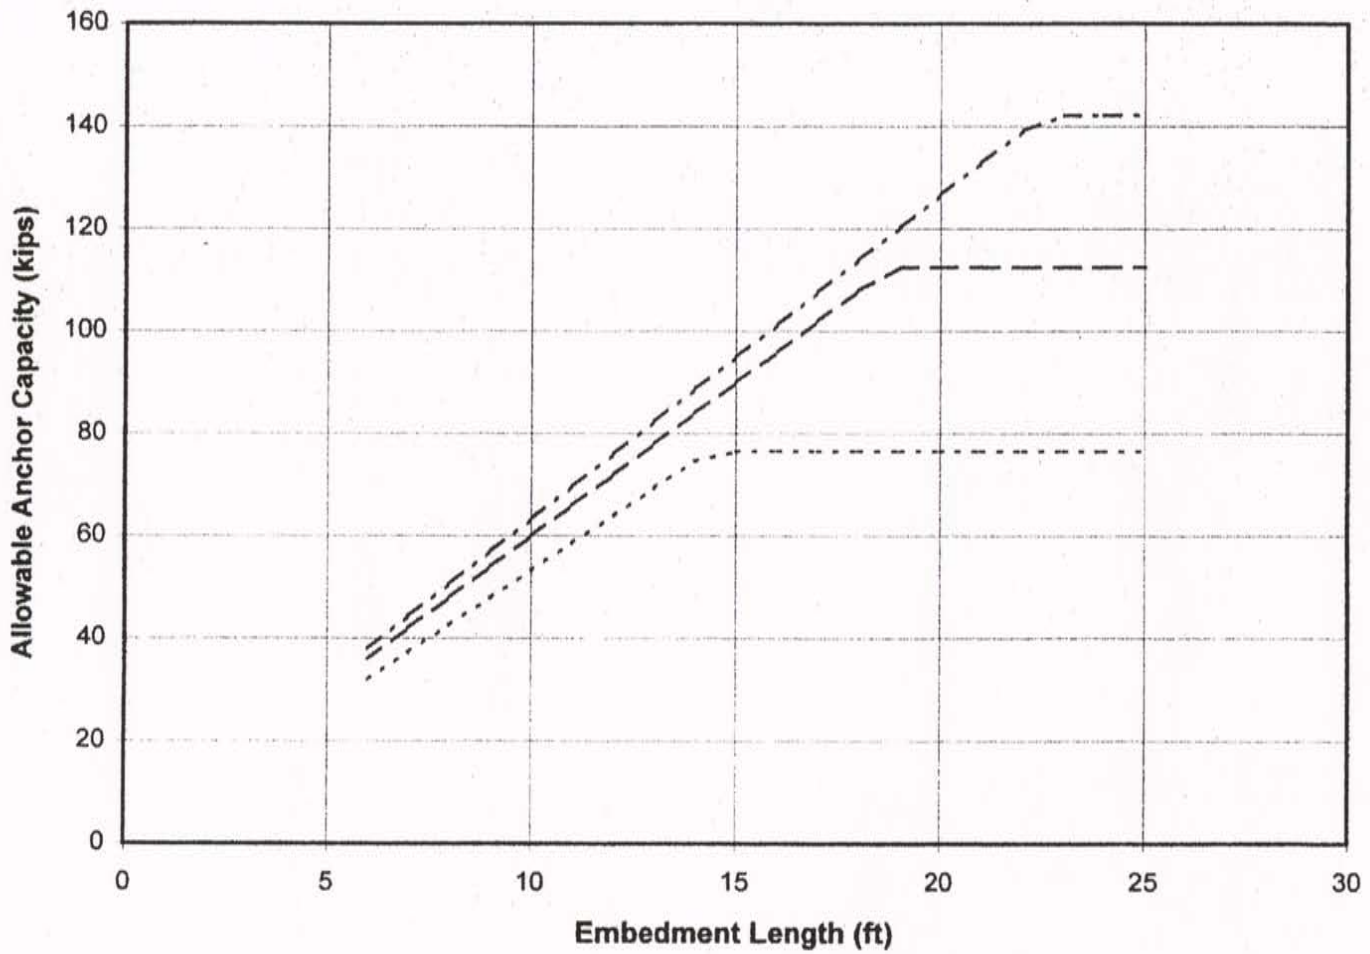
PRELIMINARY ROCK ANCHOR CAPACITY - CEMENT

150ksi Steel, 5ksi Cement

.....#8 Bar --- #9 Bar - - - - #10 Bar

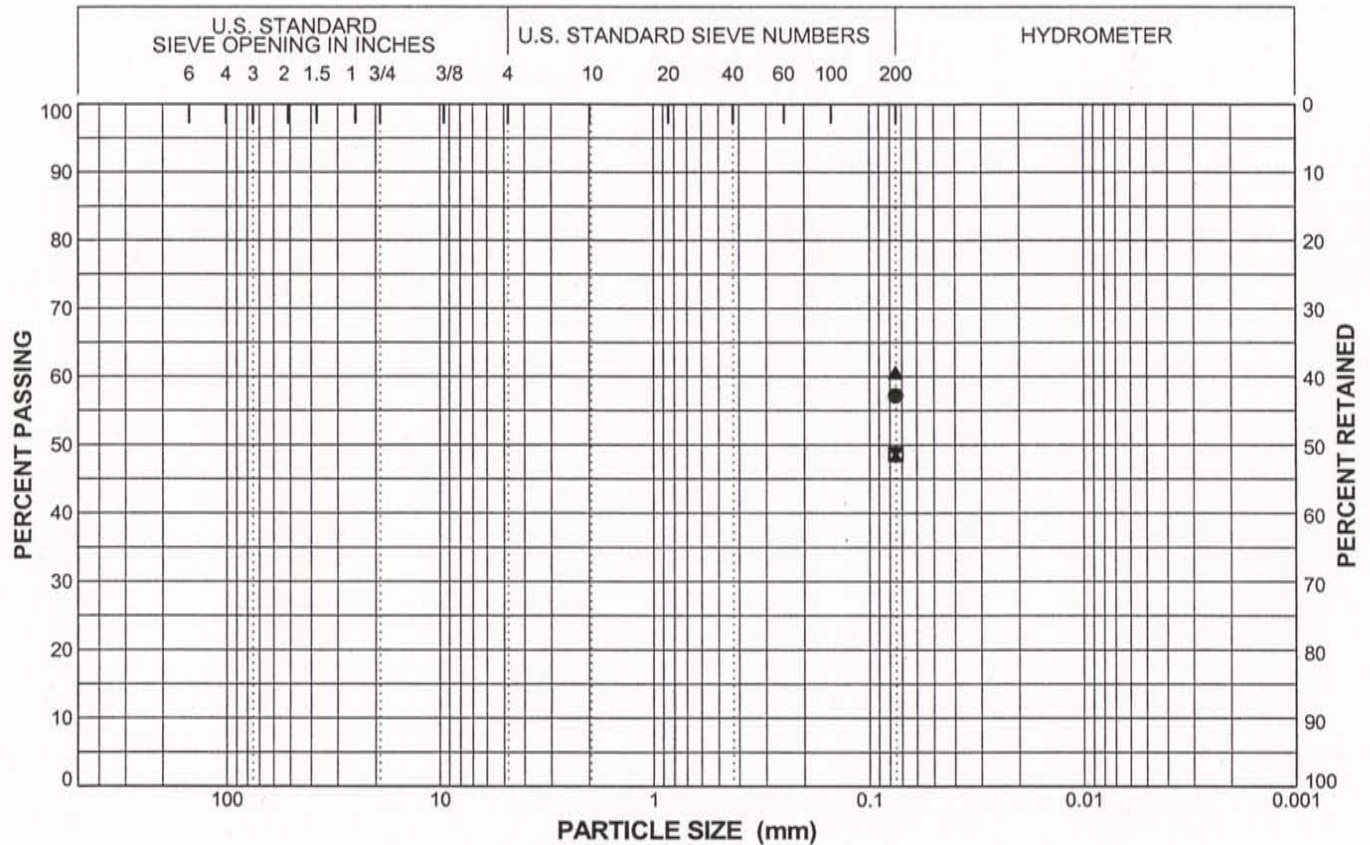
| Boring ID | Sample # | Depth (feet) | Sample Moisture (%) | Dry Density (lbs/ft <sup>3</sup> ) | Symbol | LL | PI | % G | % S | % F | Classification |
| TP-01 | 1 | 2.0-2.5 | 52.1 | | ● | 85 | 52 | | | 57.2 | Sandy Fat Clay [CH] |

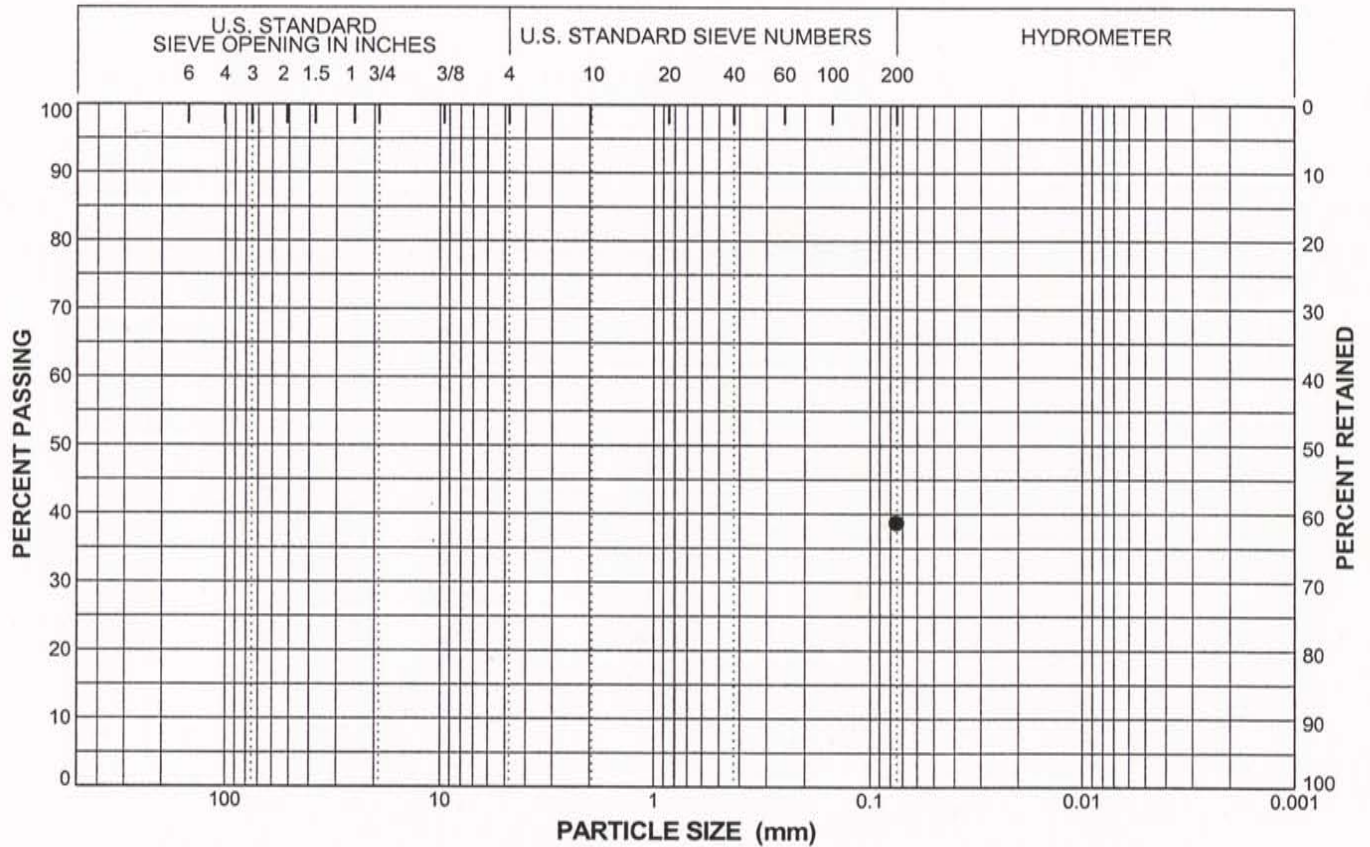
| Boring ID | Sample # | Depth (feet) | Sample Moisture (%) | Dry Density (lbs/ft <sup>3</sup> ) | Symbol | LL | PI | % G | % S | % F | Classification |
| TP-12 | 1 | 1.5-2.0 | 15.3 | | ● | | | | | 38.7 | Silty Sand [SM] |

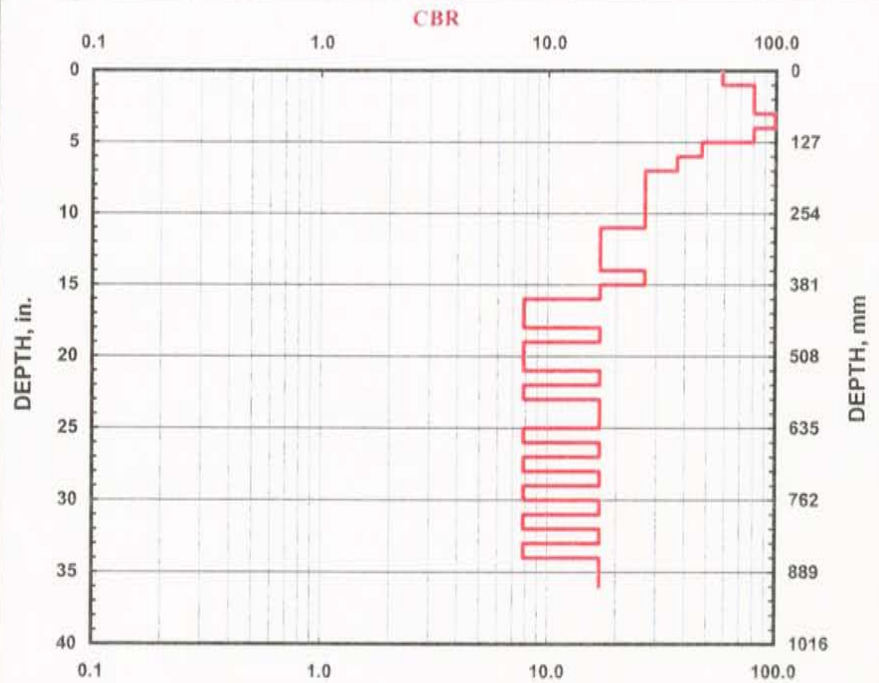
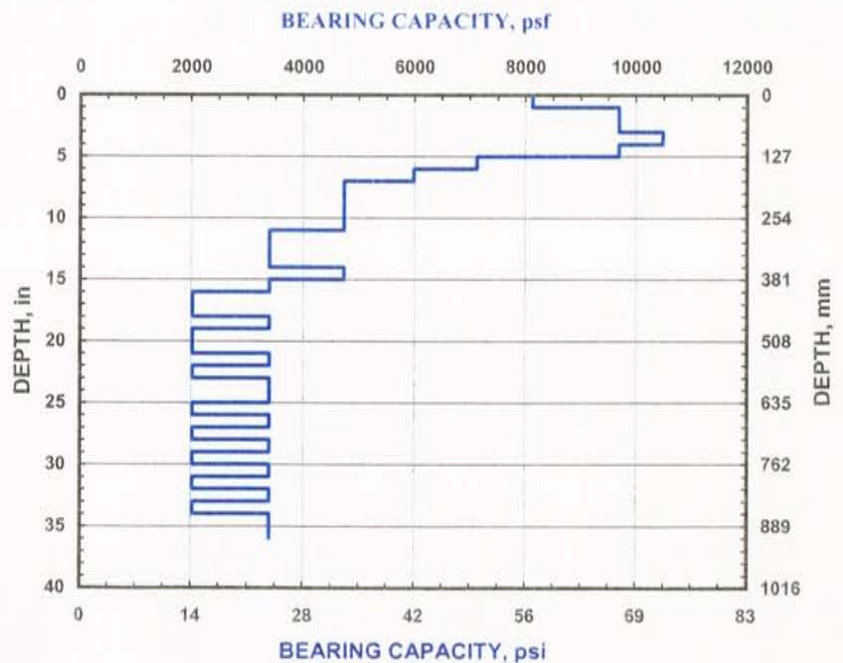
DCP-02

Bearing Capacity based on correlations of CBR and Bearing values (Design of Concrete Airport Pavement, Portland Cement Association, page 8, 1955)

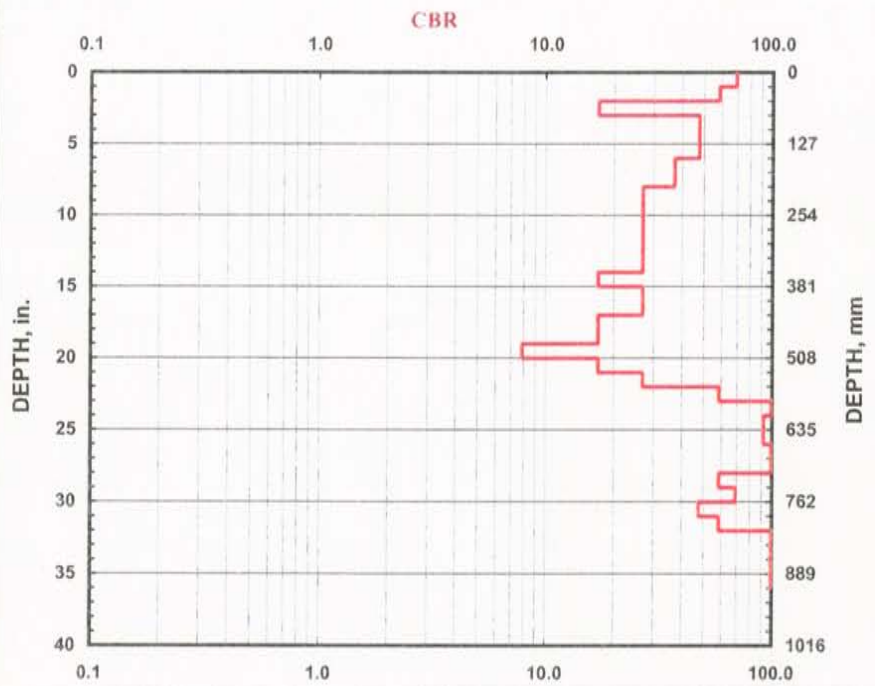
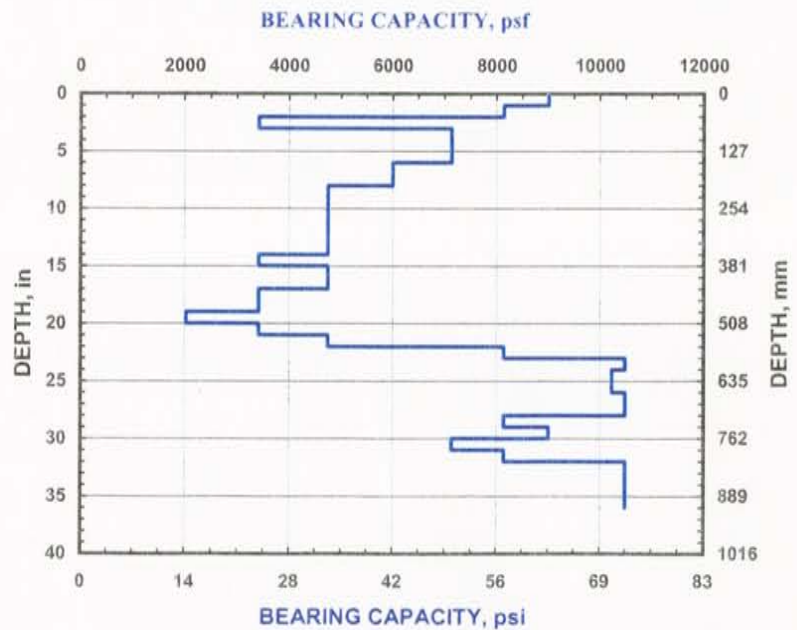
DCP-05

Bearing Capacity based on correlations of CBR and Bearing values (Design of Concrete Airport Pavement, Portland Cement Association, page 8, 1955)

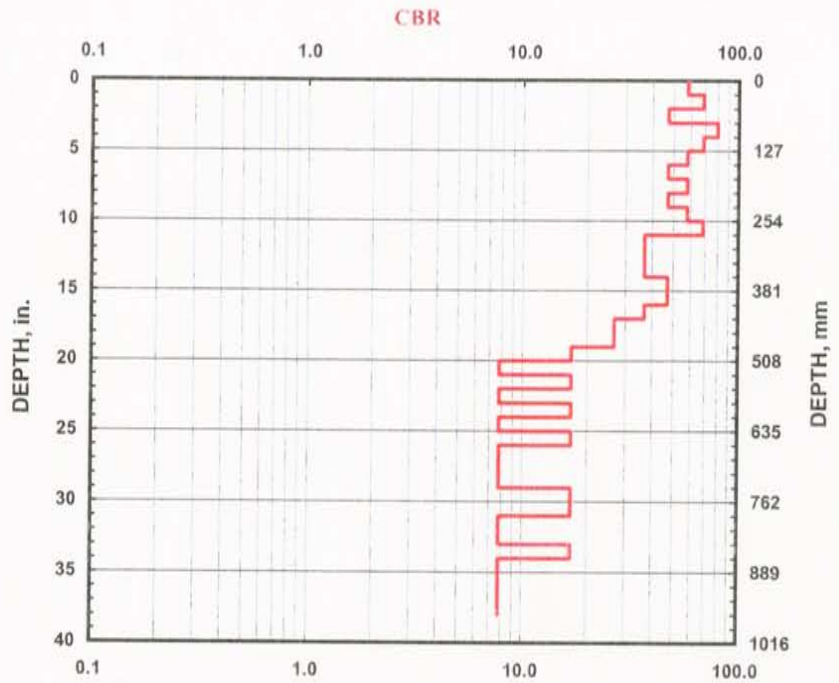
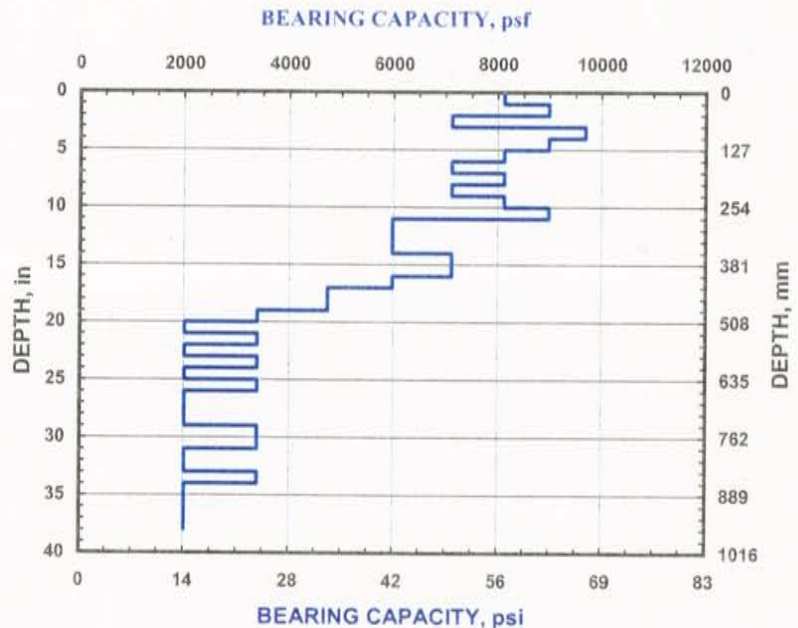
DCP-07

Bearing Capacity based on correlations of CBR and Bearing values (Design of Concrete Airport Pavement, Portland Cement Association, page 8, 1955)

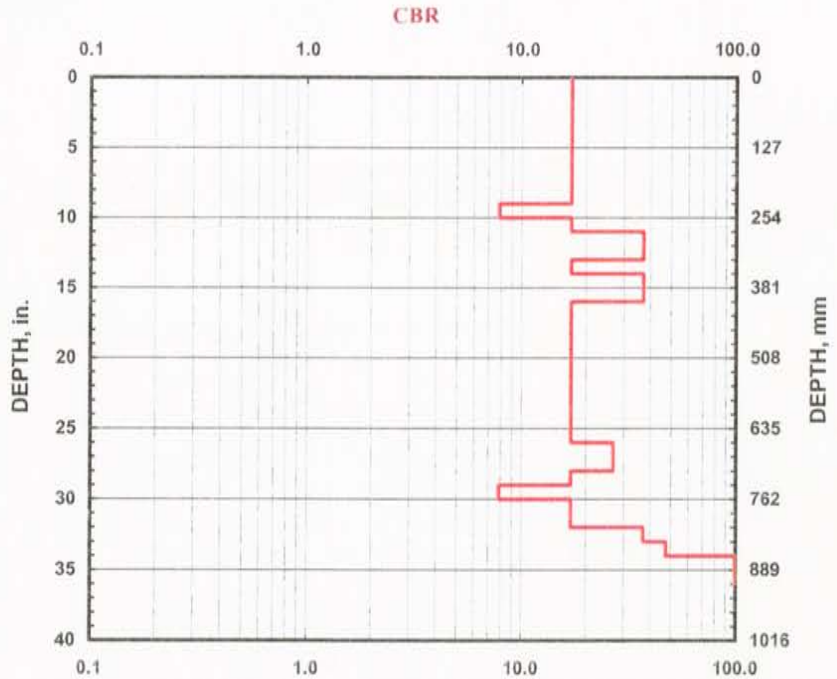
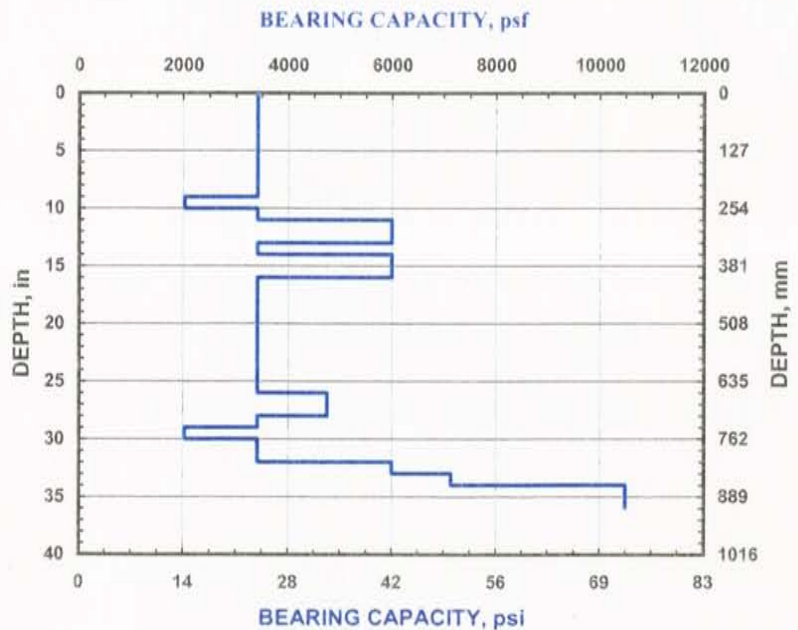
## DCP-09

Bearing Capacity based on correlations of CBR and Bearing values (Design of Concrete Airport Pavement, Portland Cement Association, page 8, 1955)

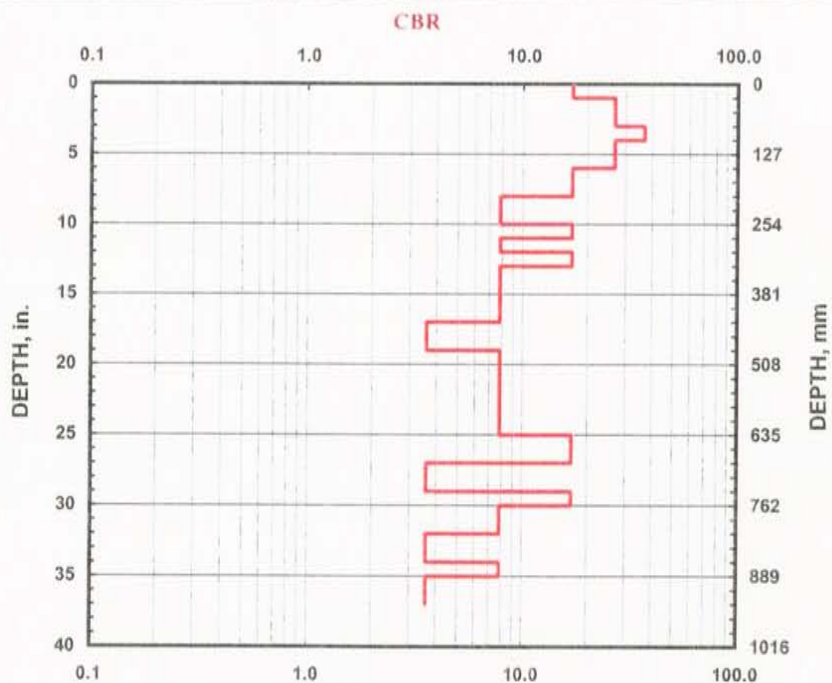
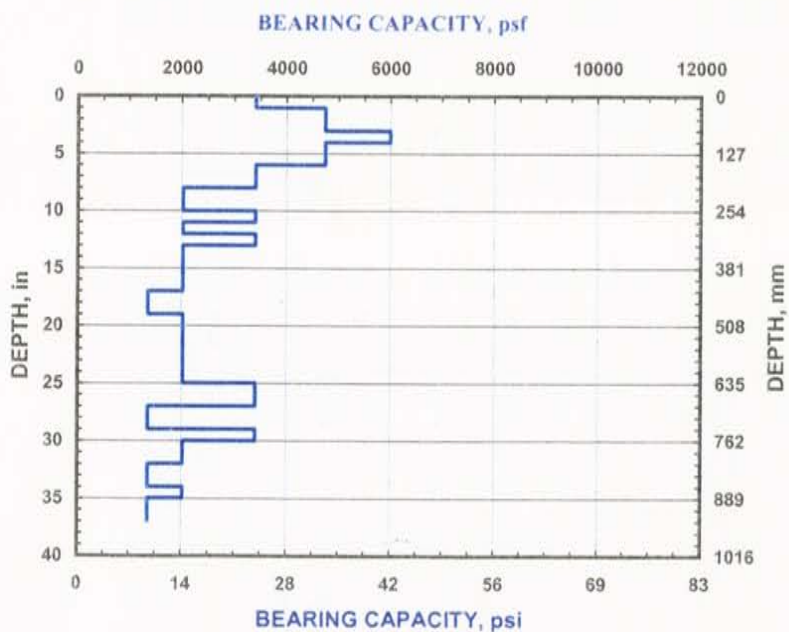
DCP-11

Bearing Capacity based on correlations of CBR and Bearing values (Design of Concrete Airport Pavement, Portland Cement Association, page 8, 1955)

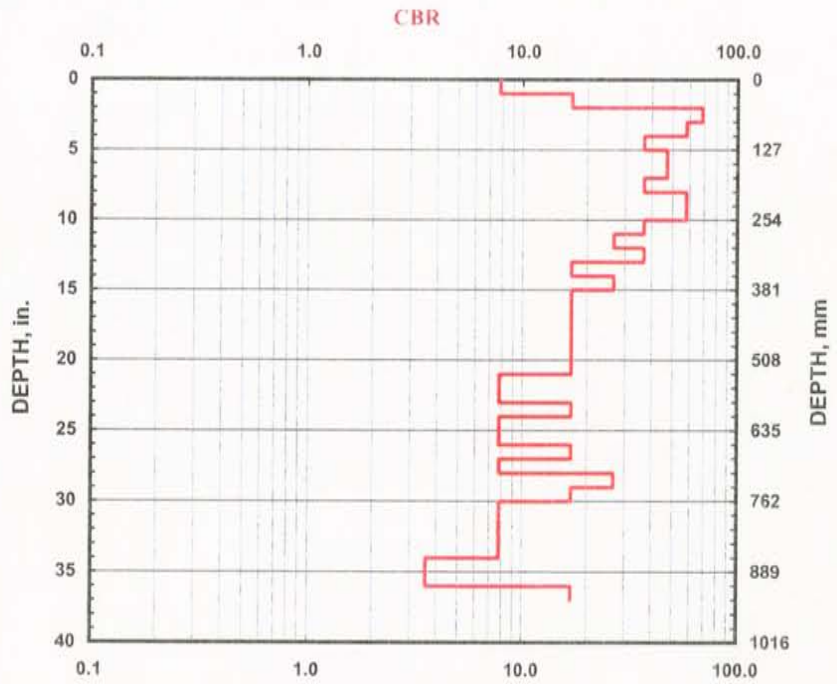
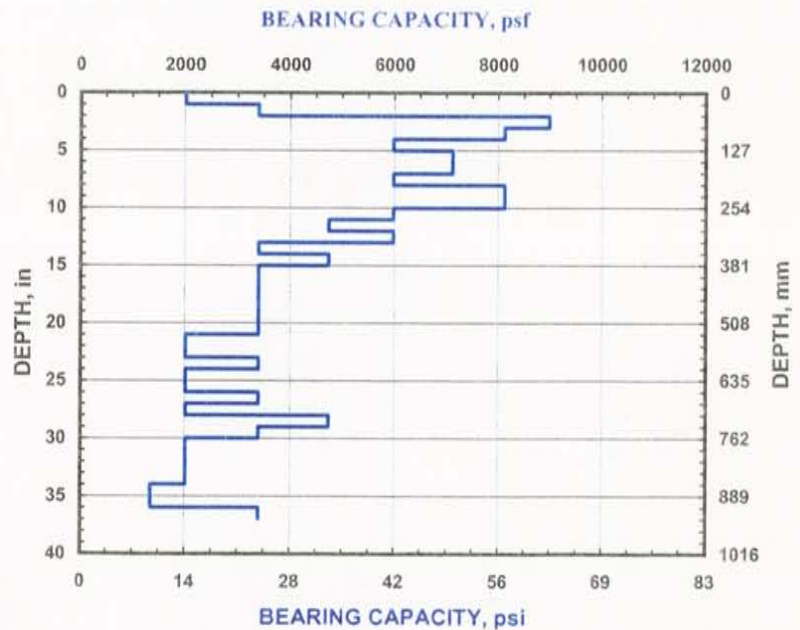
## DCP-12

Bearing Capacity based on correlations of CBR and Bearing values (Design of Concrete Airport Pavement, Portland Cement Association, page 8, 1955)

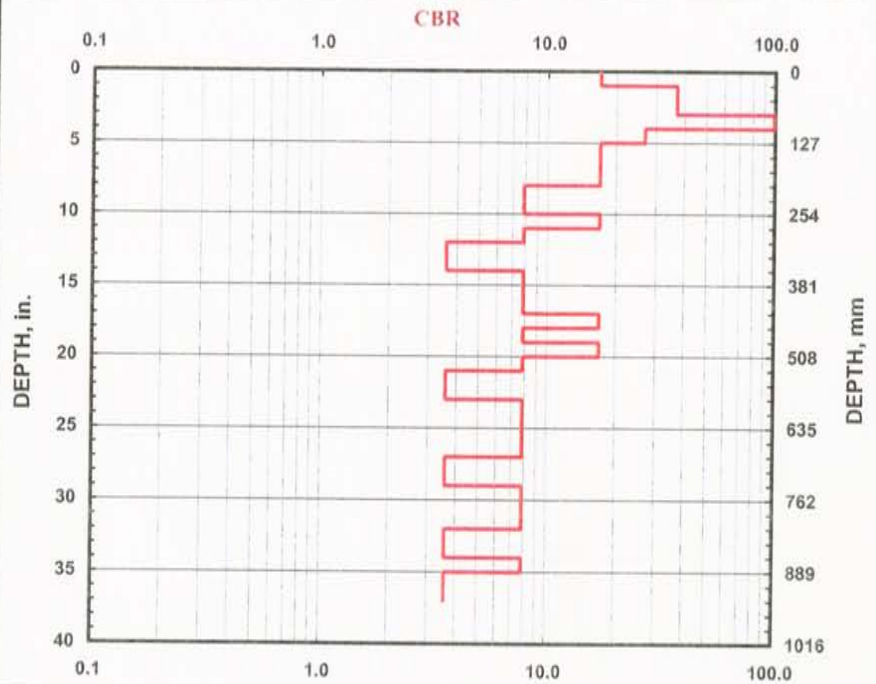
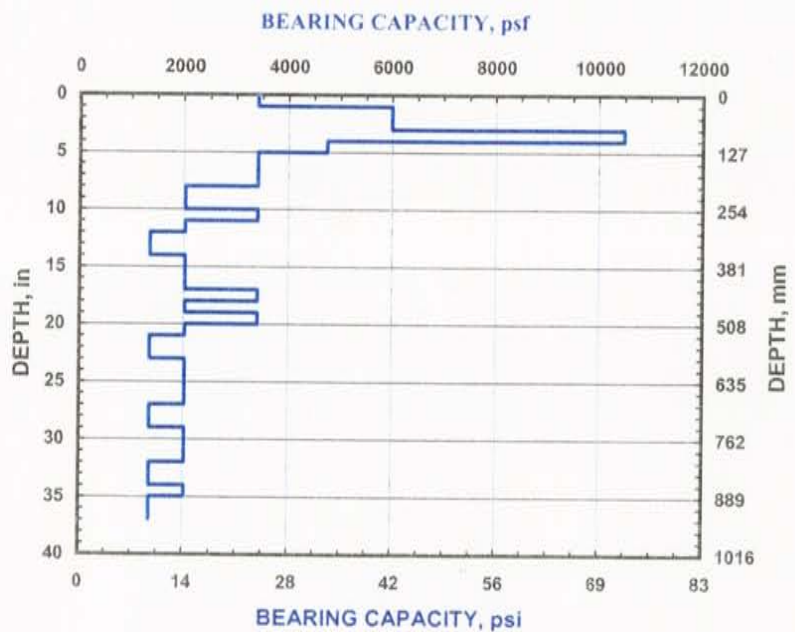
## DCP-13

Bearing Capacity based on correlations of CBR and Bearing values (Design of Concrete Airport Pavement, Portland Cement Association, page 8, 1955)

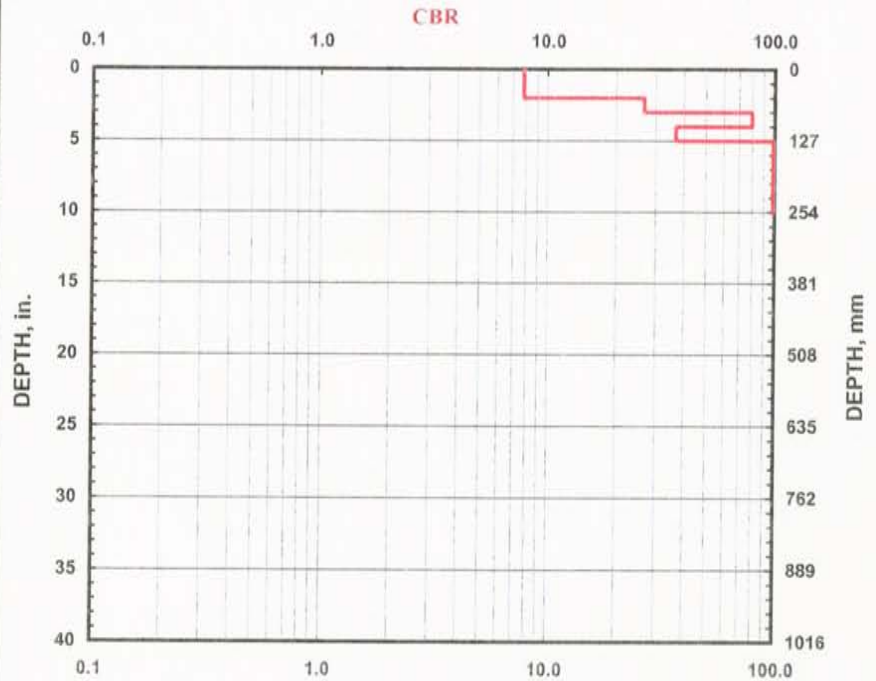
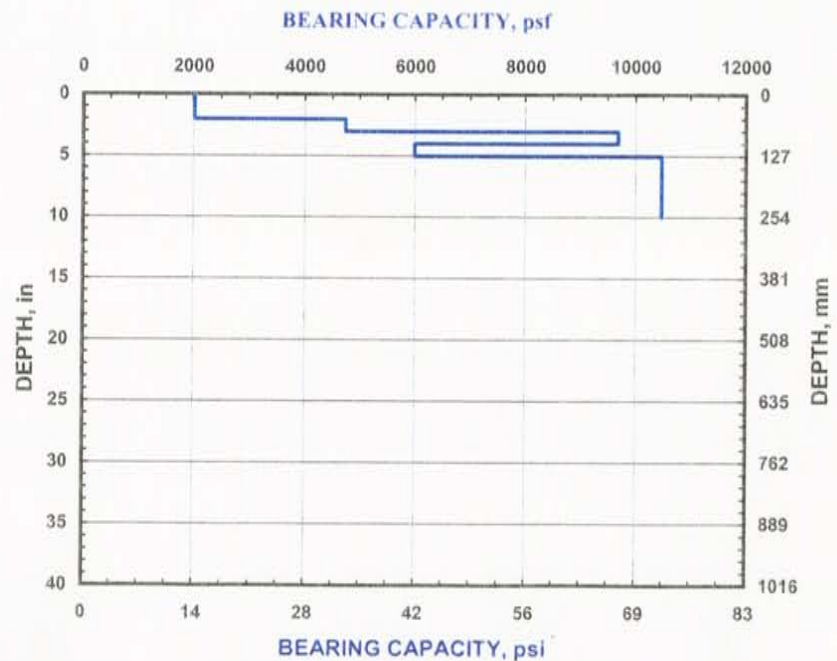
## DCP-14

Bearing Capacity based on correlations of CBR and Bearing values (Design of Concrete Airport Pavement, Portland Cement Association, page 8, 1955)

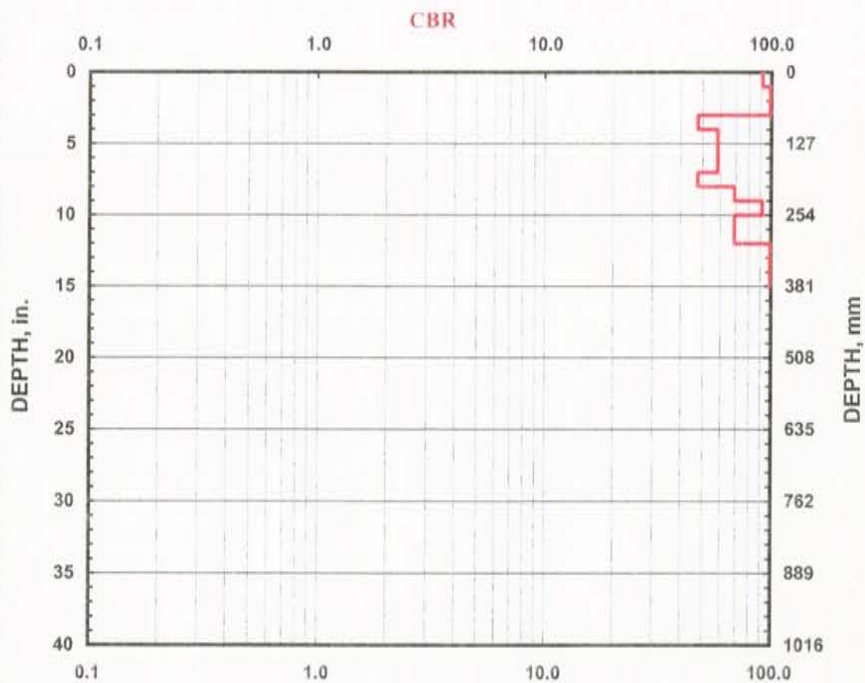
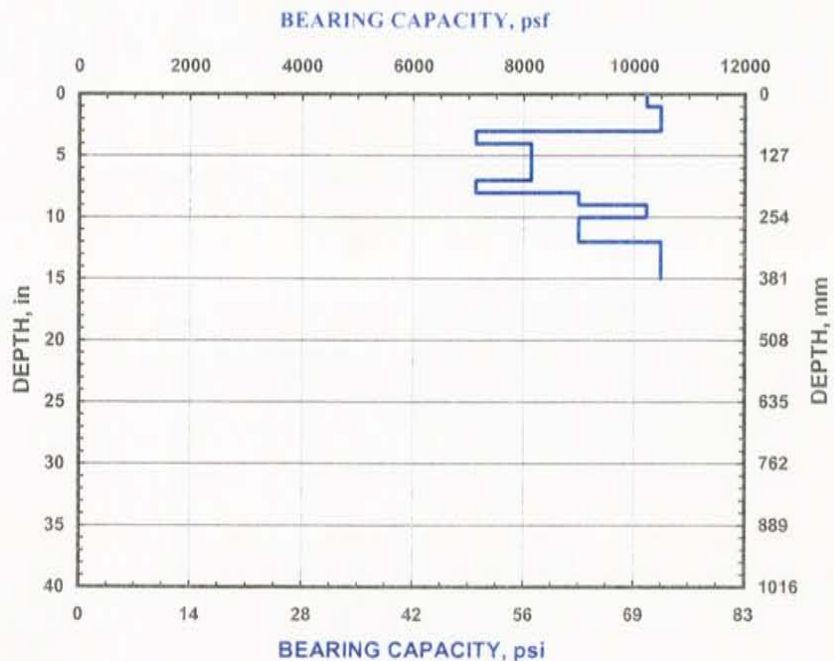
## DCP-15

Bearing Capacity based on correlations of CBR and Bearing values (Design of Concrete Airport Pavement, Portland Cement Association, page 8, 1955)

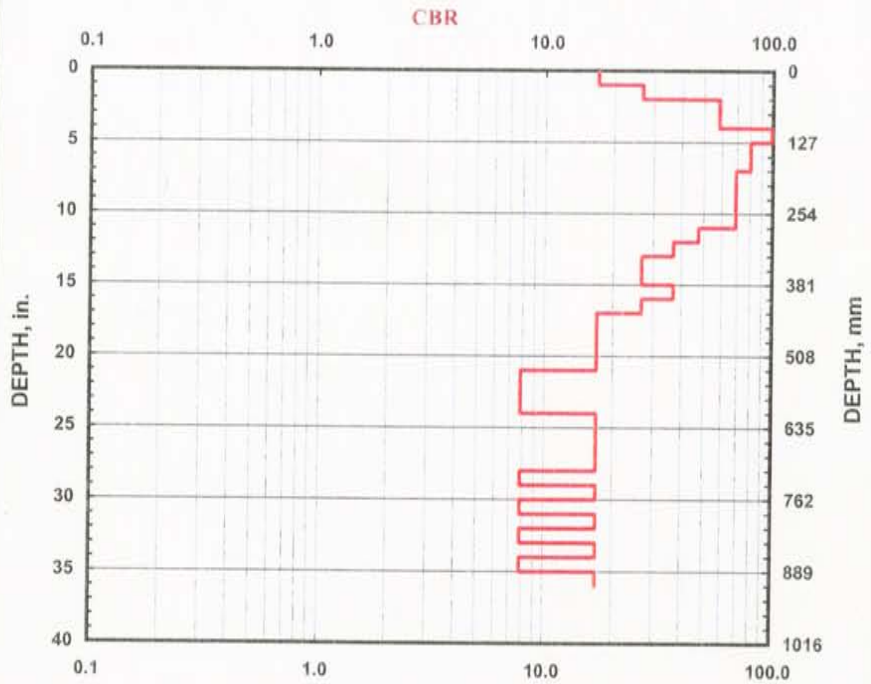
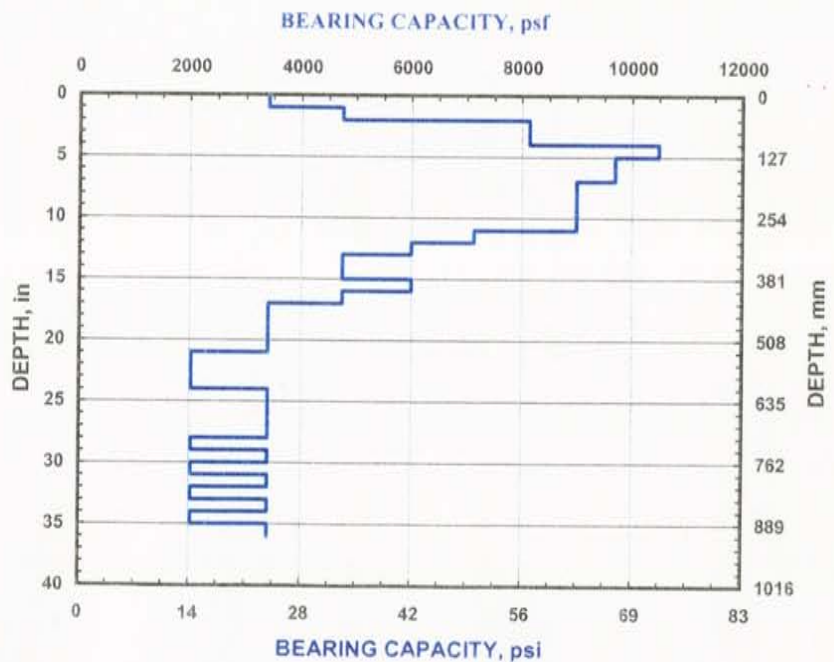
Bearing Capacity based on correlations of CBR and Bearing values (Design of Concrete Airport Pavement, Portland Cement Association, page 8, 1955)

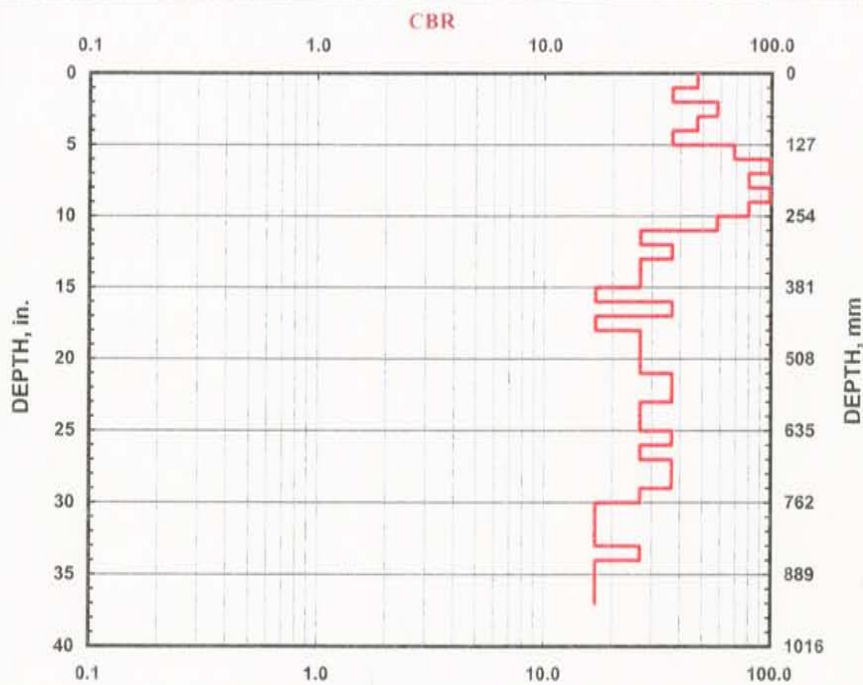
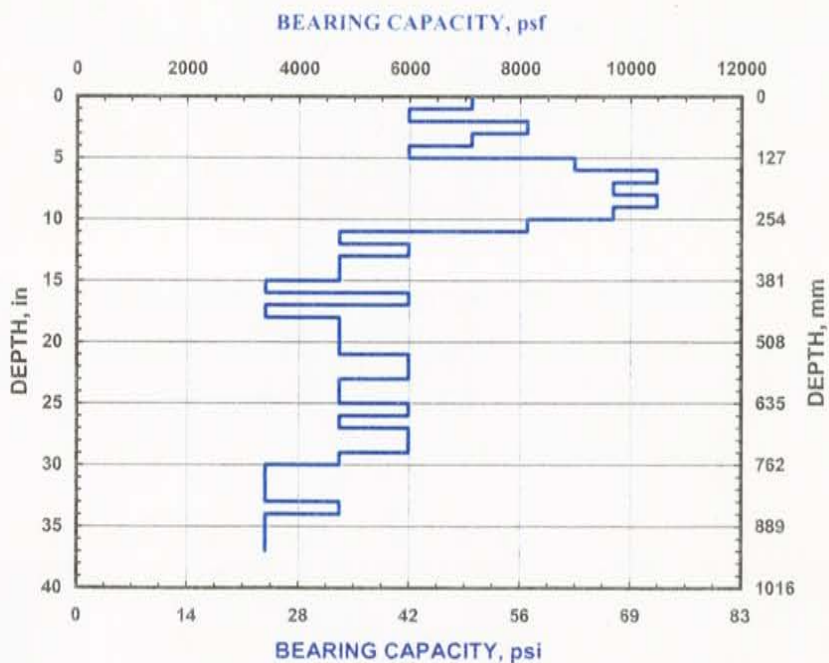
Bearing Capacity based on correlations of CBR and Bearing values (Design of Concrete Airport Pavement, Portland Cement Association, page 8, 1955)

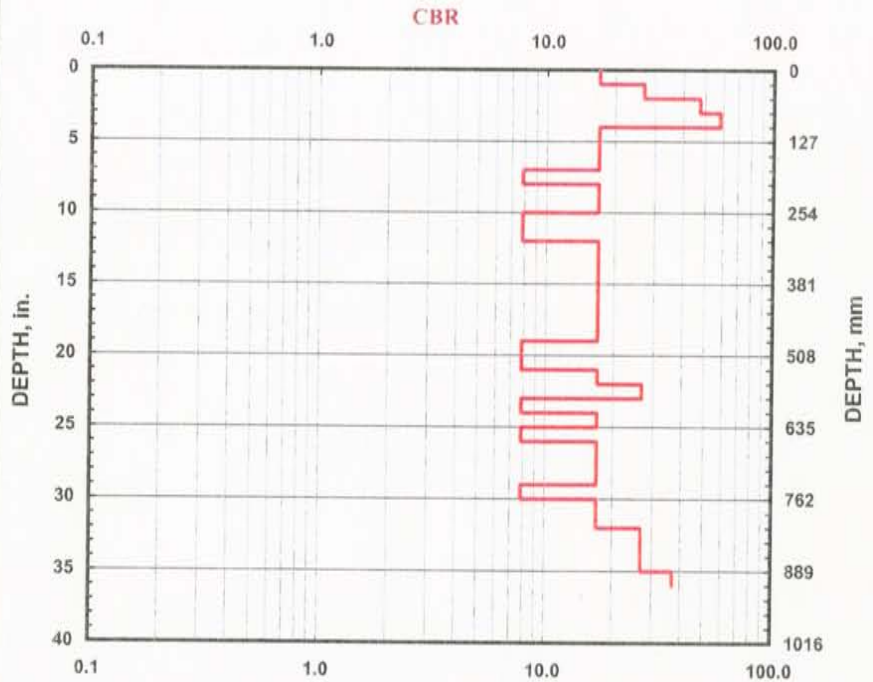
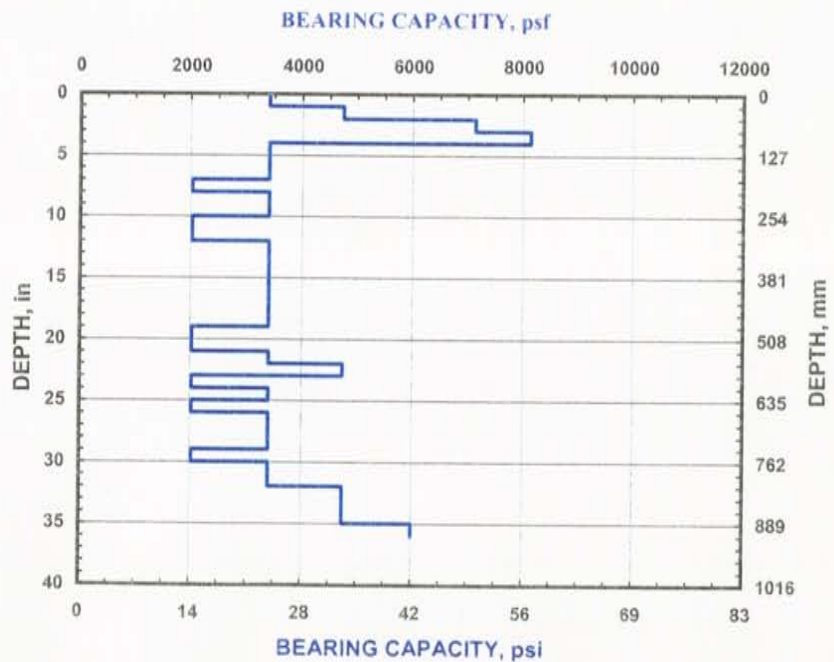
Bearing Capacity based on correlations of CBR and Bearing values (Design of Concrete Airport Pavement, Portland Cement Association, page 8, 1955)
