**Appendix B**  
**Geotechnical Report**  
**November 2007**

Preliminary Geotechnical Report  
Saddleback Wind Energy Project  
White Salmon, Washington

*Prepared by*  
**URS Corporation**  
URS Job #33758687

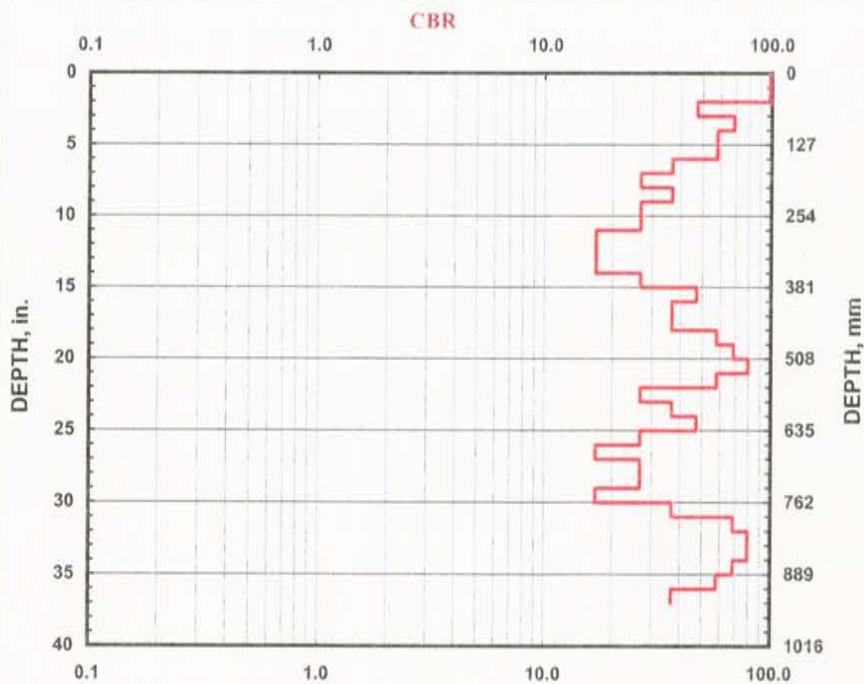
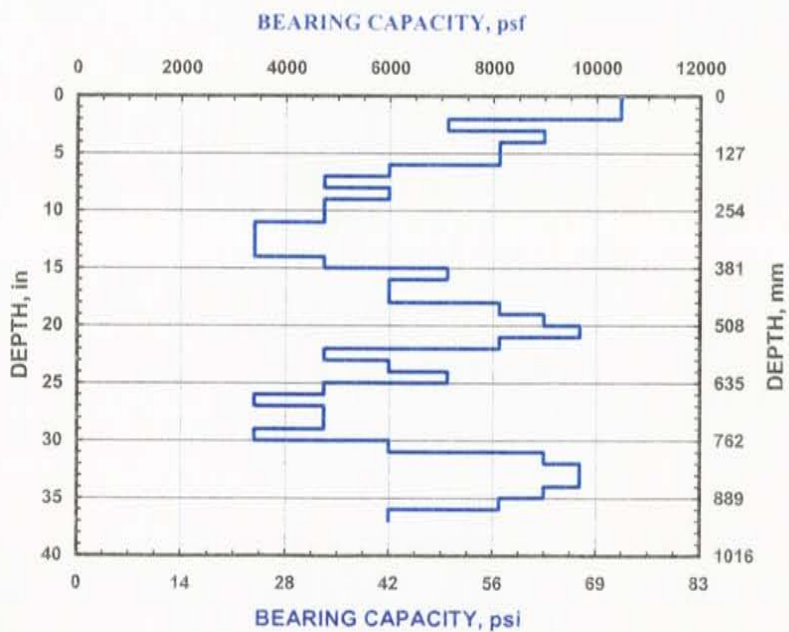
Bearing Capacity based on correlations of CBR and Bearing values (Design of Concrete Airport Pavement, Portland Cement Association, page 8, 1955)

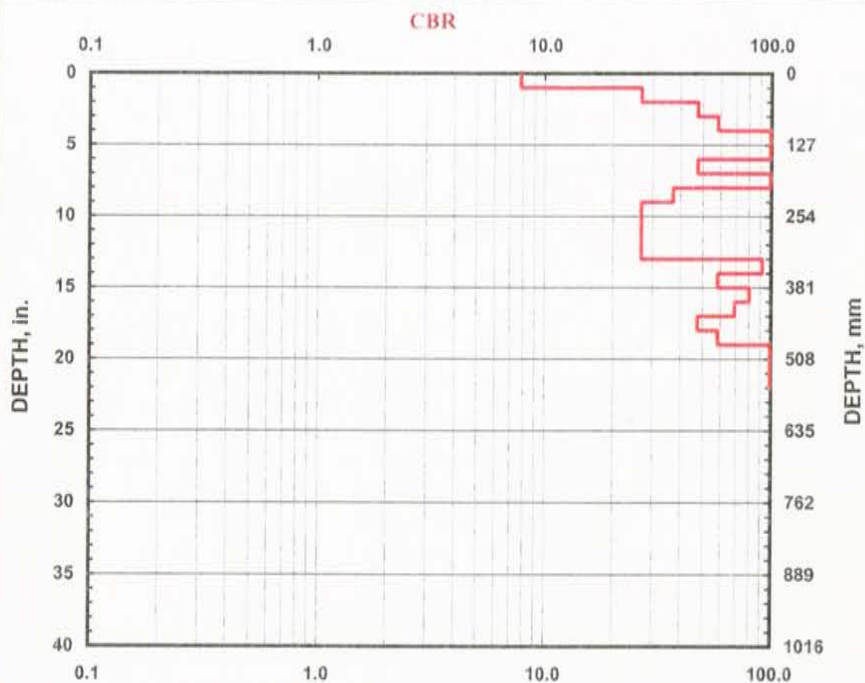
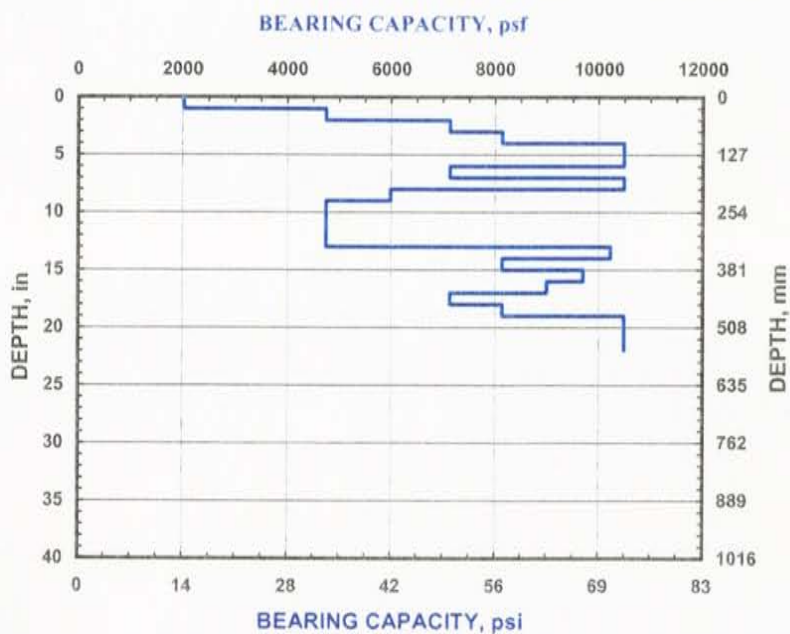
Bearing Capacity based on correlations of CBR and Bearing values (Design of Concrete Airport Pavement, Portland Cement Association, page 8, 1955)

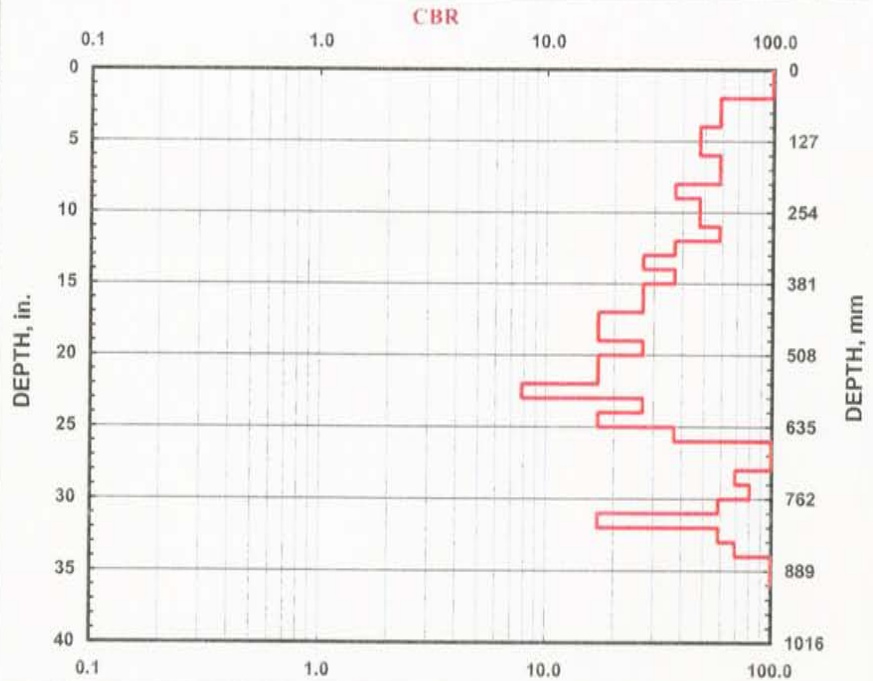
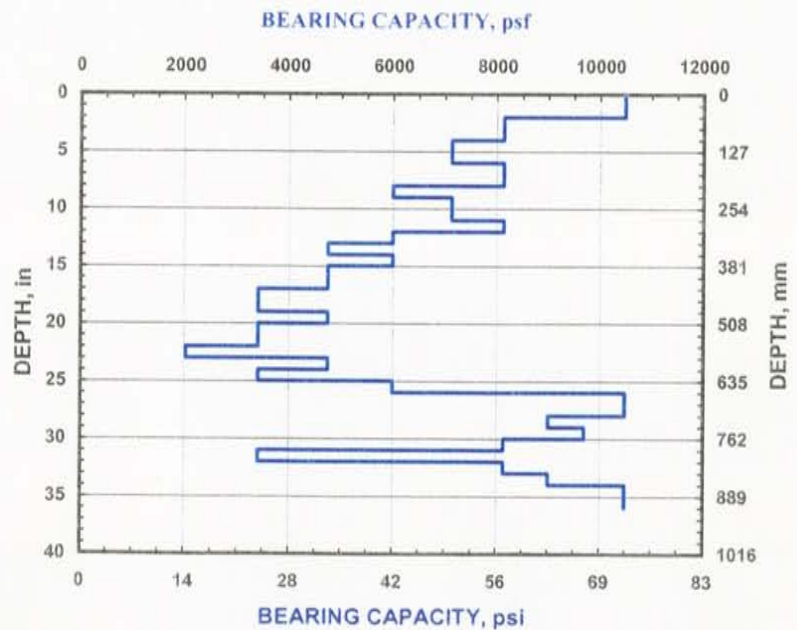
DCP-23

Bearing Capacity based on correlations of CBR and Bearing values (Design of Concrete Airport Pavement, Portland Cement Association, page 8, 1955)

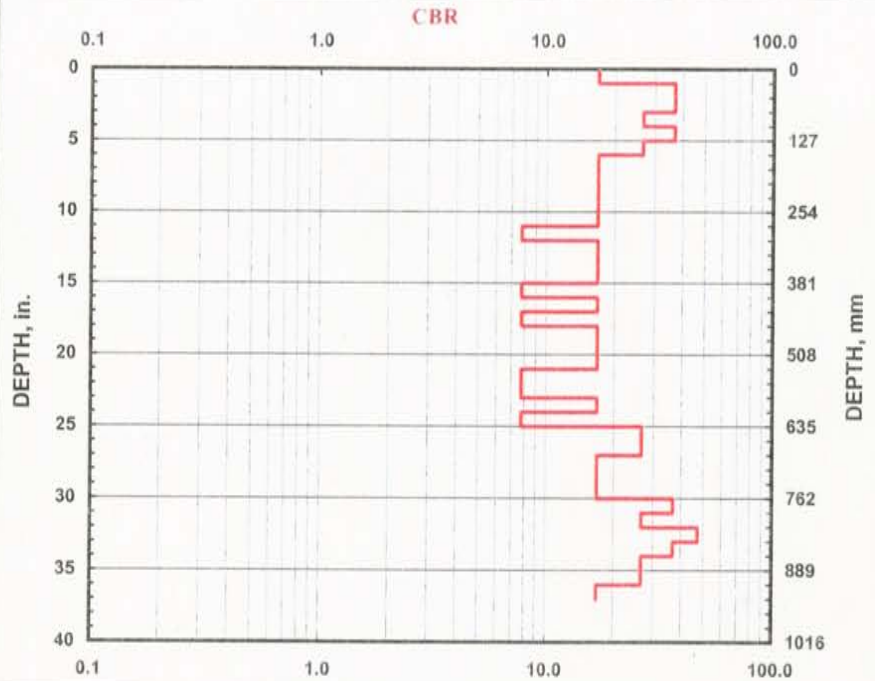
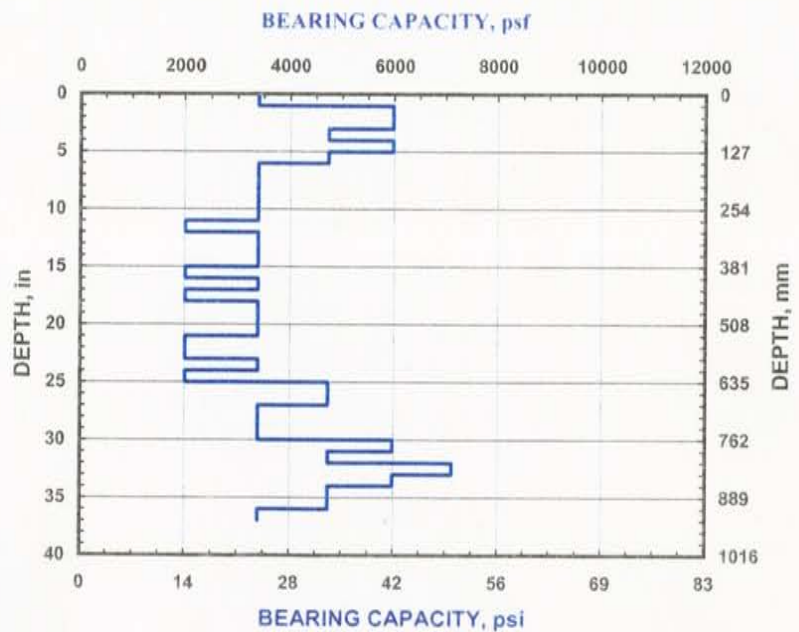
Bearing Capacity based on correlations of CBR and Bearing values (Design of Concrete Airport Pavement, Portland Cement Association, page 8, 1955)

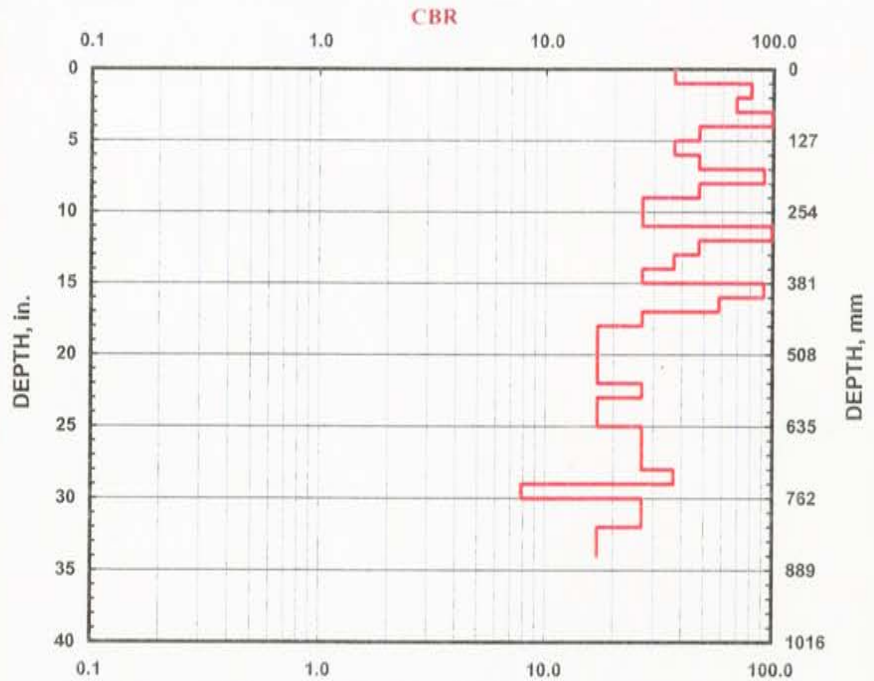
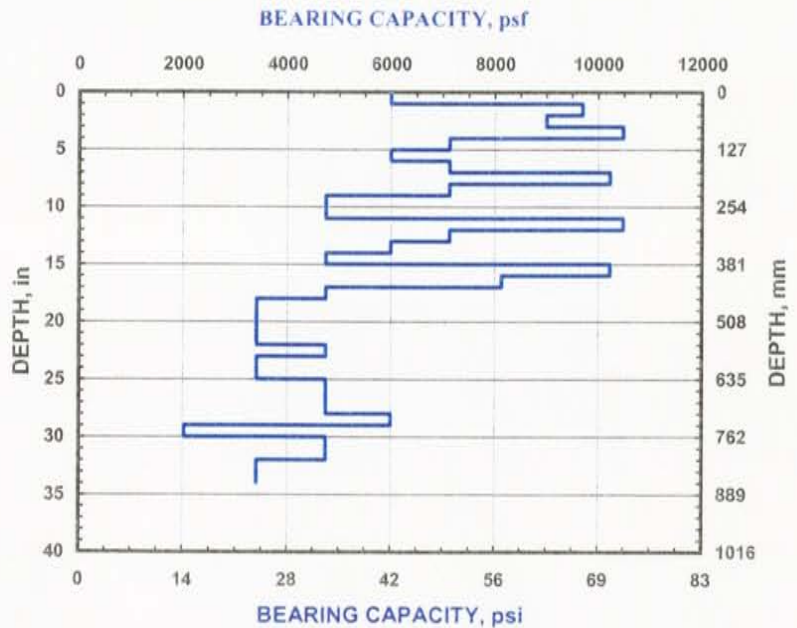
DCP-25

Bearing Capacity based on correlations of CBR and Bearing values (Design of Concrete Airport Pavement, Portland Cement Association, page 8, 1955)

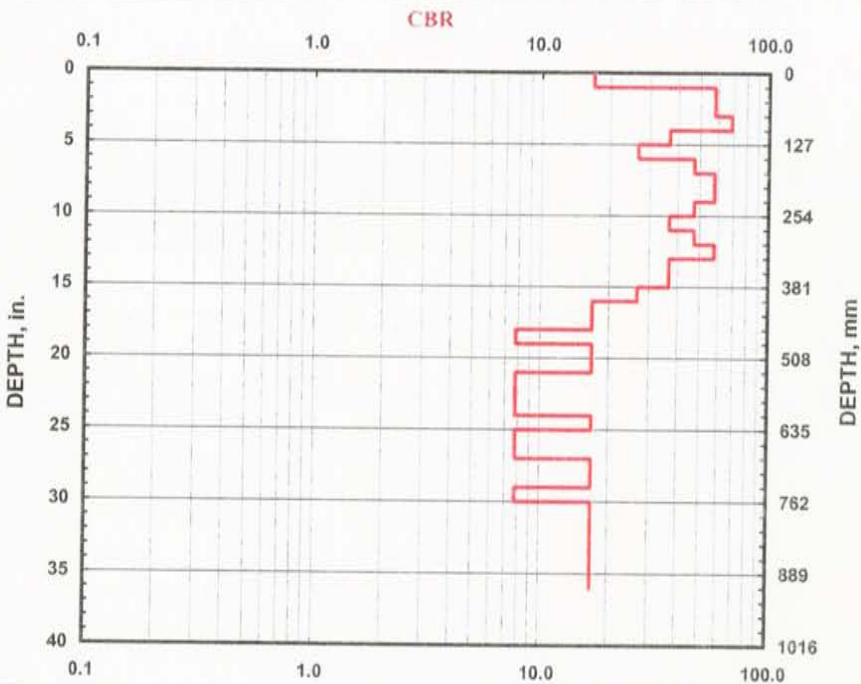
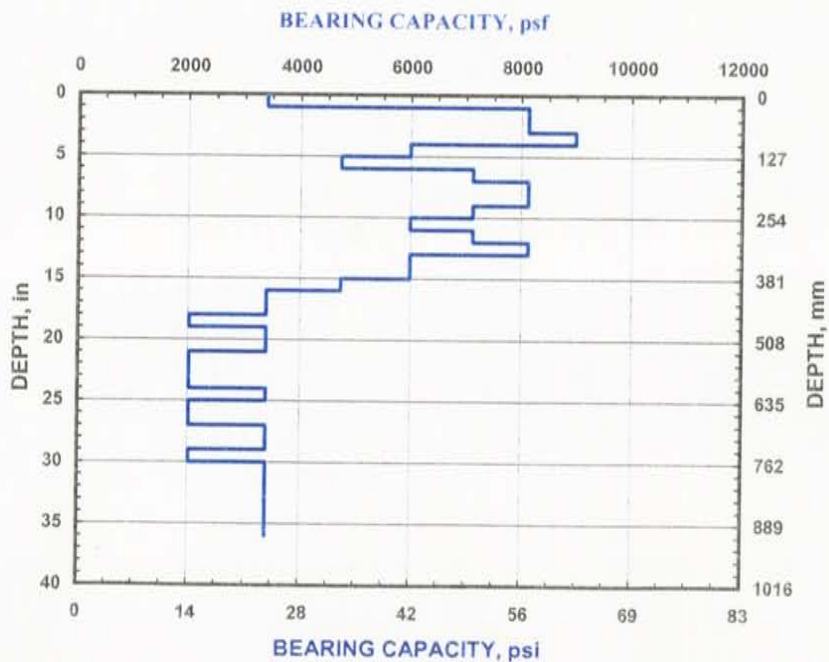
DCP-26

Bearing Capacity based on correlations of CBR and Bearing values (Design of Concrete Airport Pavement, Portland Cement Association, page 8, 1955)

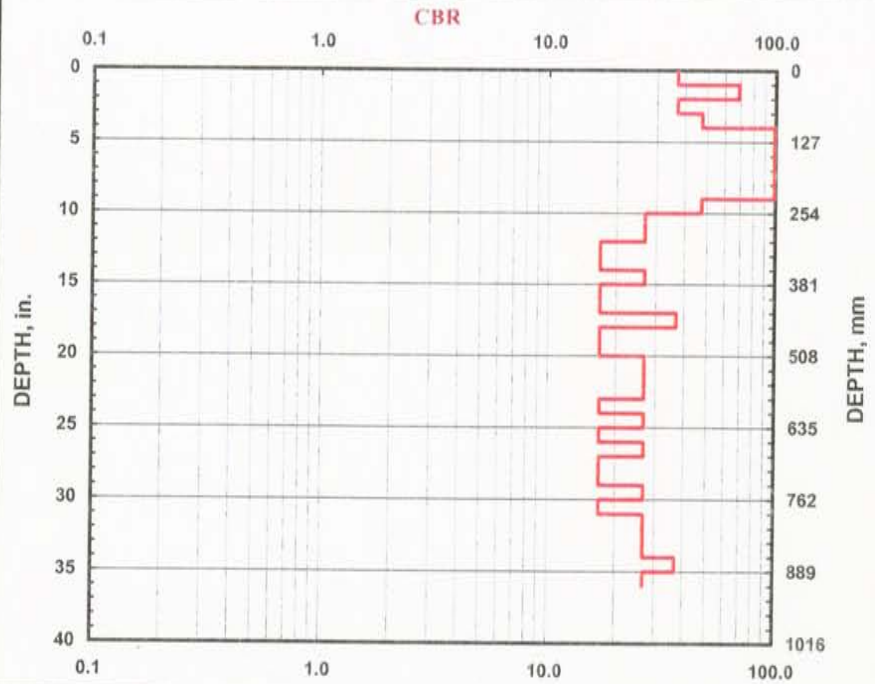
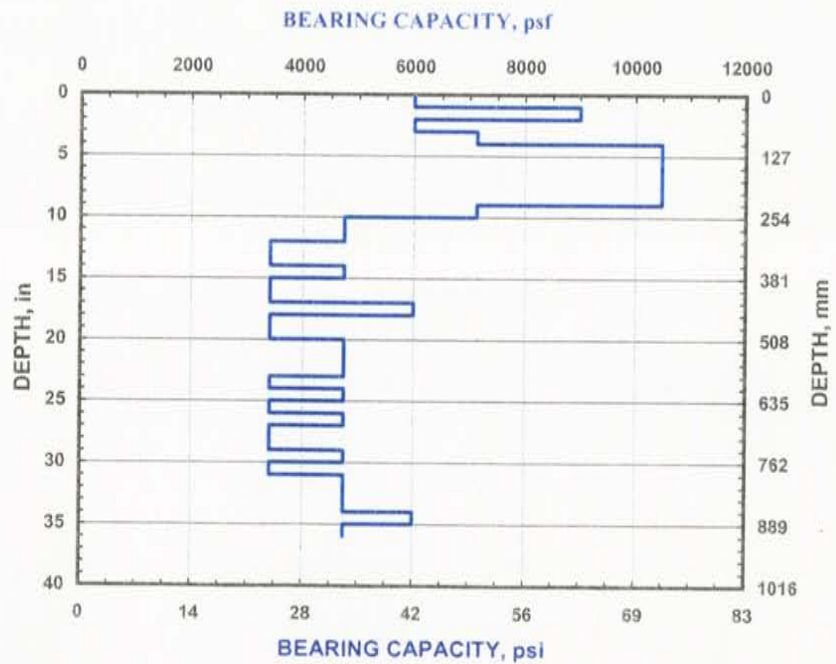
Bearing Capacity based on correlations of CBR and Bearing values (Design of Concrete Airport Pavement, Portland Cement Association, page 8, 1955)

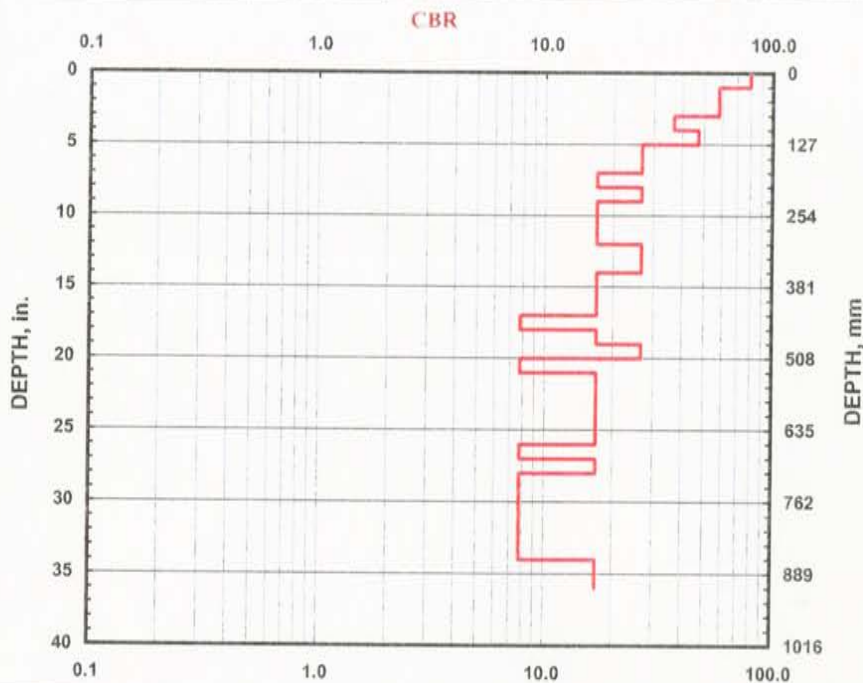
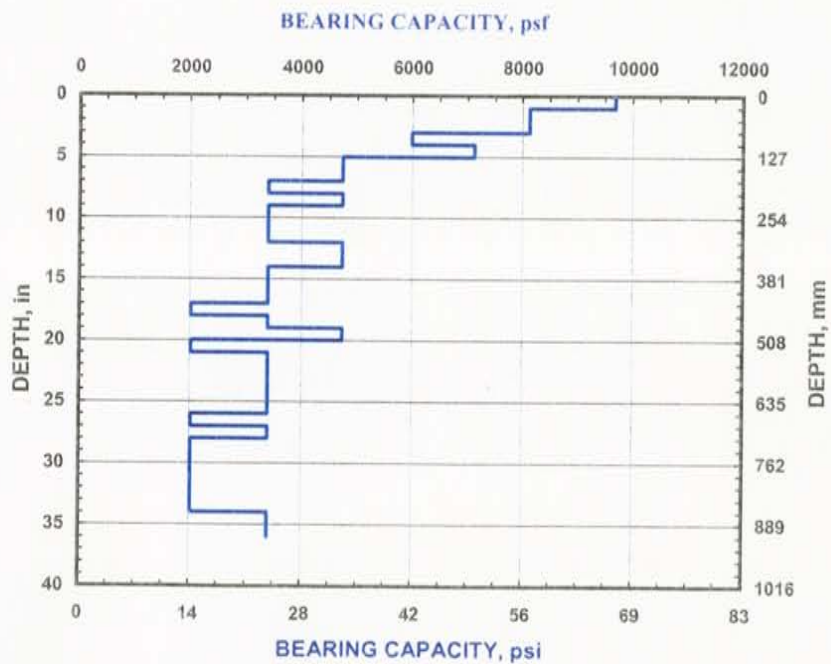
Bearing Capacity based on correlations of CBR and Bearing values (Design of Concrete Airport Pavement, Portland Cement Association, page 8, 1955)

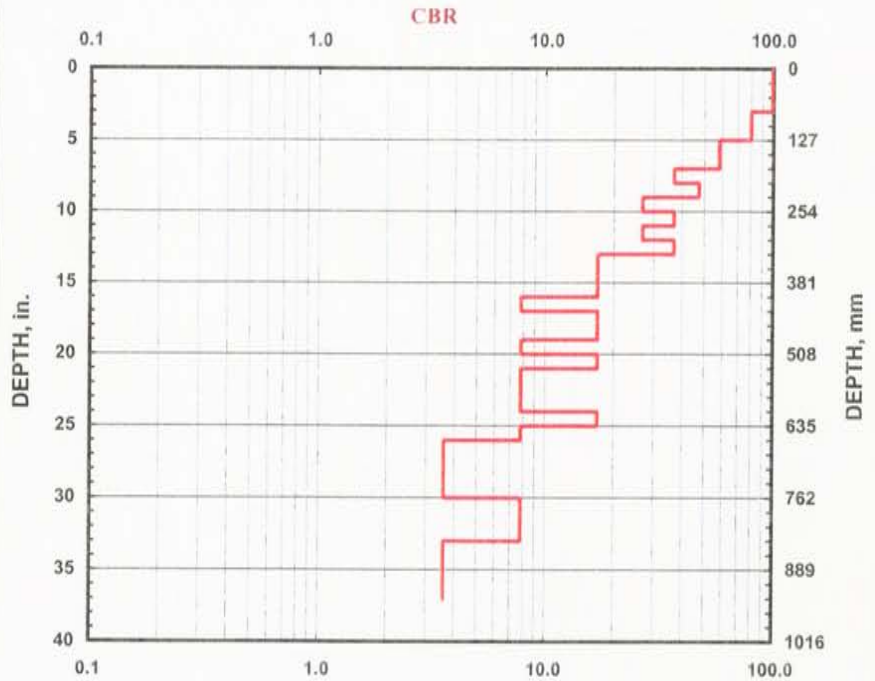
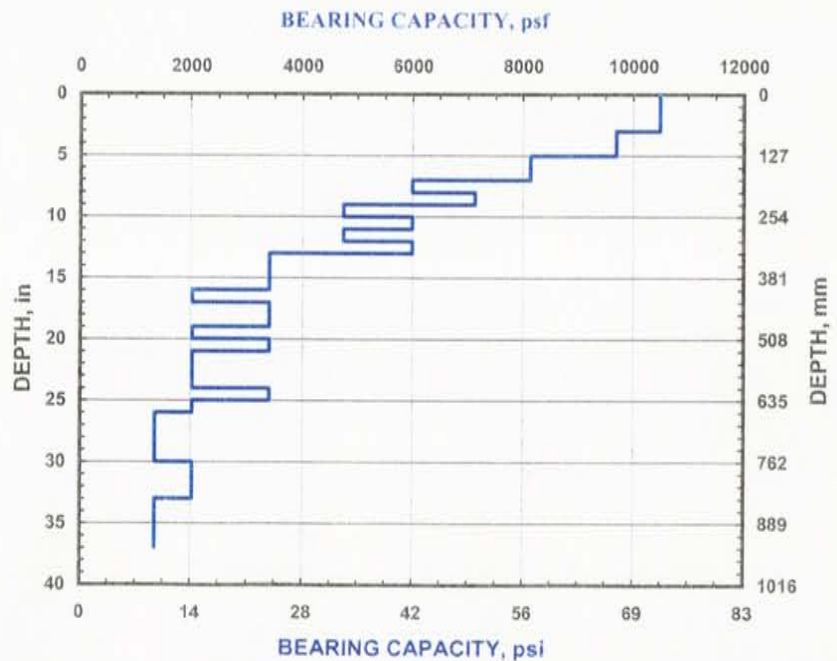
Bearing Capacity based on correlations of CBR and Bearing values (Design of Concrete Airport Pavement, Portland Cement Association, page 8, 1955)

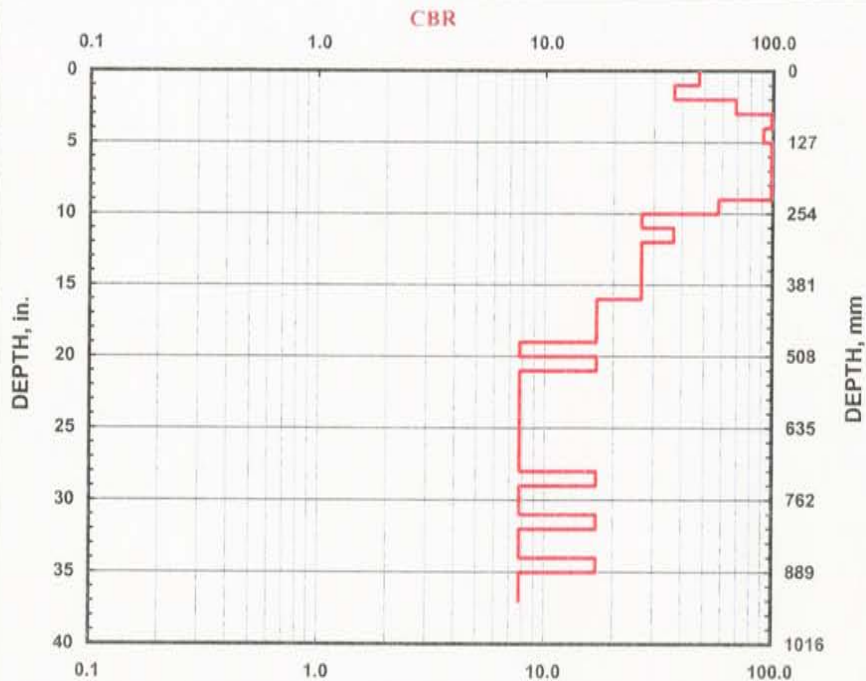
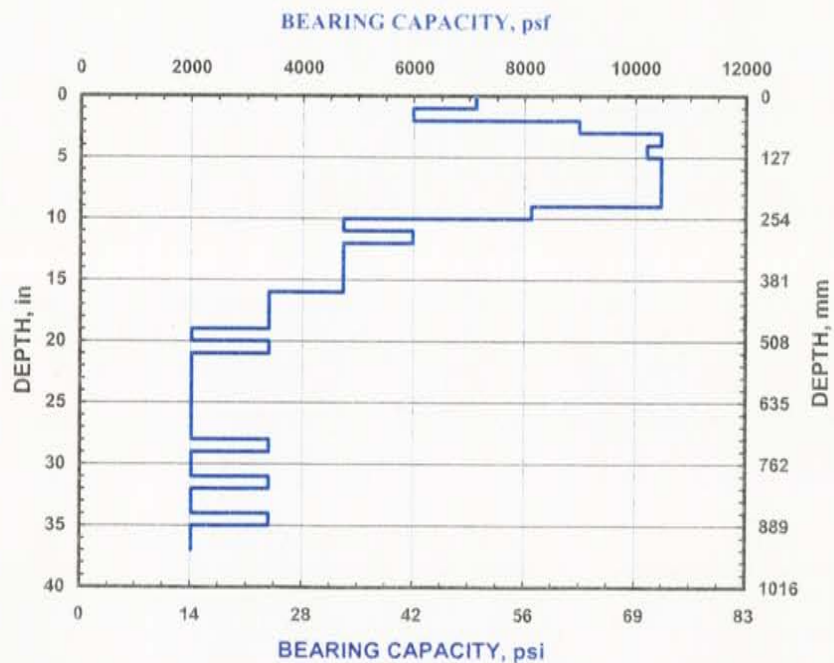
Bearing Capacity based on correlations of CBR and Bearing values (Design of Concrete Airport Pavement, Portland Cement Association, page 8, 1955)

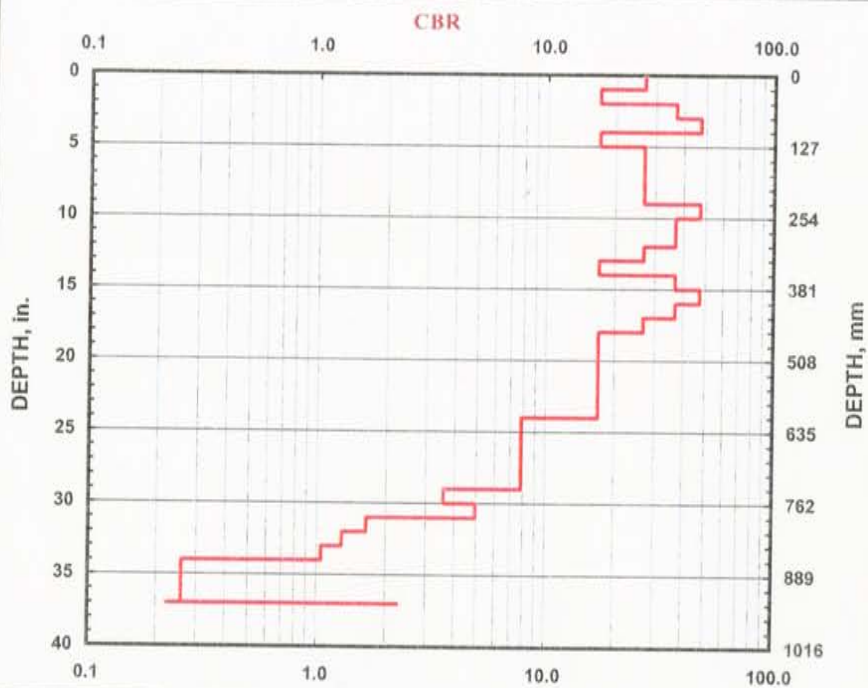
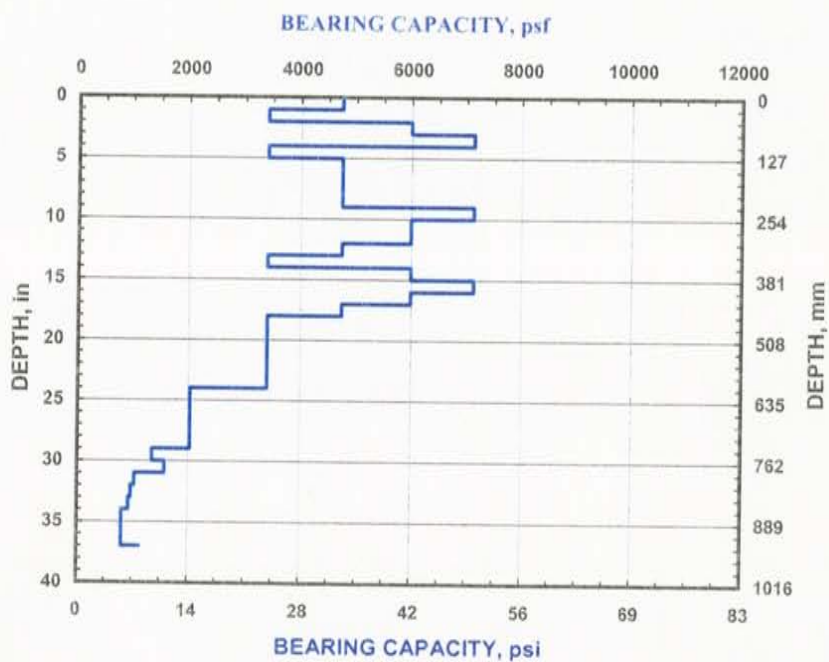
## DCP-30

Bearing Capacity based on correlations of CBR and Bearing values (Design of Concrete Airport Pavement, Portland Cement Association, page 8, 1955)

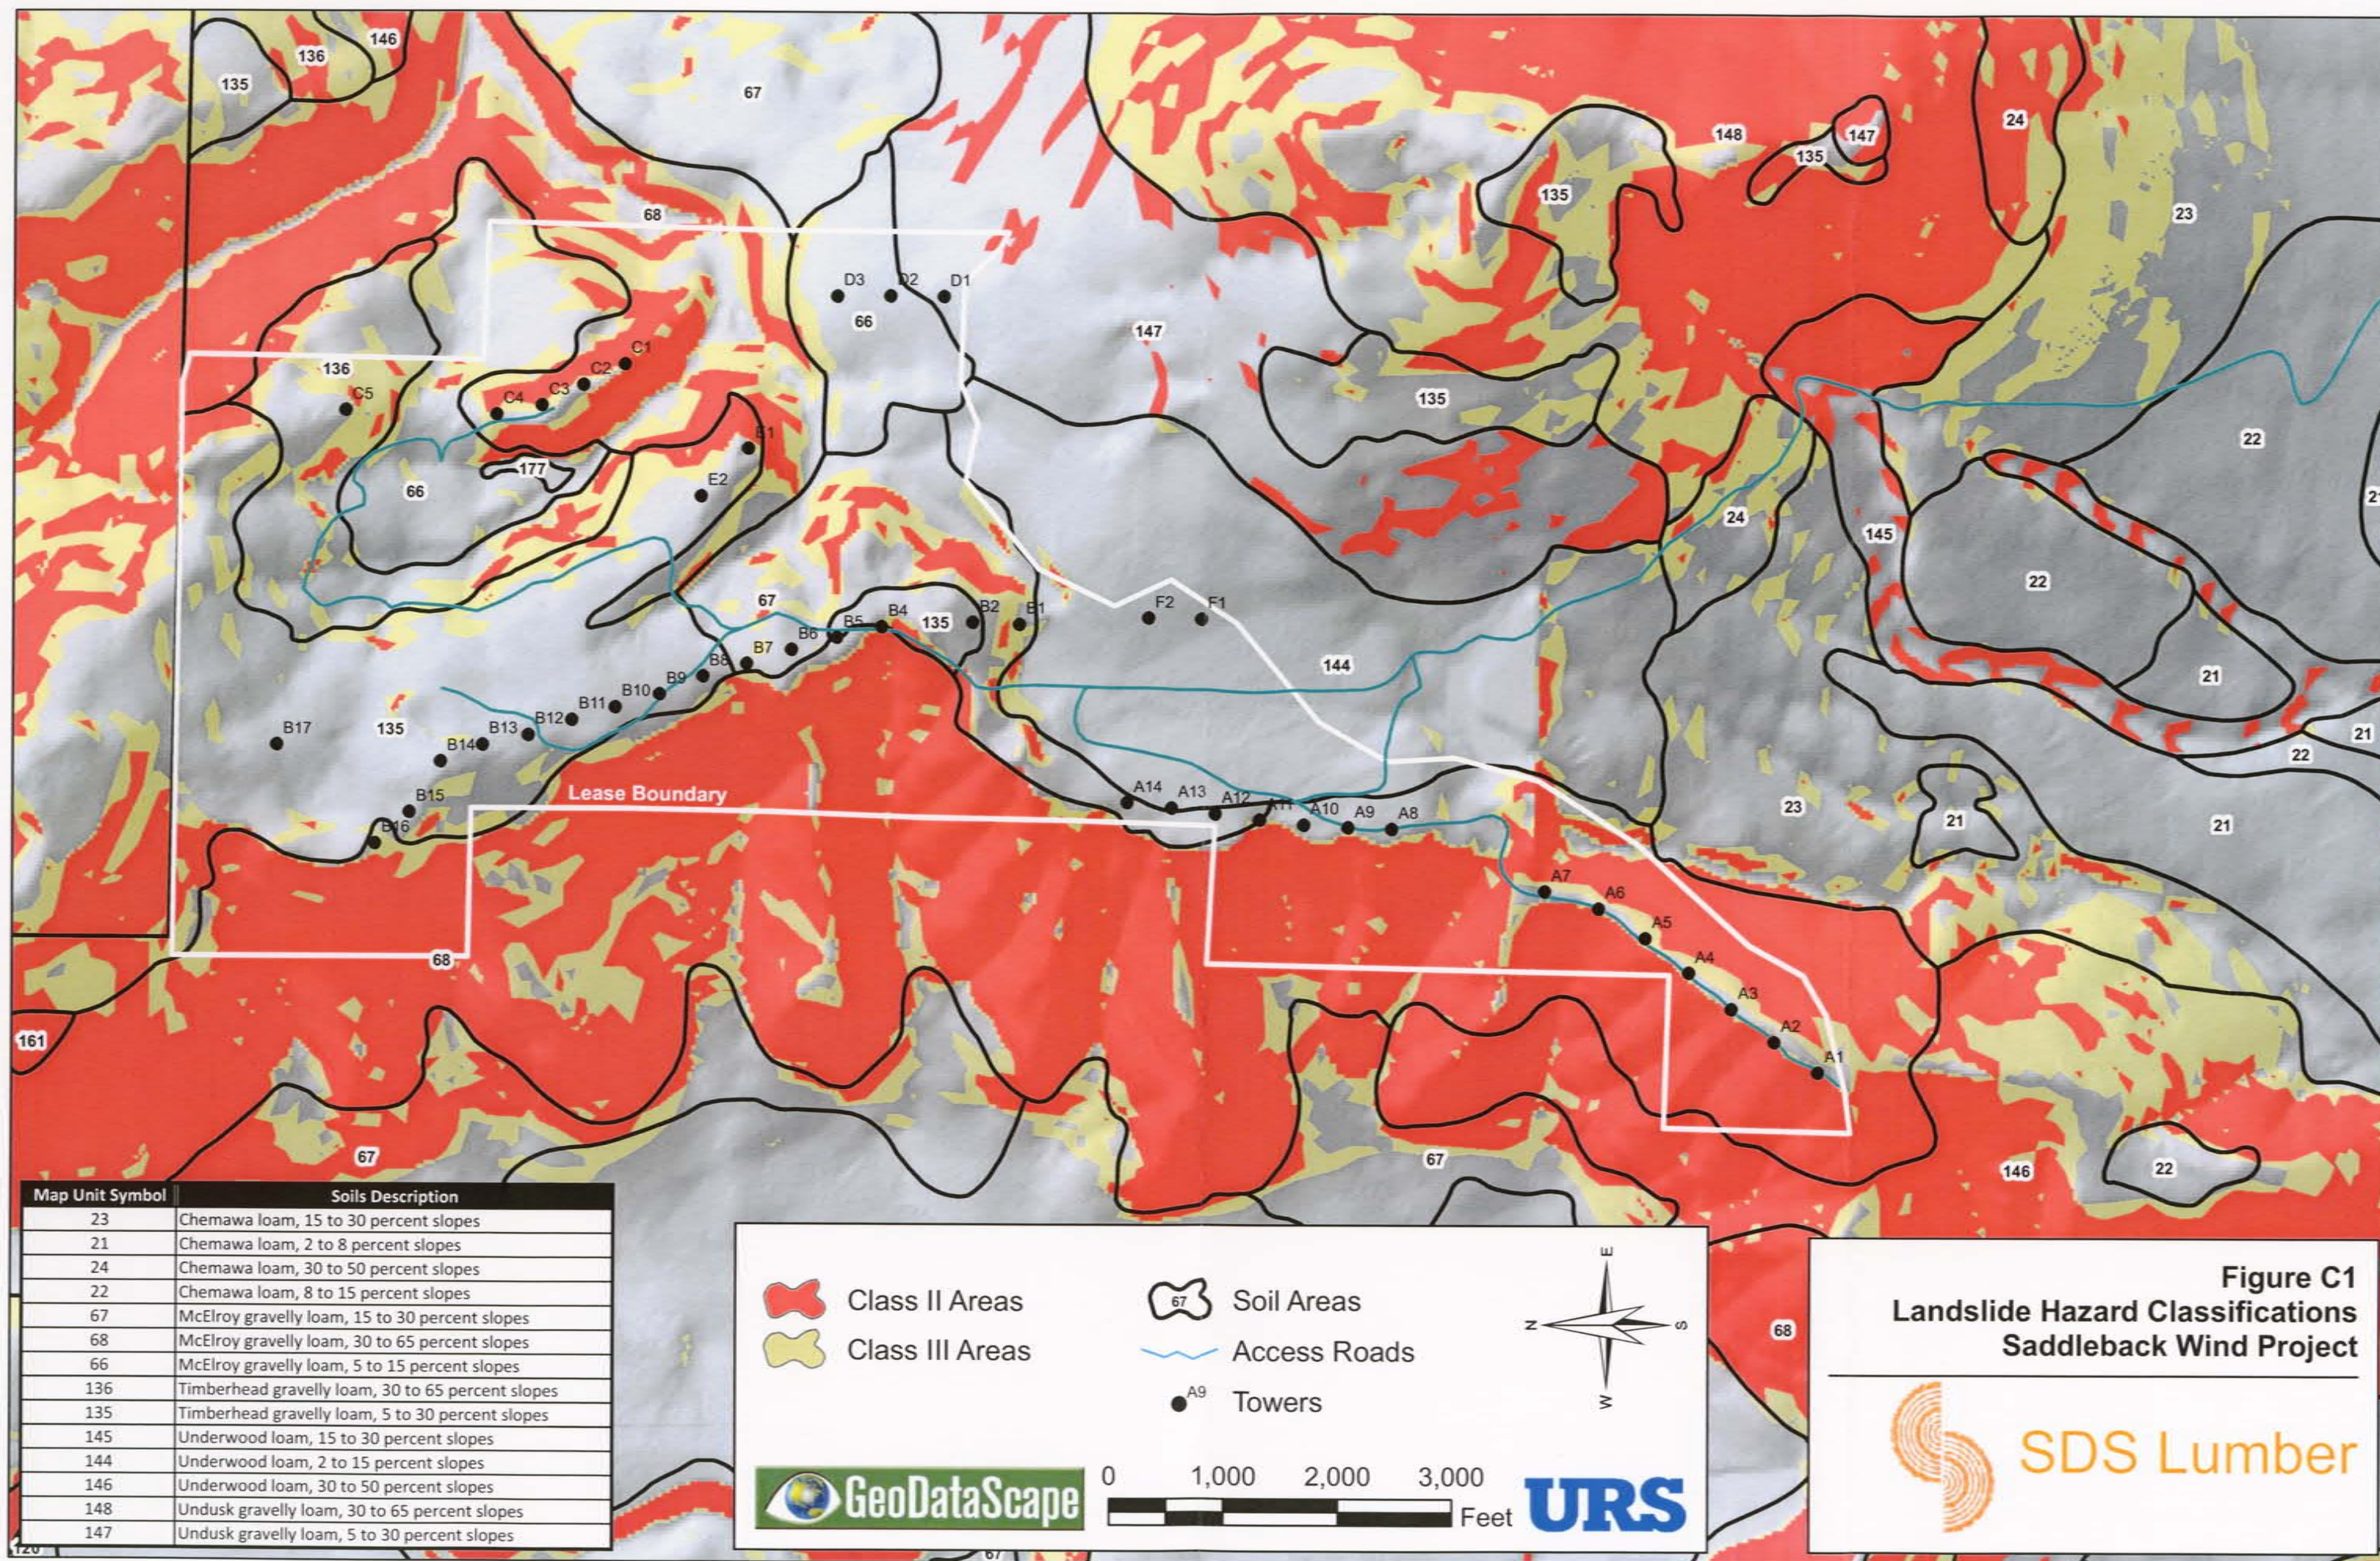
**Figure C1**  
Landslide Hazard Classifications  
Saddleback Wind Project

URS has conducted a Landslide Hazard Evaluation for the proposed SWE wind farm project in Southeast Skamania County. The evaluation has identified several areas where the proposed wind turbine generators are located adjacent to slopes that meet Skamania County's criteria for Class II and Class III Landslide Hazard Areas. The primary hazard to the proposed towers appears to be the potential for exposure to headward erosion of steep drainages on the slopes below some of the tower locations. Exposure of the towers to headward erosion of the steep slope drainages can be minimized by providing maximum possible setbacks from the tops of the steep slopes and / or by siting the turbines along portions of the ridgelines that are above intervening spur ridges. The most critical area of exposure to Class II LHAs is the narrow ridge at the southern portion of the 'A' Line.

Landslide hazards were assessed as part of the public document review, aerial photograph investigation, and field reconnaissance. Results of the landslide hazard review are presented as a separate technical report in Appendix D to this report.
