Subject: Badger Mountain Solar Energy Project: Data Request 3 Response – Wetlands and Waters

Badger Mountain Solar Energy Project

Figure 1 Sample Points and Potential Offsite Wetlands

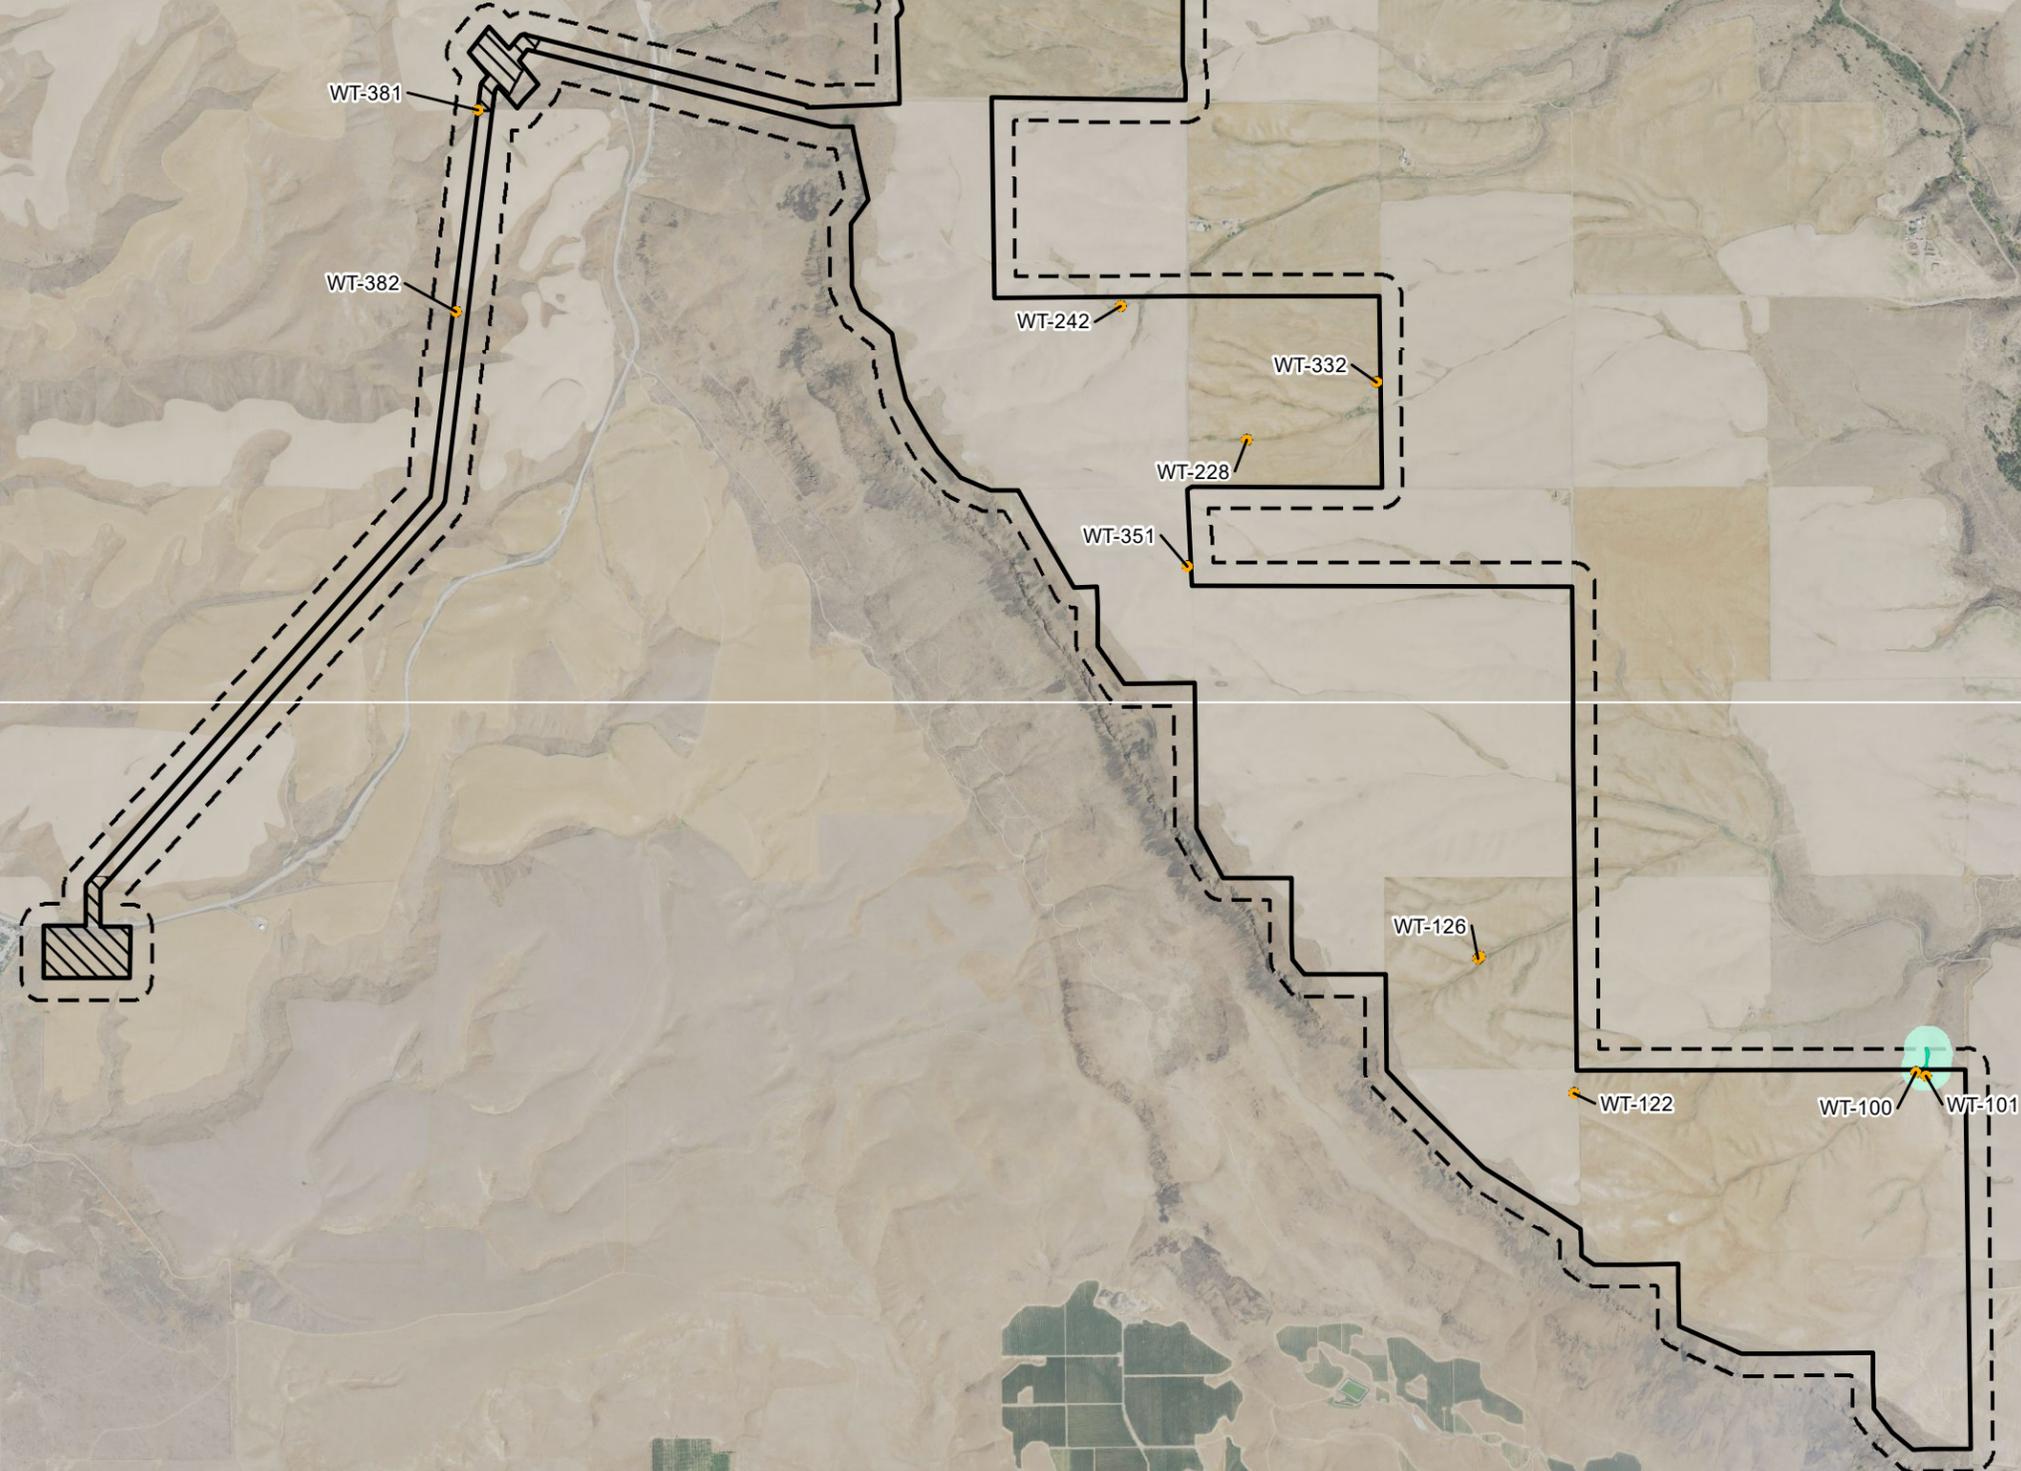
Response: In response to items 1 and 2, Figure 1 shows the locations of additional sample points that were collected in the Project Area and Attachment A provides the data sheets for each sample point.

Response: In response to item 4, Figure 1 shows the location of the potential wetland within a conservative 300-foot buffer of the Project boundary, data sheets for sample points WT-100 and WT-

NHD and NWI locations within the buffer are classified as waterways (R3UBH) without wetland characteristics. There is one location near sample points WT-100 and WT-101 where surveyors did observe some cattails during the growing season outside of the Project area boundary. That desktop delineated wetland is buffered and shown on the attached Figure 1.

- Drawing a conservative 300-foot buffer around the Project Area boundary at the request of EFSEC and the Washington Department of Ecology.
- Analyzing the 300-foot buffer for any signs of water inundation or pooling within the growing season in the historical orthoimagery.
